**Structural and Nonstructural Building System Performance During
Earthquake and Post-Earthquake Fire**

Fire Test Program – Full Report

Department of Fire Protection Engineering
Worcester Polytechnic Institute
Worcester, MA 01609 USA
<http://www.wpi.edu/academics/fpe.html>

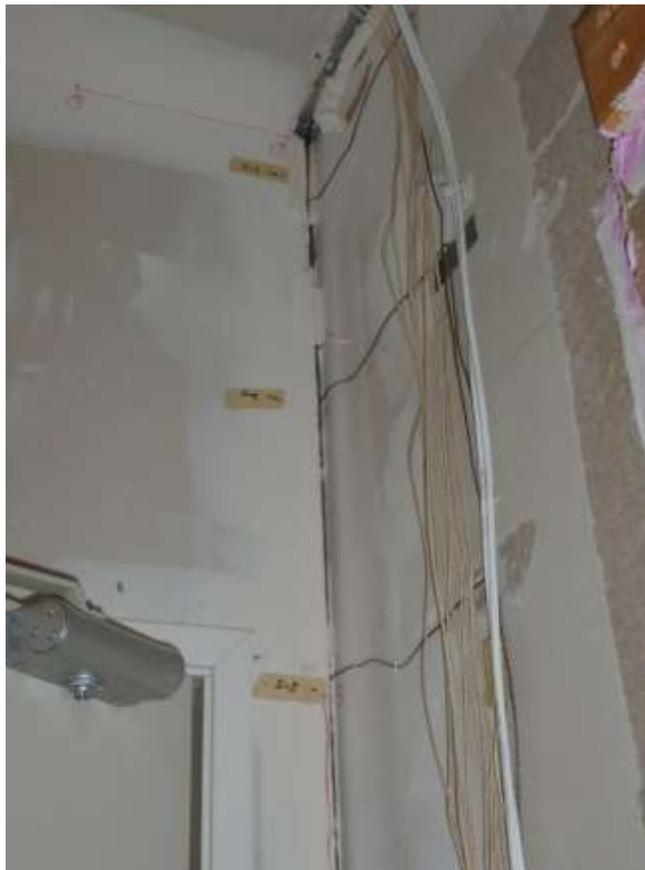
The great increase of the leakage area was induced as seismic motions caused openings to form in various areas. Figure 5.3 shows the gap that was formed between the partition wall and the north wall of the building, increasing the leakage area of the SBR and LBR. This as well as the leaky installation of the fire door on the partition wall caused a greater leakage area only in the SBR compared to the both areas of SBR and LBR combined.

Figure 5.3. Gap formed on the partition wall between LBR and SBR

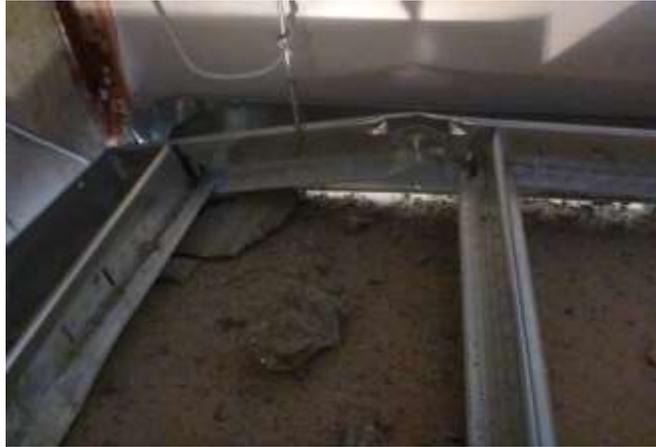
Gaps developed in the joint areas as the building was subject to seismic motions. Figure 5.4 shows the gap in the joint area above the LBR ceiling, allowing for leaks through the balloon framing. Figure 5.5 shows gaps that were formed in the joint areas increasing the overall leakage area.

Figure 5.4. Gap formed in the north wall balloon framing in the joint area above the LBR ceiling

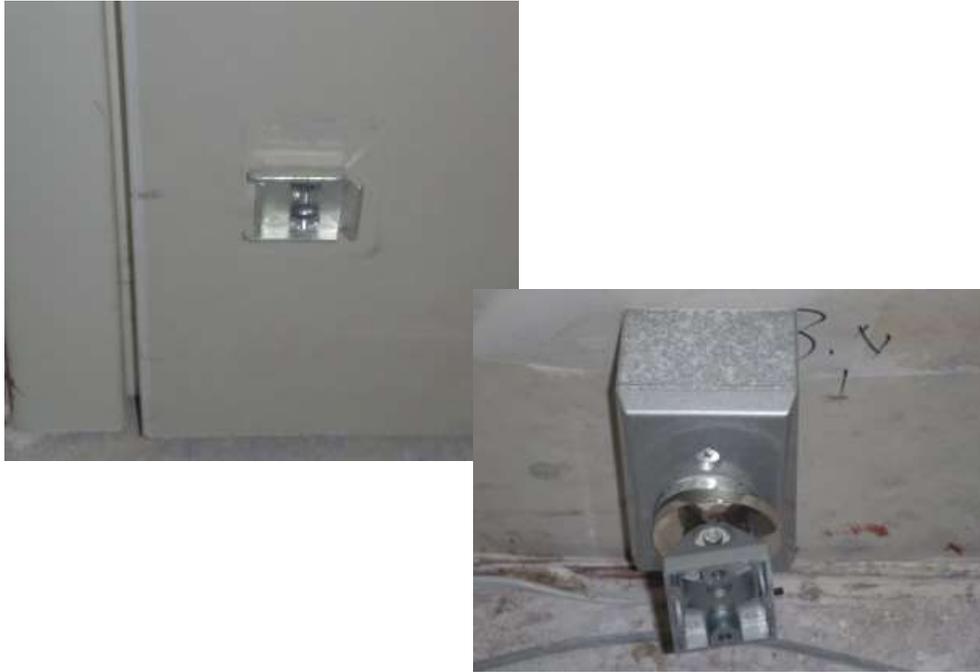
The magnetic door holder of the SBR was found to have been completely ripped off the back of the door, failing to meet the demands of the seismic motions as shown in Figure 5.6.

Figure 5.6. Magnetic door closer failure

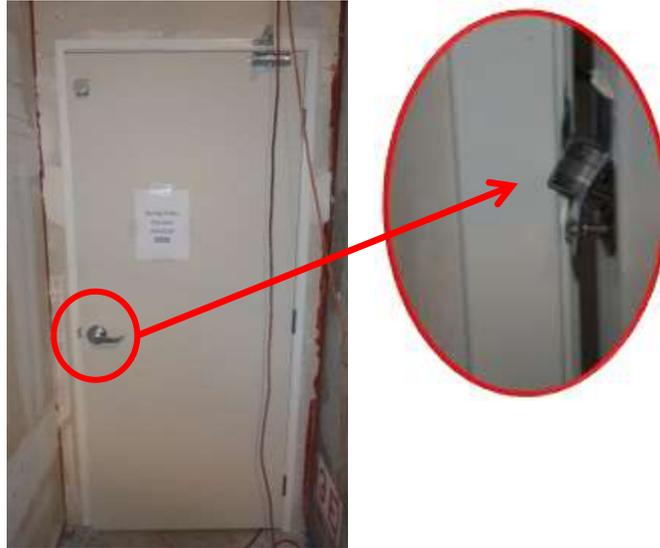
There were other noticeable issues in Floor 3 that were observed to add to the compartmentation issues outside of the room areas. It was found that the door in the corridor area was jammed not allowing for the door to close completely as shown in Figure 5.7.

Figure 5.7. Corridor door jam

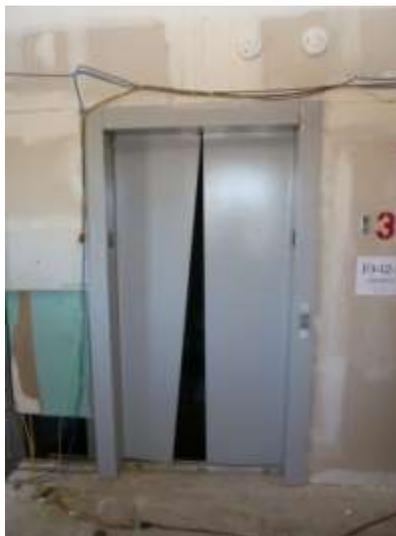
The elevator door was also severely damaged with a large opening was created as the doors were wrecked and failed to close as shown in Figure 5.8.

Figure 5.8. Damage to the elevator door in Floor 3

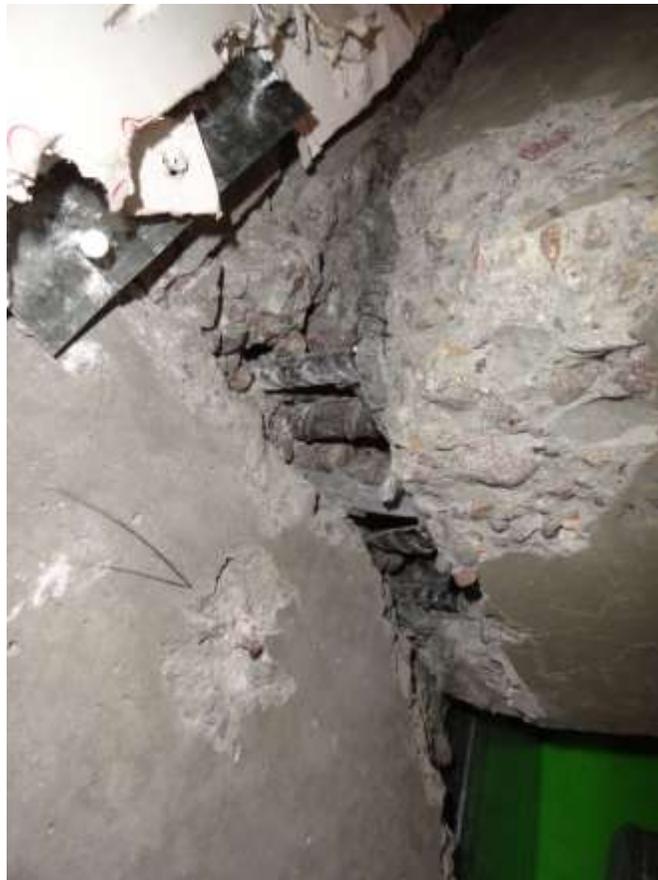
Figure 6.1. Floor 2 north column in the middle

After FB-6, the steel rebars of beam-column connections were completely exposed in several places of the building. Figure 6.1 shows the Floor 2 beam-column connection on the north wall that was damaged. This could severely limit the structural performance and the fire rating of the structural components when exposed to elevated temperatures.

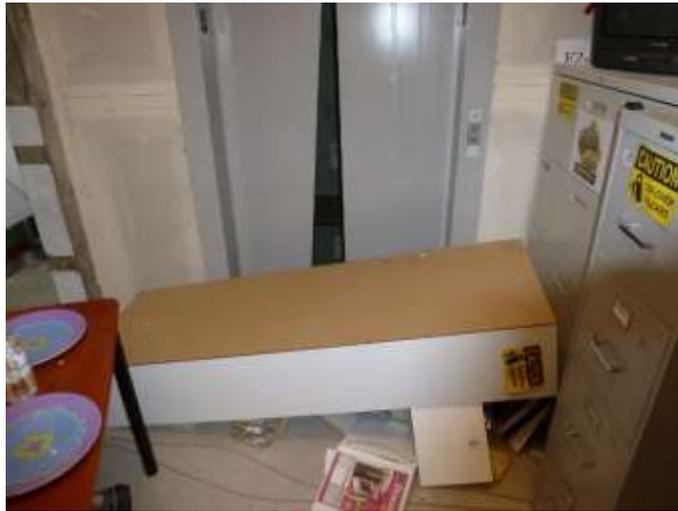
The living room contents of the elevator lobby and the chemical lab equipment in the room area of Floor 2 were greatly displaced and spread throughout the floor following FB-5 and FB-6. Small items such as cups and books as well as large items such as a book shelf, table and an anchored TV were displaced. The items on the floor in Figure 6.2 could be a fuel source for fires.

Figure 6.2. Floor 2 elevator lobby after FB-6

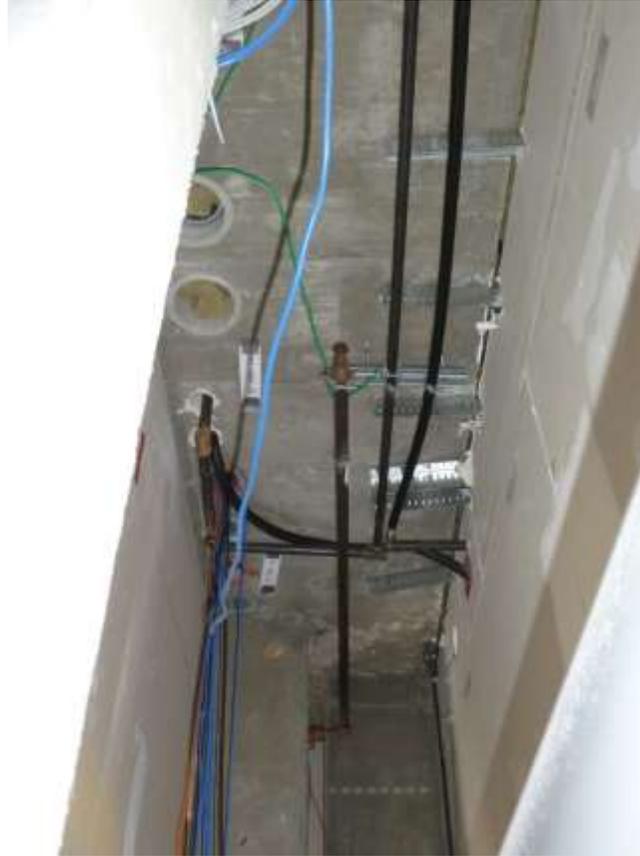
Following the largest ground motion (FB-6), a rigid steel pipe, representative of a fuel gas line, was damaged at a connection on Floor 1. The broken connection is shown in Figure 6.3. In the absence of other protective measures, such as shutoff valves, such a failure could lead to release of fuel gas in a building.

Figure 6.3. Floor 1 rigid gas pipe disconnection

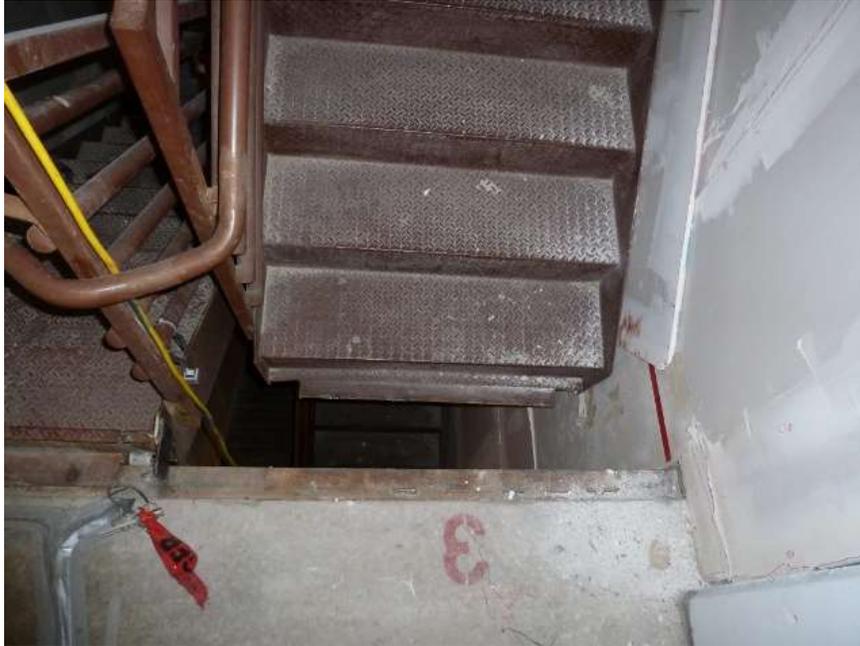
The stair connection failed and detached off of the stair landing on Floor 3 following FB-6 as shown in Figure 6.4. Handrails had been disconnected following FB-5 as shown in Figure 6.5. Gypsum wallboards detached and fell off around the staircase and landing areas as shown in Figure 6.6 and at multiple locations throughout the building. Such issues as well as the displacement of building contents could hinder the evacuation of occupants during building fires.

Figure 6.4. Floor 3 stair landing following FB-6

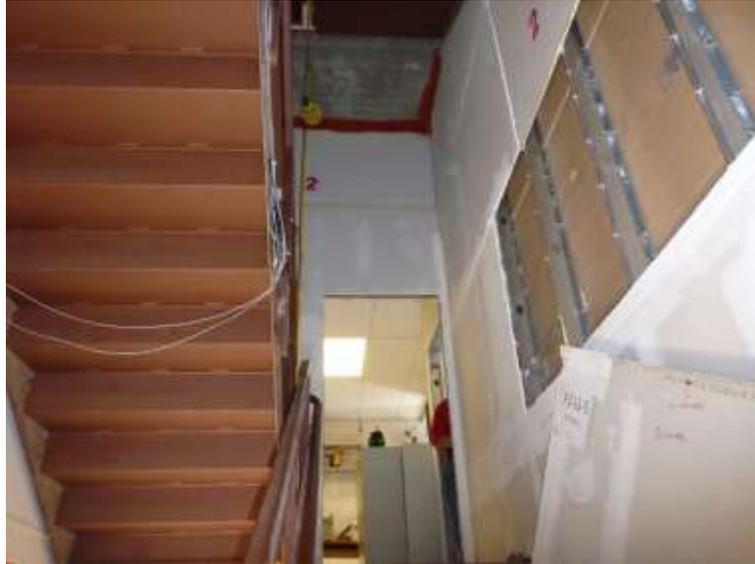
Figure 6.6. Wallboard detachment following FB-6 around intermediate landing of Floor 1 and 2

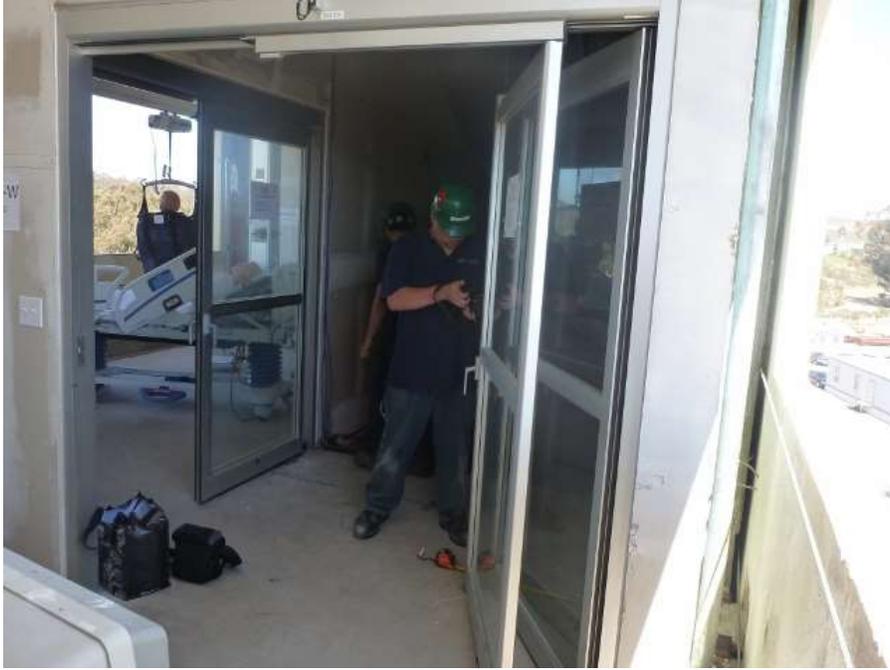
Two ICU breakout doors were installed in the Floor 4 landing area leading to the elevator lobby and ICU room. Both doors performed well and remained intact during the entire seismic test series except for the ICU door from the landing to the elevator lobby was damaged during FB-5. The ICU breakout doorframe performed well but a portion of the door was detached from the doorframe as shown in Figure 6.7.

Figure 6.7. ICU breakout door on Floor 4 following FB-5

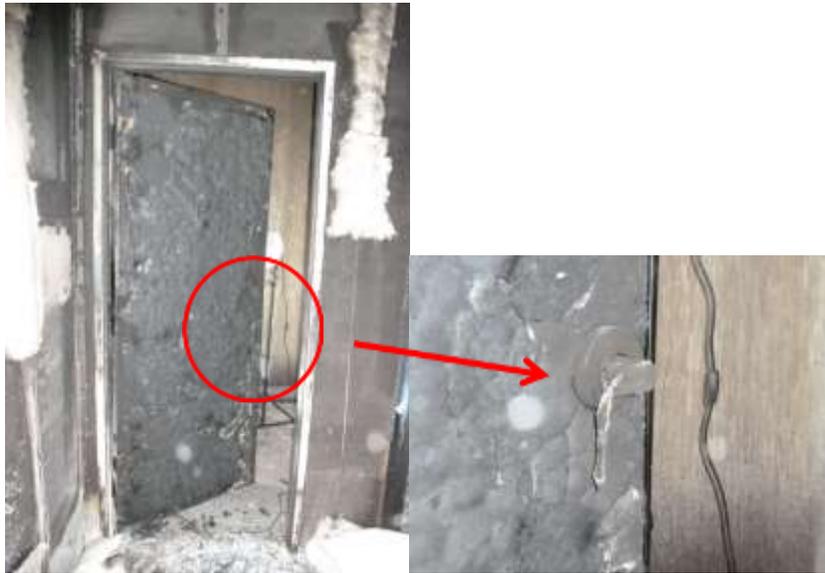
Figure 8.28. Partition wall door 1 after LBR-2 fire test

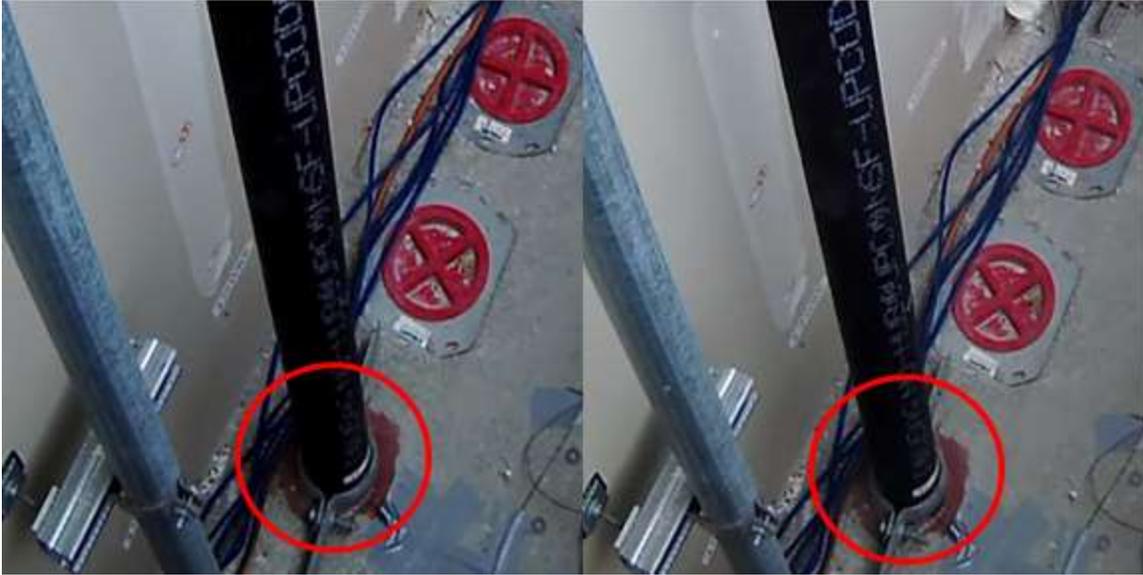
Figure 9.1. Lifting of vertical pipe penetration firestop during ES fire test
