Earthquake and post-earthquake fire performance of a mid-rise cold-formed steel framed building

Tara Hutchinson, Xiang Wang, Gil Hegemier¹, Brian Meacham, Praveen Kamath², Fernando Sesma³ and Kelly Holcomb⁴

Abstract

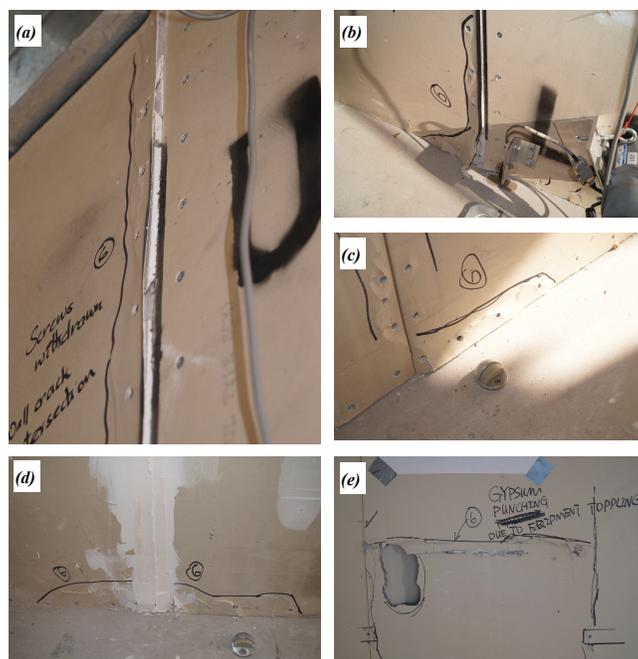
Due to the low seismic demands during the service level tests at all levels of the test building (PFA < 0.5 g, PIDR < 0.1%), the interior sheathing sustained only a few instances of minor damage (DS-1) in the form of incipient screw withdrawal and localized gypsum crushing at bulging at level 3 and 4 while no visible damage to interior sheathing occurred at all other levels. The extant of sheathing damage, however, was considered inadequate to classify the walls into an appreciable damage state. Damage to the interior sheathing however did continue to develop as the seismic drift demand increased during the 50% design event (EQ5) and design event (EQ6). Screw withdrawal and gypsum crushing of the

corridor shear walls and gravity walls became more pervasive at all levels (except level 6), in particular at the corridor shear wall–gravity wall boundaries as well as the window and door openings (Figure 19a-d). In contrast, damage to the corner shear walls remained minor, as they occurred only in the form of localized gypsum crushing at the corner and formation of gaps between gypsum panels. Since the interior gypsum was mudded and tapped at level 2 and 6 (in preparation for the fire tests), tape cracking or flaking along the panel joints was also observed at these levels. Other ancillary damage was also noted, for example, a punched opening was detected on the gypsum panels at the northeast room at level 6 due to the toppling of a water heater during EQ6 (Figure 19e).

Figure 19. Sheathing damage following the design level test (EQ6): (a) corridor shear wall–gravity wall boundary at level 4 (upper), (b) (a) corridor shear wall–gravity wall boundary at level 4 (lower), (c) pervasive screw withdrawal and corner crushing of gravity wall at level 4, (d) corridor gravity wall boundary crushing at level 2, and (e) a punched opening on the gypsum panel at level 6.

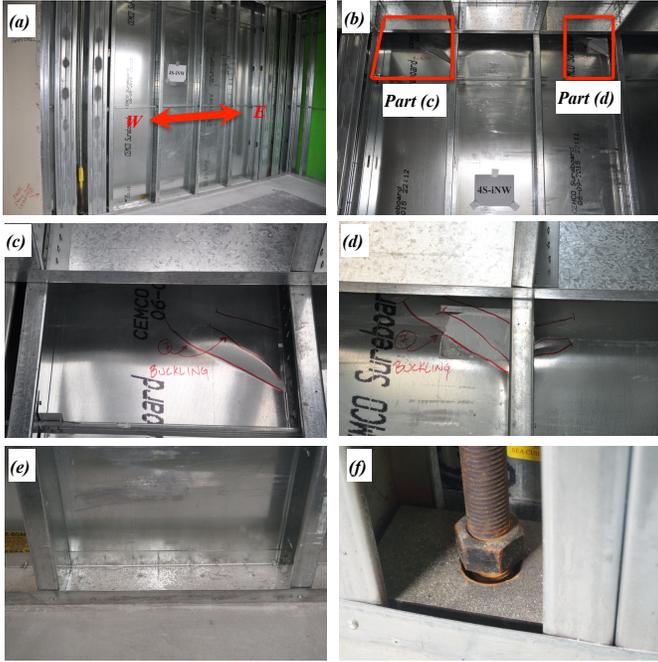
Following the completion of the pre-fire earthquake test sequence, the gypsum panels of the northwest compartment at level 4, which represented the level with the largest drift demand during the pre-fire test sequence, were removed to allow for inspection of the shear wall framing and sheathing steel (Figure 20a). As shown in Figure 20b-d, localized buckling of the sheathing steel was detected at the top of corridor shear wall, while the framing studs and tracks did not sustained apparent damage (Figure 20e). In contrast, the

wall framing and sheathing steel of the corner shear wall in the same compartment sustained no apparent damage. In addition, loosening of the bolts at the floor bearing connections was detected, resulting in very loose tie rods at the end of the pre-fire sequence.

Figure 20. Longitudinal corridor shear wall framing following the pre-fire MCE test (EQ7): (a) wall framing, (b) localized buckling at the top of sheathing steel, (c) and (d) close-up of the localized buckling, (e) bottom track, and (f) loosened bolt of the tie-rod bearing connection.

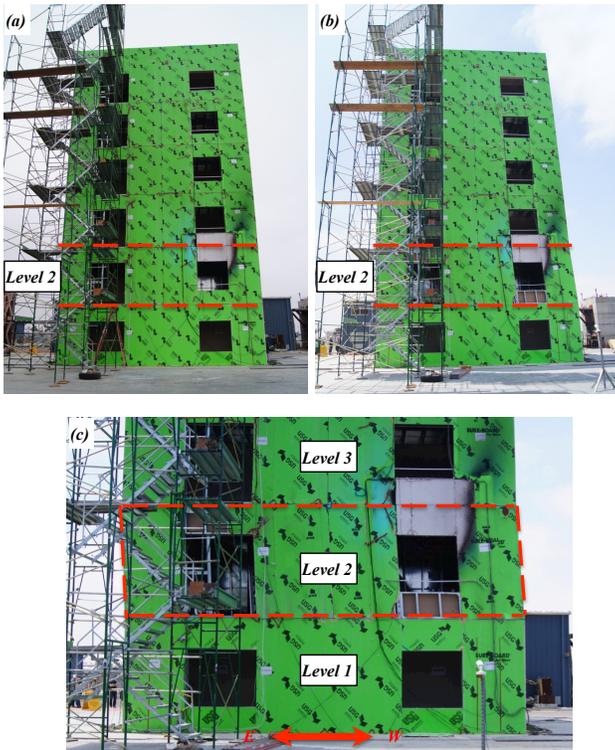
the structural panels by removing the compartment-side interior gypsum panels. Due to the extremely large drift demands at level 2 of the test building (transient PIDR > 12% and residual IDR ~ 6%) during EQ9, the building developed a soft-story mechanism at the completion of the extreme event test (Figure 24).

Figure 24. North exterior elevation of the test building: (a) pre-EQ9 condition, and (b) post-EQ9 condition, and (c) post-EQ9 condition at the lower three levels.

The excessive interstory drift demands are associated with severe damage to the structural components of level 2 and, importantly, revealed the ultimate damage mechanism of the lateral loading resisting system. The test building, however, resisted collapse largely due to redistribution of loads and the framing action of the continuous rod tie-down system. Despite the larger interstory drift demands, the damage to the building at all remaining levels was similar to those observed in the pre-fire test sequence. In this regard, herein the focus is on observed damage of level 2. Interested readers are referred to the technical report (Wang et al., 2017b) for additional damage documentation.

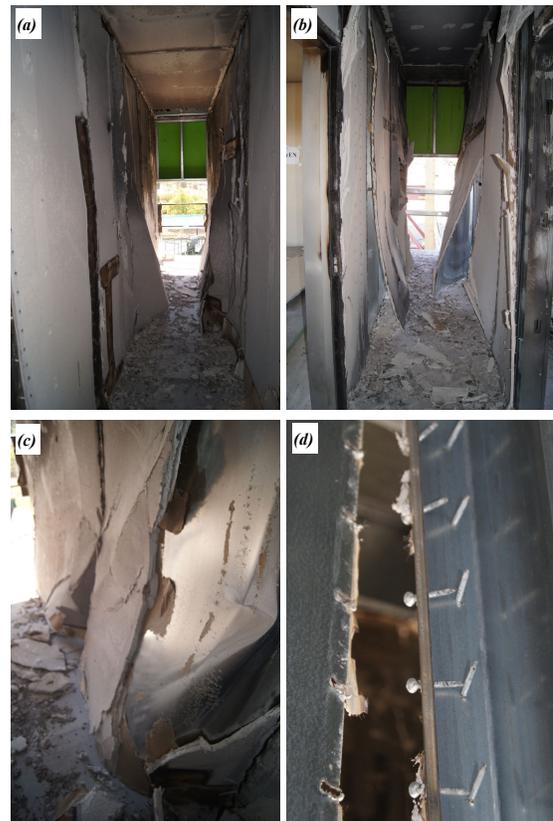
Figure 25 offers an example of the structural sheathing damage of the corridor and the four compartments. It is noted that steel sheathed panels of the corridor shear walls were located on the corridor side, while those of the corner walls were located on the exterior side. On the other hand, the building interior (compartment side) was all sheathed with

Evident in the post-event physical inspection was the near complete tearing of a large extent of the structural sheathing, partial or full-delamination of sheathing face gypsum and associated detachment of gypsum on the opposing face. Consequently, structural components of the wall (framing members) suffered extensive global and local buckling (e.g. Figure 26).

Figure 25. Damage observed to corridor shear wall steel sheathed panels following the completion of the extreme MCE event (EQ9): (a) east corridor, (b) west corridor, (c) global buckling of steel sheathed panels, and (d) fastener pull-over failure.

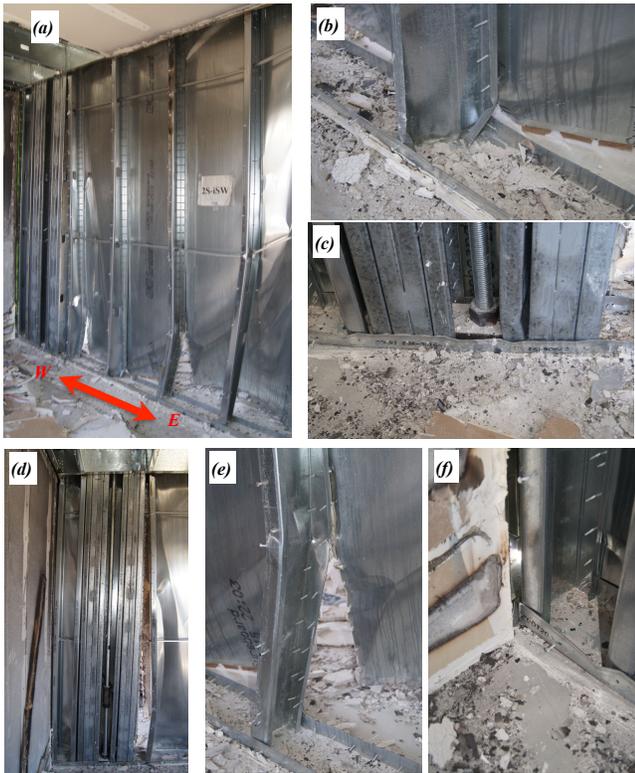
Figure 26. Damage observed to Southwest corridor shear wall at level 2 following of the extreme MCE event (EQ9): (a) wall framing, (b) vertical study local buckling at the base and stud-to-track connection failure, (c) compression post local buckling at the base, (d) tie-down assembly (west side), (e) stud global buckling, and (f) uplifted bottom track at the west end of the wall.
