**STRUCTURAL SYSTEMS
RESEARCH PROJECT**

Report No.
SSRP-16/07
CFS Test Program
Report #1

**Earthquake and fire performance of
a mid-rise cold-formed steel framed
building – test program and test
results: *Rapid Release Report***

December 2016

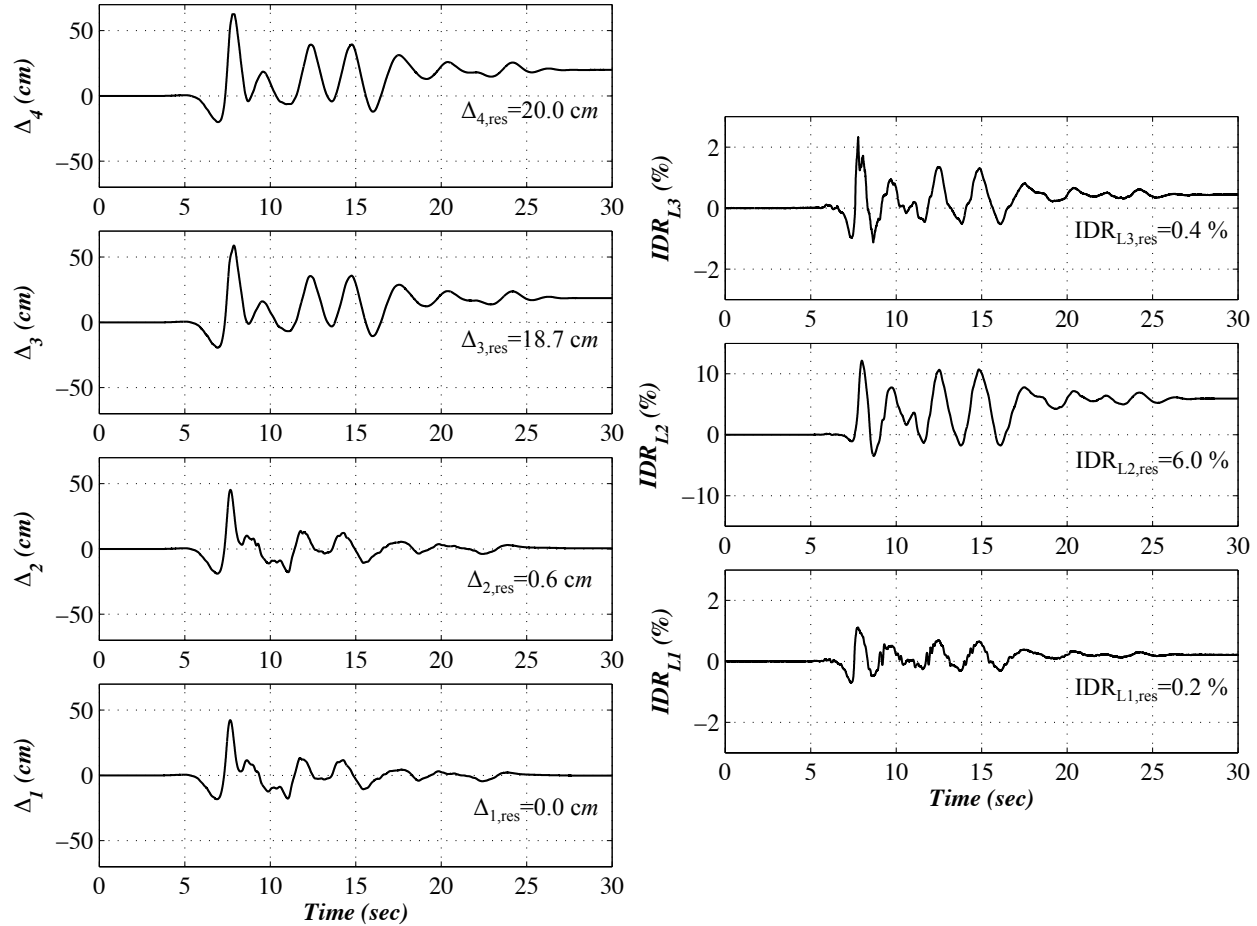
As shown in Table 5.1, the test building sustained extremely large residual displacement demands during the last earthquake test (EQ9). Figure 5.5 presents the absolute displacement and interstory drift ratio time histories of the lower three levels during test EQ9. It is noted that the displacements were measured directly using the string potentiometers located on the east side of the building. As clearly shown in the figure, the residual displacements at the lower two floors were relatively small (< 1 cm) but increased significantly to 19 cm at floor 3 and 20 cm at level 4, indicating that about 90% of the residual building drift was concentrated at level 2. This observation is further demonstrated by comparing the residual interstory drift results of level 2 with the adjacent levels (about 6% at level 2 as compared to only 0.4% for level 3 and 0.2% for

level 1). The transient PIDR at level 2 were also significantly larger than those of the adjacent levels, attaining a value of about 12% in the positive (east) direction and above 4% in the negative direction.

Figure 5.5. Time histories of the absolute displacement of the lower four floors and interstory drift ratio of the lower three levels during test EQ9.

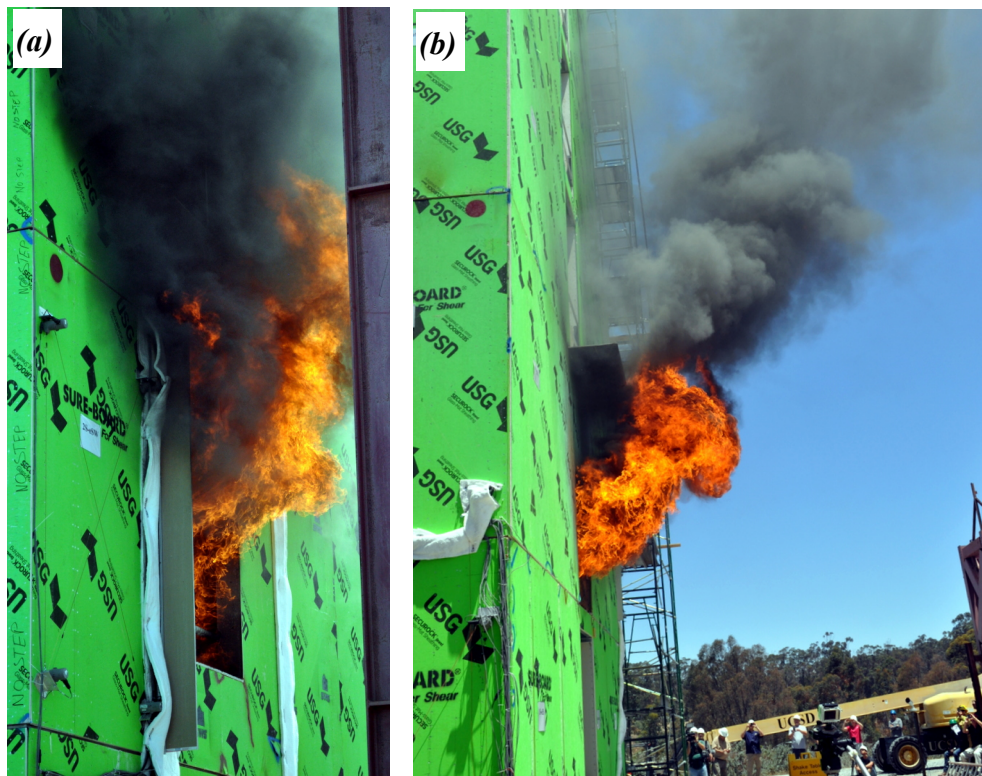
height extended ~ 3 m vertically and ~ 1 m horizontally. In addition, smoke also spread out from the window opening of the adjacent compartment, indicating the propagation of smoke through the adjacent compartment due to the failure of the fire-rated door. During Fire test 4 (the corridor at level 2), flame and smoke was observed at the opening at the east end of the corridor in about 40 seconds from ignition. While the flame extension was contained by eastward wind in the initial burning stage, the flame extended up by 3.0 m and the smoke up to 6.0 m in about 150 seconds from ignition due to the prevailing wind condition. In addition, the horizontal flame extended 1.8 m due to the congruent nature of the direction of wind flow and the openings that created a ‘tunnel effect’. This is confirmed by the absence of flame extension around the opening at other end of the corridor. Smoke propagation from the corridor to the adjacent compartments was also observed in this test. This revealed the ineffectiveness of fire-rated door and gypsum wallboard in containing the flame and smoke spread.

Figure 5.12. Flame and smoke extension from the compartment openings: (a) Fire Test 1, and (b) Fire Test 4.

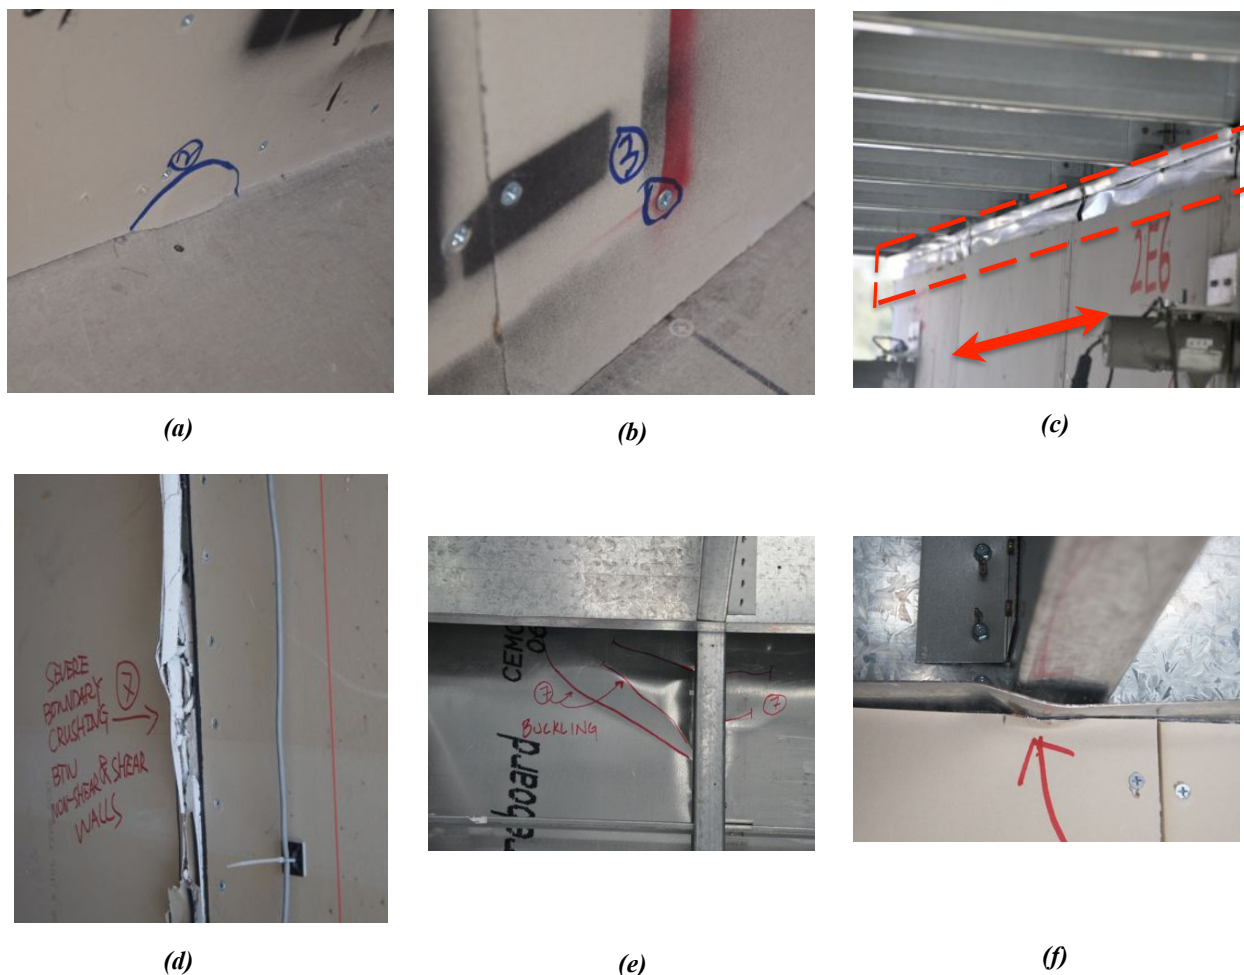
(PIDR > 1.5%). In addition, rim track flange buckling was detected at several locations of at level 3 and 4 (Figure 5.13f).

Figure 5.13. Damage to the test building during the pre-fire earthquake test sequence: (a) gypsum bulging on the bottom edge (EQ2), (b) gypsum screw popping (EQ3), (c) buckled sheet steel of corridor shear wall at level 1 (EQ6), (d) sheathing panel crushing between the shear wall and gravity wall at level 4 corridor (EQ7), (e) buckled composite panel sheet steel of corridor shear wall at level 4(EQ7), and (f) buckled rim track flange above gravity wall at level 4 (EQ7).

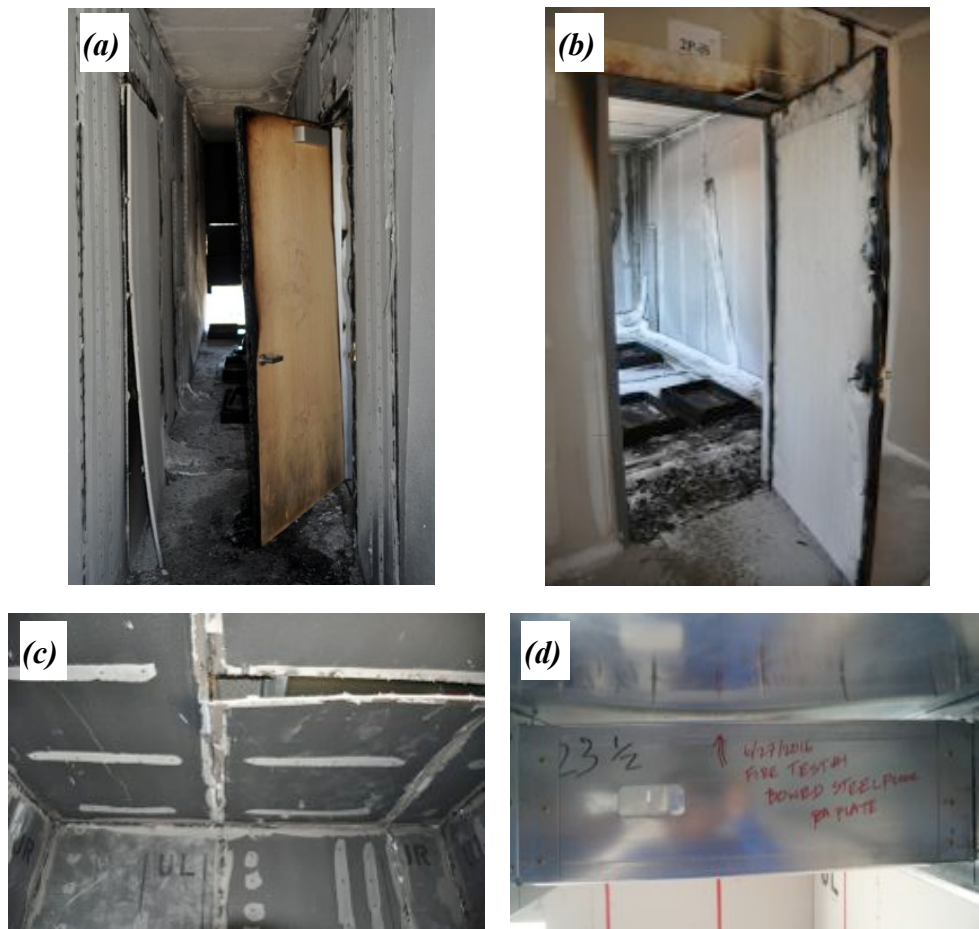
(about 1.5 cm) of the floor system at the second floor as a result of deteriorated cement boards on top of the sheet steel (Figure 5.14d).

Figure 5.14. Damage to the test building following the fire tests: (a) level 2 corridor, (b) partially detached door, (c) partially detached gypsum ceiling, and (d) sagging floor system at the second floor.

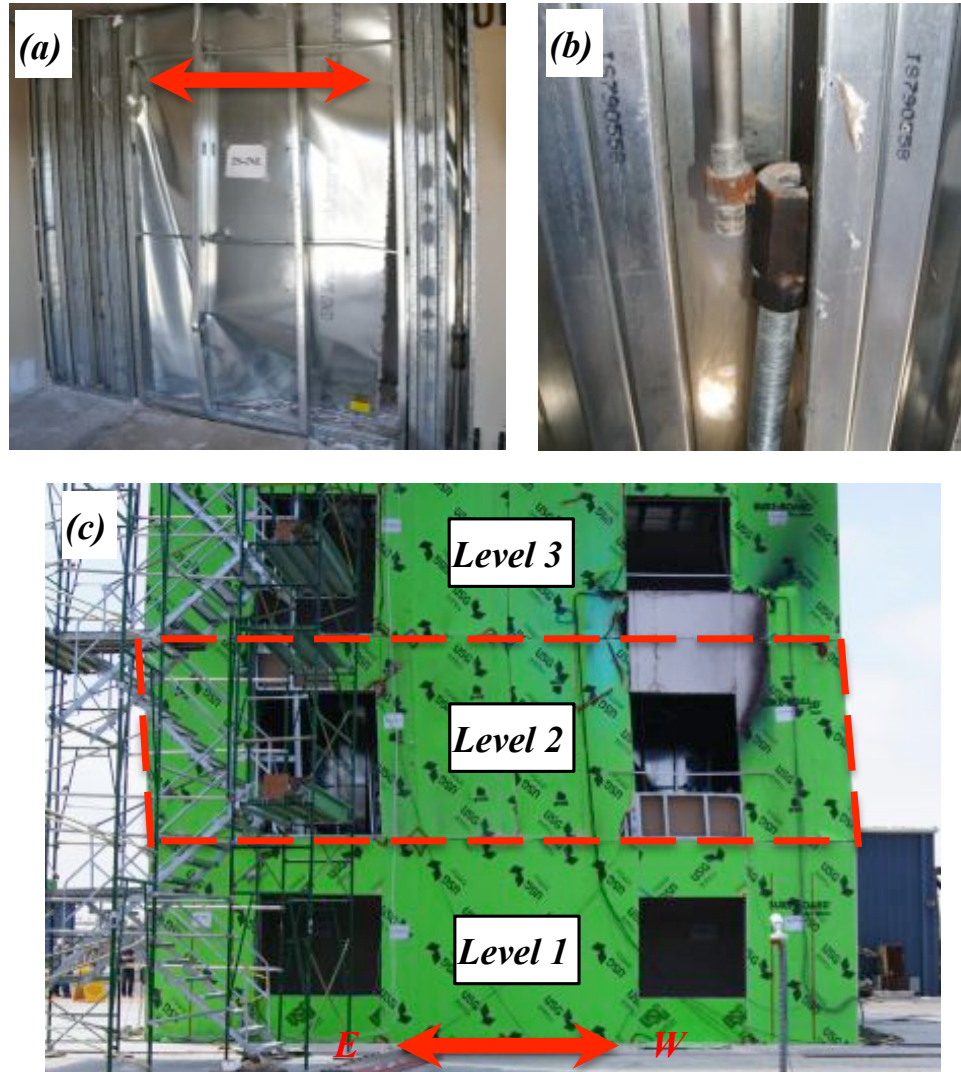
addition, one instance of tension rod connection failure was observed at the longitudinal wall of the southeast corner (Figure 5.15b). The test building, however, resisted collapse largely due to redistribution of loads and framing action of the building rod tie-down system.

Figure 5.15. Damage of the test building at the completion of the test program: (a) severely damaged corridor shear wall at level 2, (b) dislodged tension rods at the corner shear wall at level 2 (southeast room), and (c) north façade of the building at the lower three levels with apparently residual drifts at level 2.

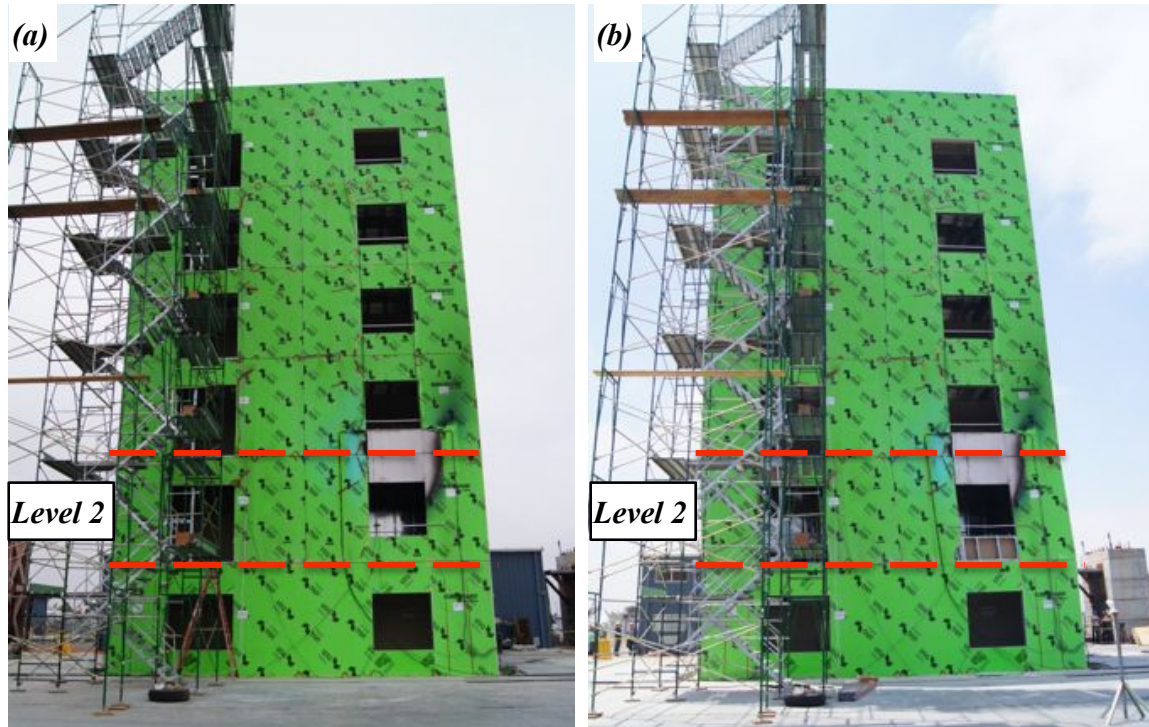
Figure 5.16. North elevation of the test building: (a) pre-EQ9 condition, and (b) pre-EQ9 condition.

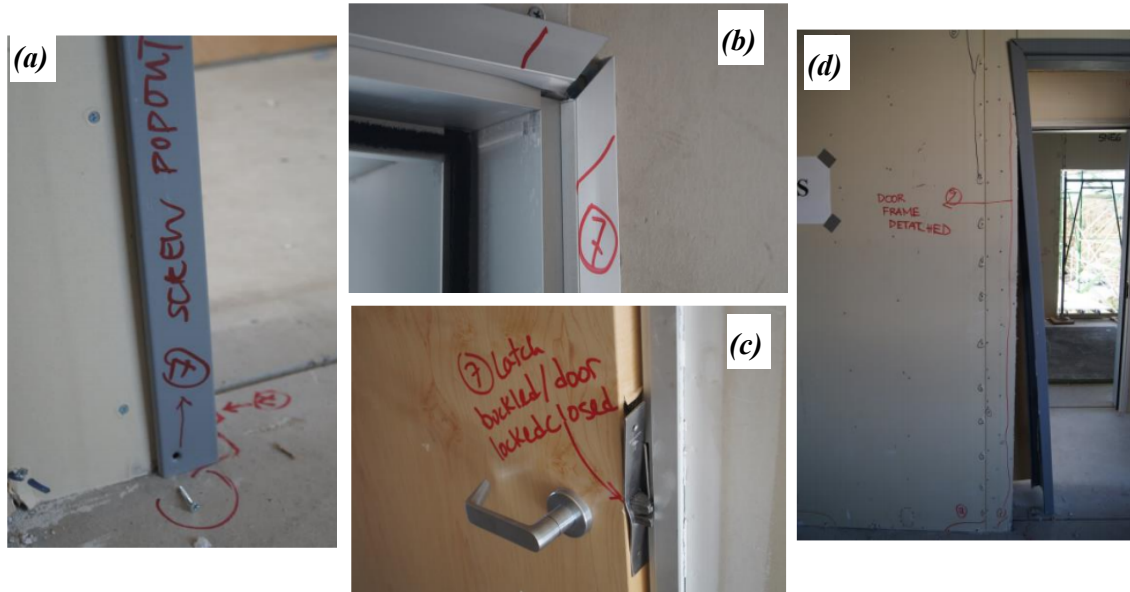
Physical damage to the doors was inspected at four inspection stages throughout the test program: post-EQ3, post-EQ6, post-EQ7 and post-EQ9. Dependent on the severity of damage and their implications related to functionality, the observed damage was categorized into three damage states (DSs). The damage states and the associated physical damage characteristics are presented in Table 5.3, and the typical damage modes as observed during the earthquake tests are illustrated in Figure 5.17.

Figure 5.17. Examples of door damage: (a) door frame screw popping (DS-1), (b) door frame gapping (DS-2), (c) buckled door latch (DS-2), and (d) detached door frame (DS-3).
