# STRUCTURAL SYSTEMS RESEARCH PROJECT

Report No. **SSRP-16/08**

CFS Test Program Report #2 Earthquake and fire performance of a mid-rise cold-formed steel framed building – test program and test results: *Final Report*

Xiang Wang, Tara Hutchinson, Gilbert Hegemier, Srikar Gunisetty (UCSD)

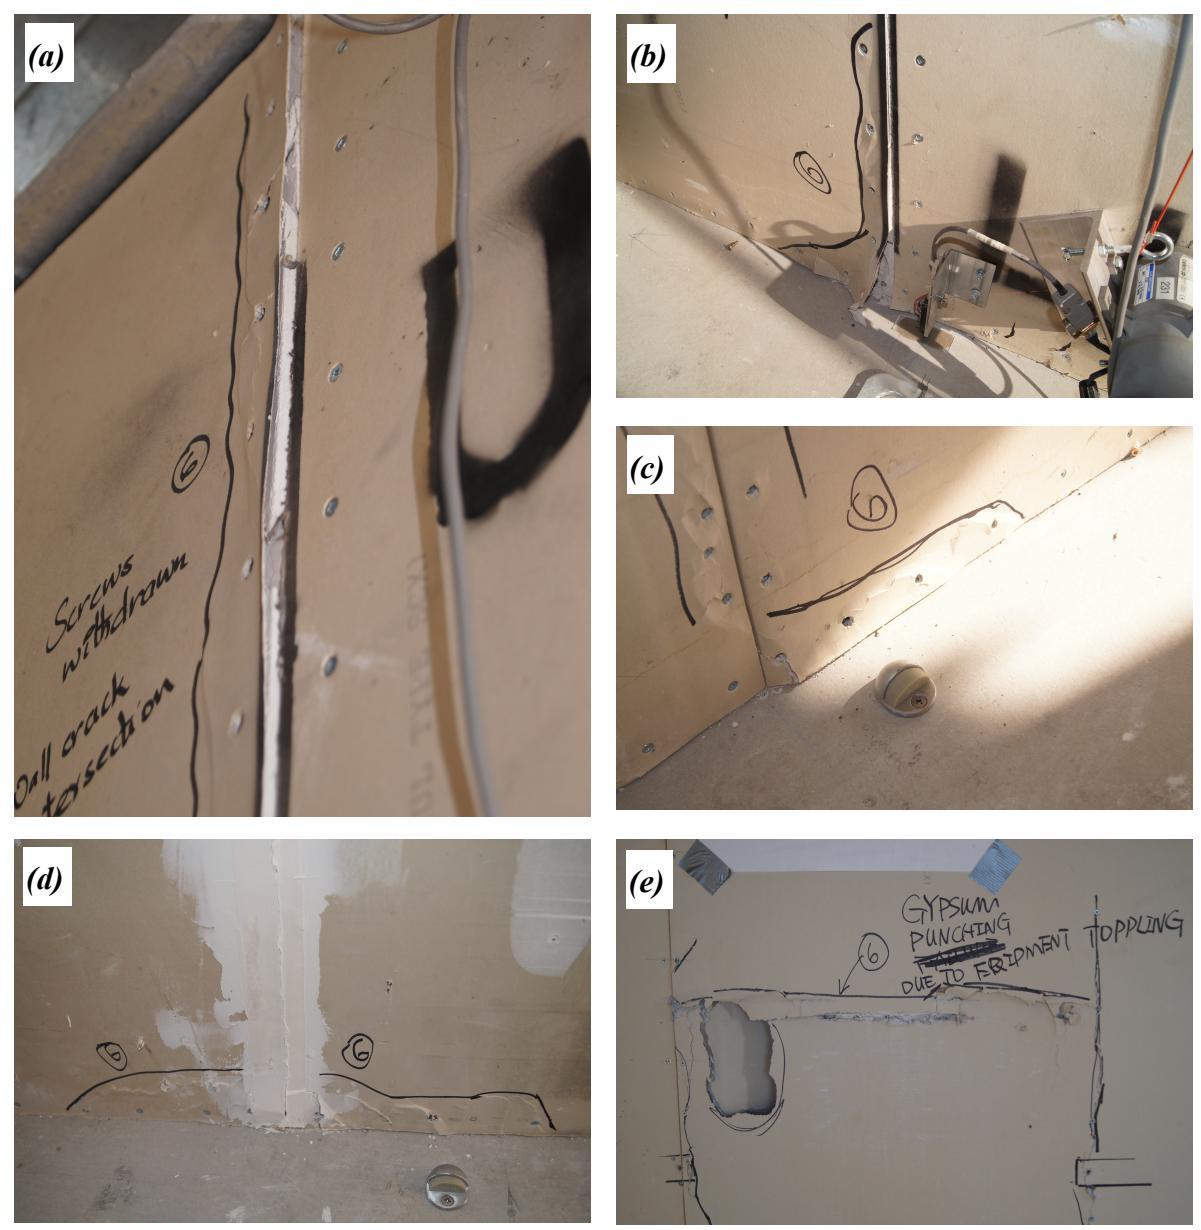
Figure 6.73. Sheathing damage following the design level test (EQ6): (a) corridor shear wall–gravity wall boundary at level 4 (upper), (b) (a) corridor shear wall–gravity wall boundary at level 4 (lower), (c) pervasive screw withdrawal and corner crushing of gravity wall at level 4, (d) corridor gravity wall boundary crushing at level 2, and (e) a punched opening on the gypsum panel at level 6.

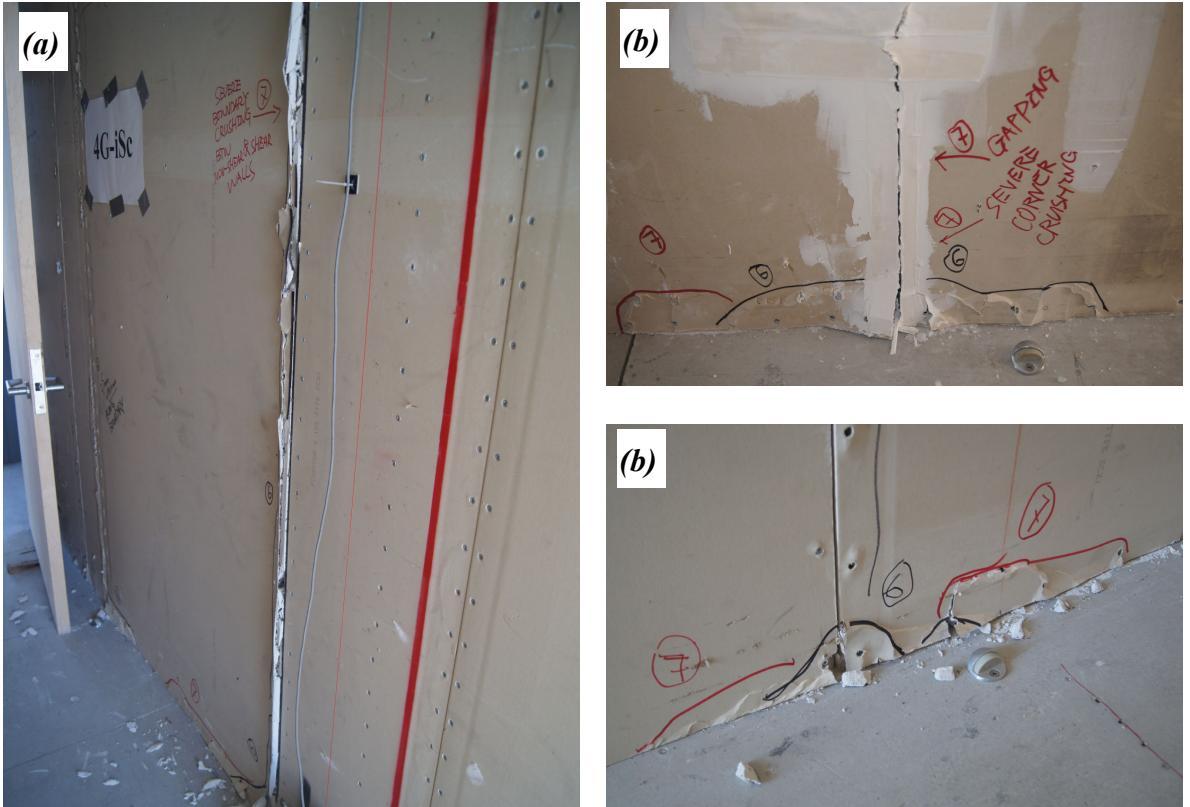
Figure 6.75. Interior sheathing damage at the completion of the MCE test (EQ7): (a) corridor shear wall–gravity wall boundary at level 4, (b) corridor shear wall–gravity wall boundary at level 2, and (c) continued corridor gravity wall boundary crushing at level 6.

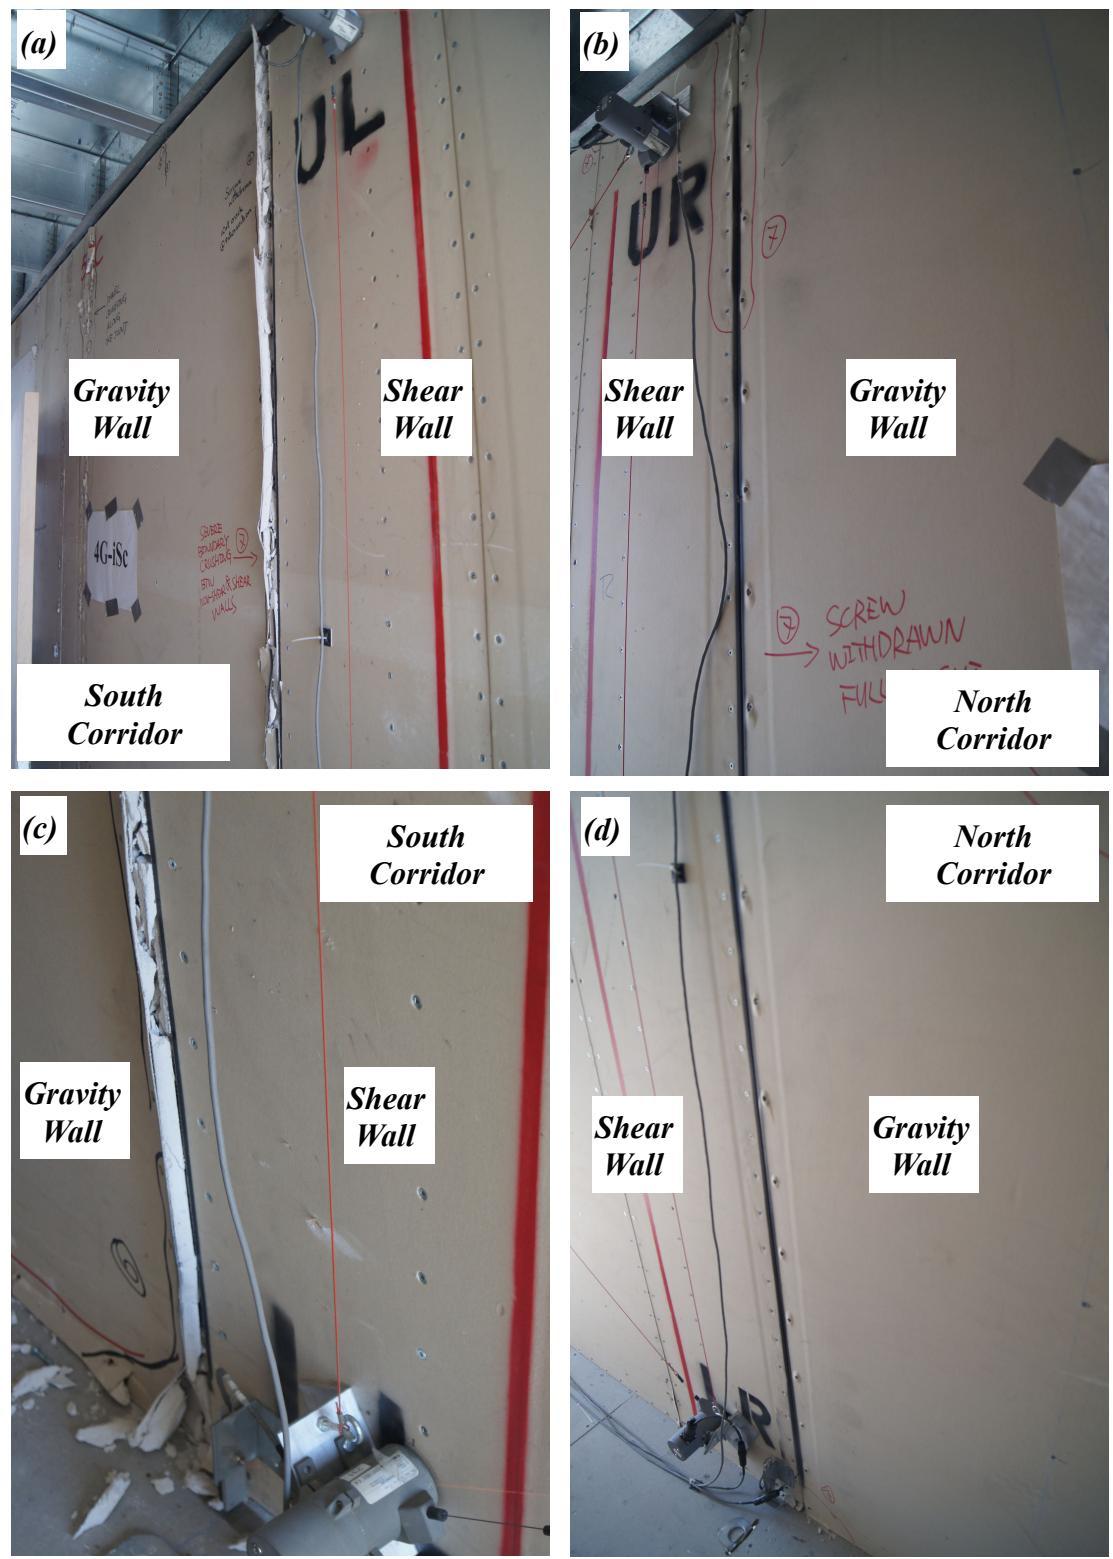
Figure 6.76. Comparison of corridor shear wall–gravity wall boundary sheathing damage following the MCE test (EQ7): (a) upper boundary – south corridor walls, (b) upper boundary – north corridor walls, (c) lower boundary – south corridor walls, and (d) lower boundary – north corridor walls.

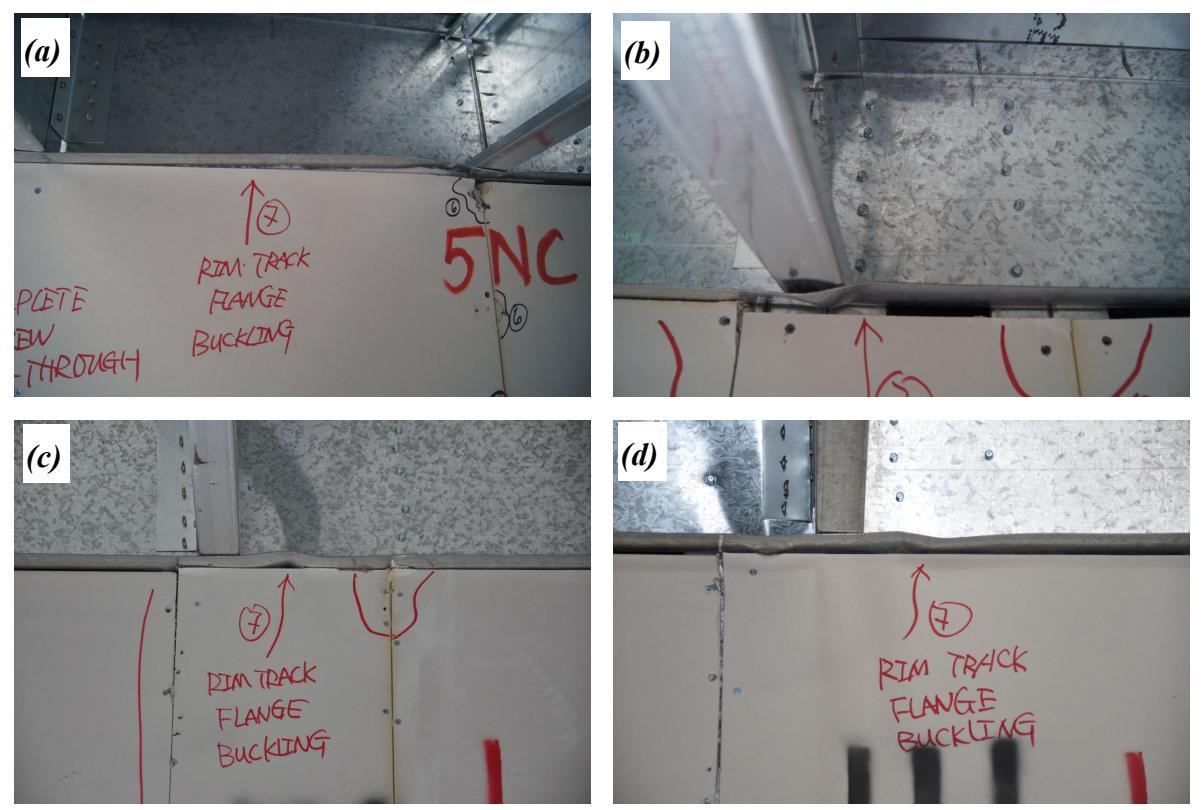
Figure 6.77. Damage to joist rim tracks following the pre-fire MCE test (EQ7): (a) buckled rim track flange above the level 4 corridor door opening, and (b) buckled rim track flange and web above the level 4 window opening, (c) buckled rim track flange and web above the level 5 corridor door opening, and (d) buckled rim track flange above the level 5 window opening.

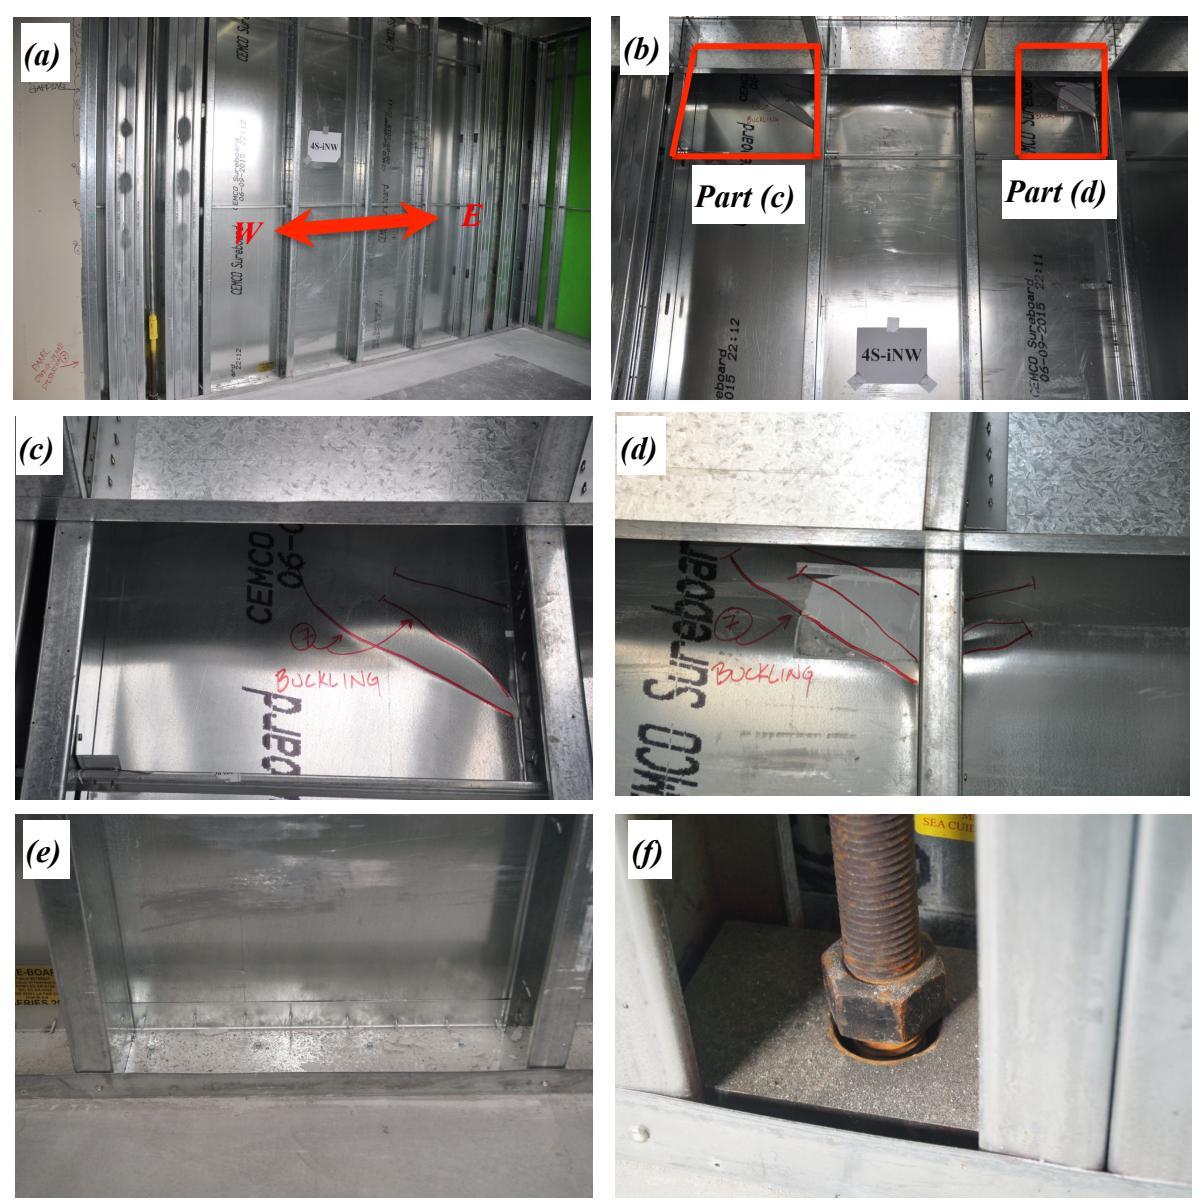
Figure 6.78. Longitudinal corridor shear wall framing following the pre-fire MCE test (EQ7): (a) wall framing, (b) localized buckling at the top of sheathing steel, (c) and (d) close-up of the localized buckling, (e) bottom track, and (f) loosened bolt of the tie-rod bearing connection.

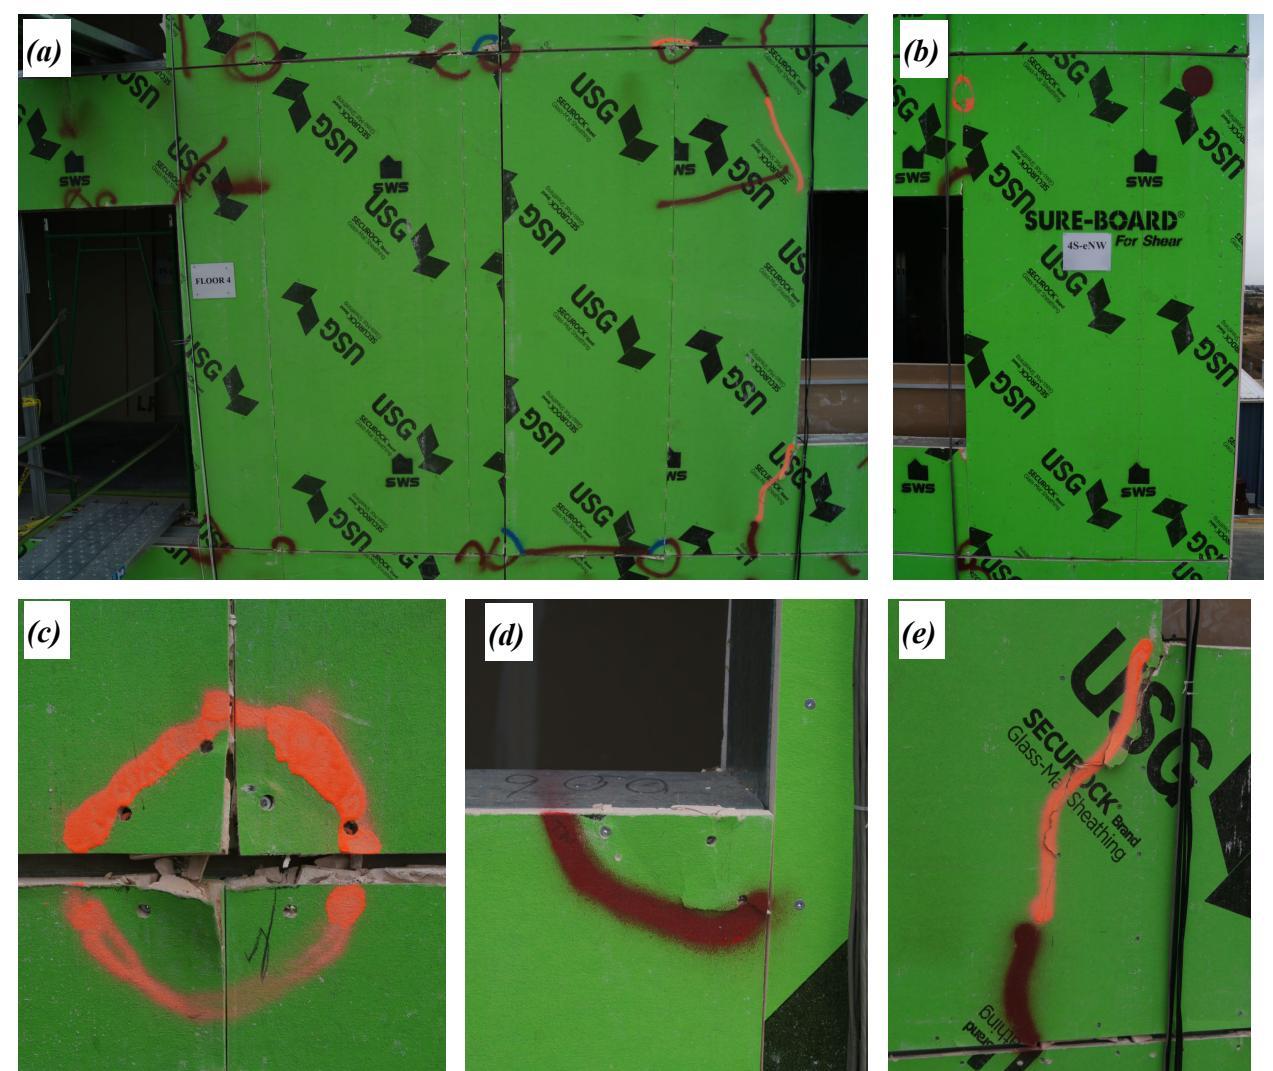
Figure 6.81. Exterior sheathing damage following the pre-fire MCE event (EQ7): (a) gravity wall and openings on the north face at level 4, (c) corner crushing, (c) corner bulging, and (e) diagonal cracks around the window opening.

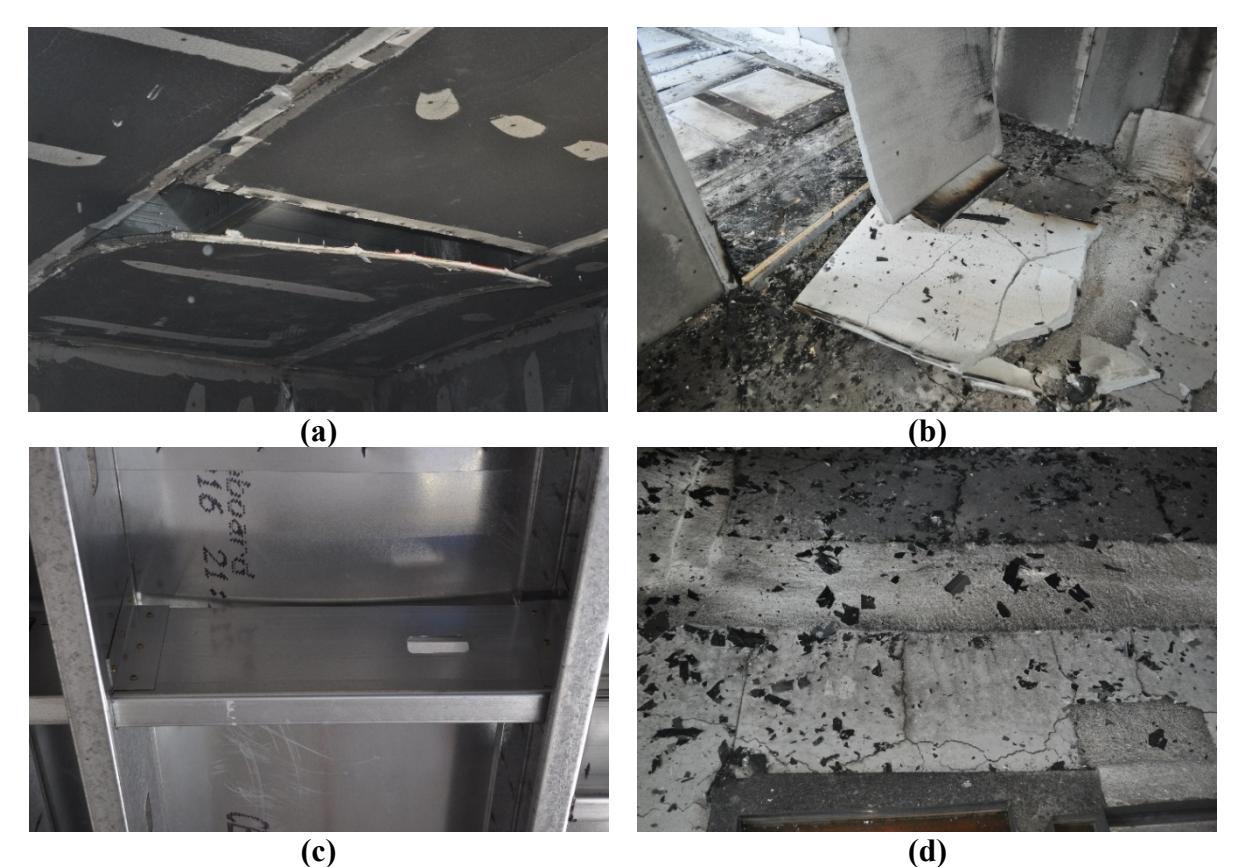
Figure 7.26. Damage to the burn compartment following Fire Test 2: (a) detached ceiling gypsum board, (b) disintegrated wood door following 2-side fire burns, (c) thermal bowing of floor sheathing board (underside), and (d) cracks on the fiber cement floor boards (upperside).

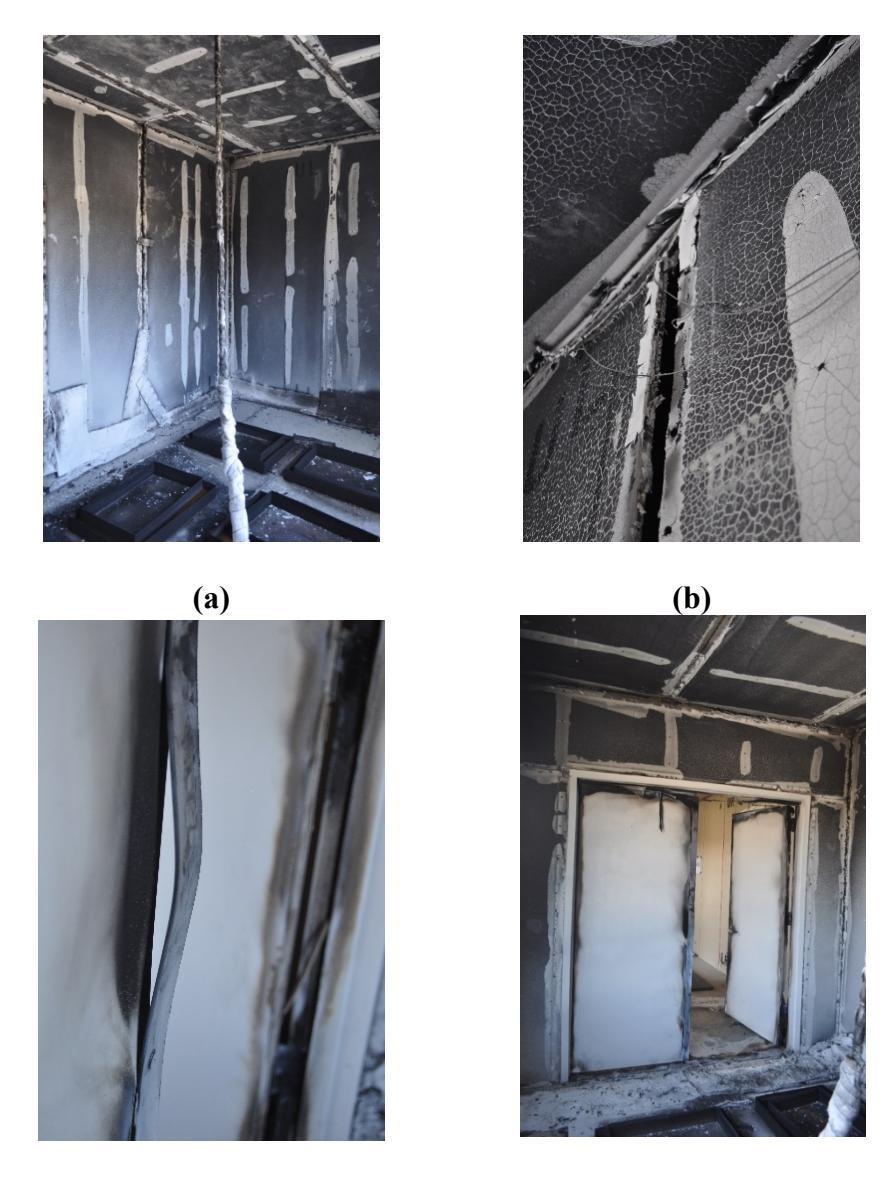
(c) (d) Figure 7.27. Damage to the northwest (burn) compartment following Fire Test 3: (a) overall view of the burn compartment, (b) gypsum surface crack, (c) buckled door frame metal, and (d) overall view of the metal door.

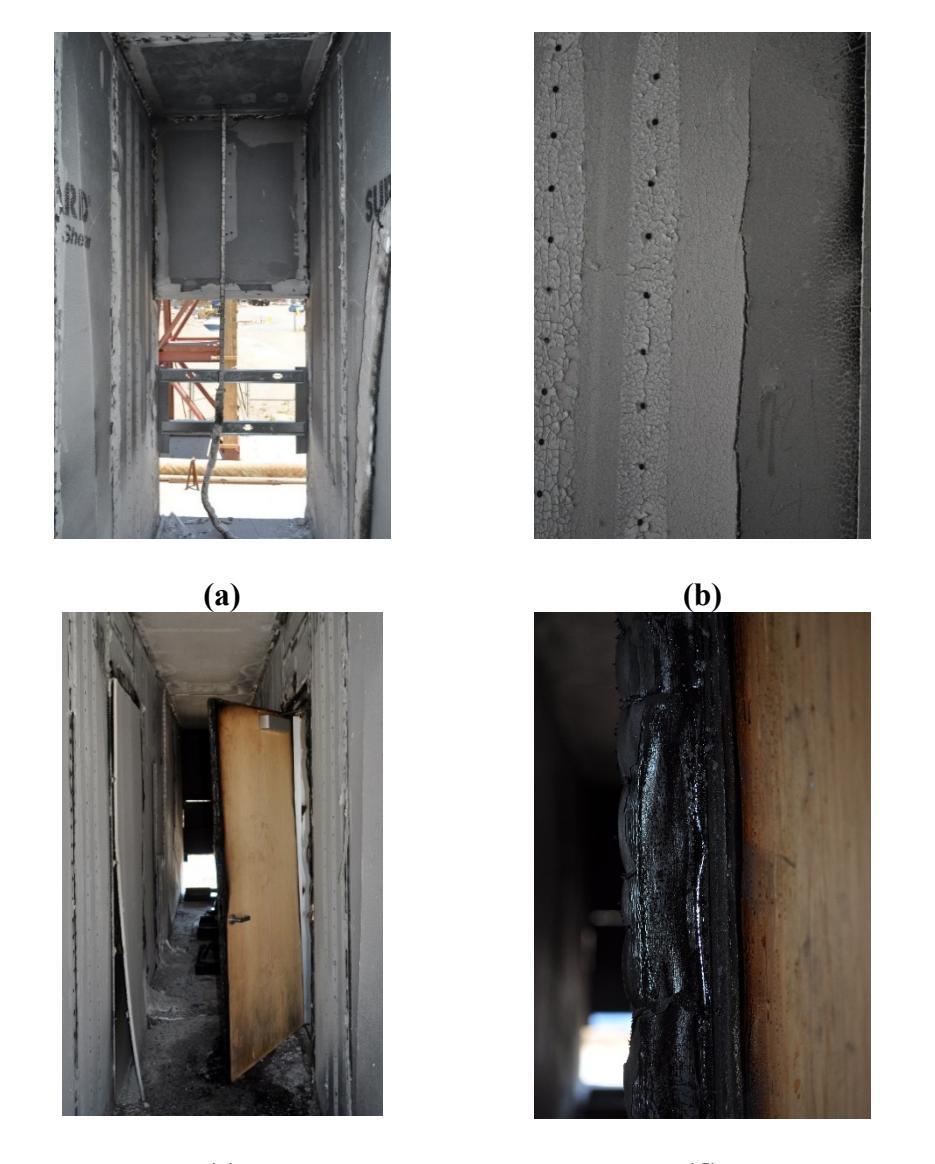
(c) (d) Figure 7.28. Damage to the burn compartment following Fire Test 4: (a) east end of the corridor, (b) gypsum board cracks, (c) north corridor door damage (facing west), (d) charring of corridor door.

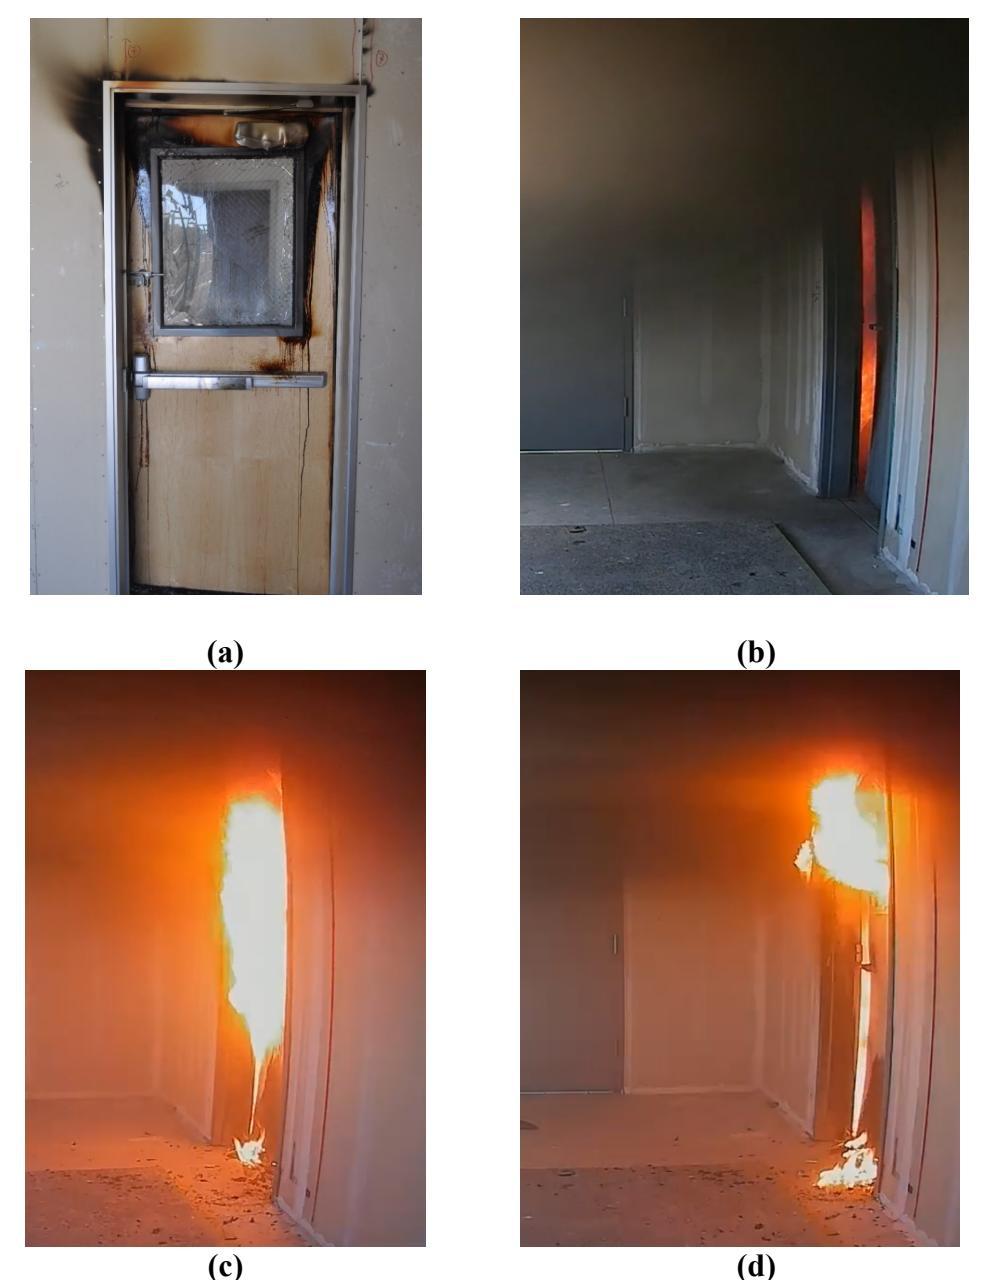
Figure 7.29. Damage to the burn compartment following Fire Test 5: (a) damage to the south corridor door (unexposed side), (b) rupture of the south corridor door, (c) flame penetration from the ruptured door frame gap, and (d) rupture of glazing of the south corridor door.

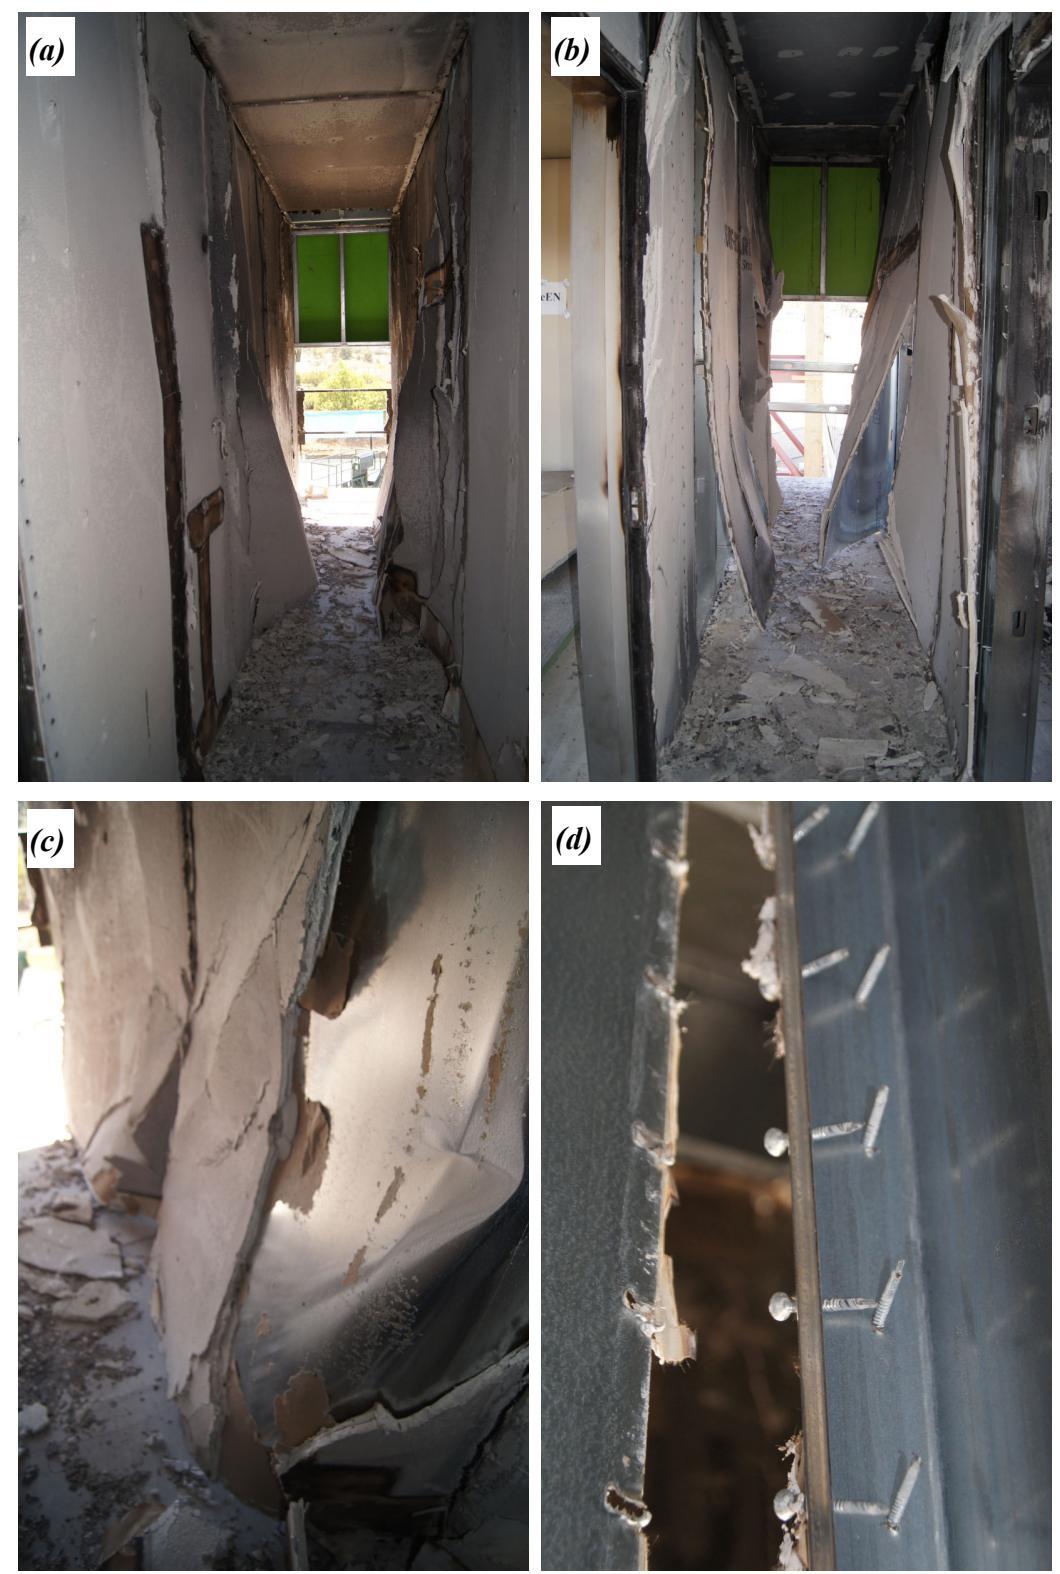
Figure 8.30. Damage to corridor shear wall steel sheathing following the completion of the extreme MCE event (EQ9): (a) east corridor, (b) west corridor, (c) global buckling of steel sheathed panels, and (d) fastener pull-over failure.

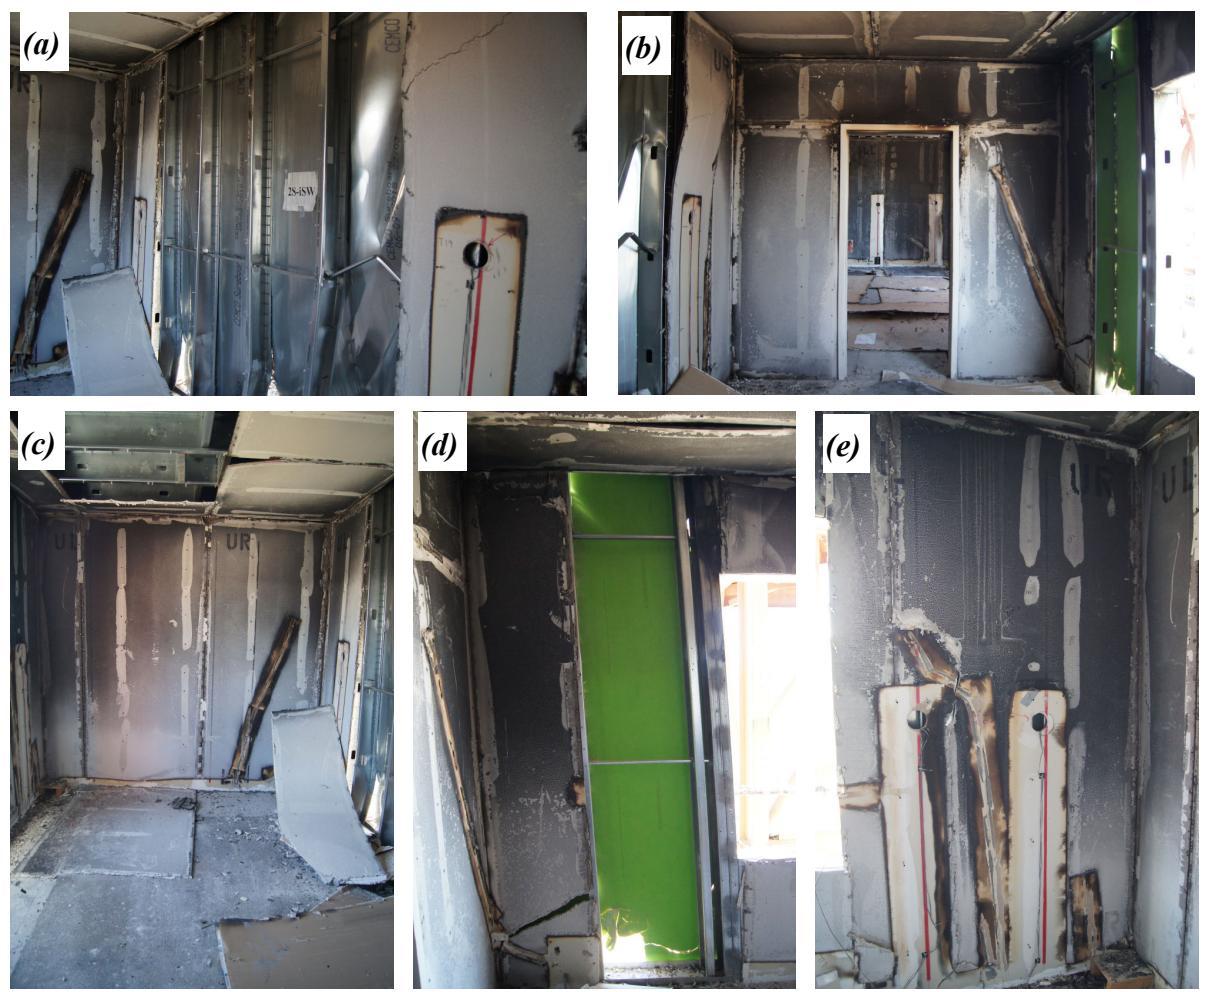
Figure 8.31. Damage to the southwest compartment following the extreme MCE event (EQ9): (a) corridor shear wall, (b) interior partition wall, (c) transverse wall on the west side, (d) gravity wall, and (e) corner shear wall.

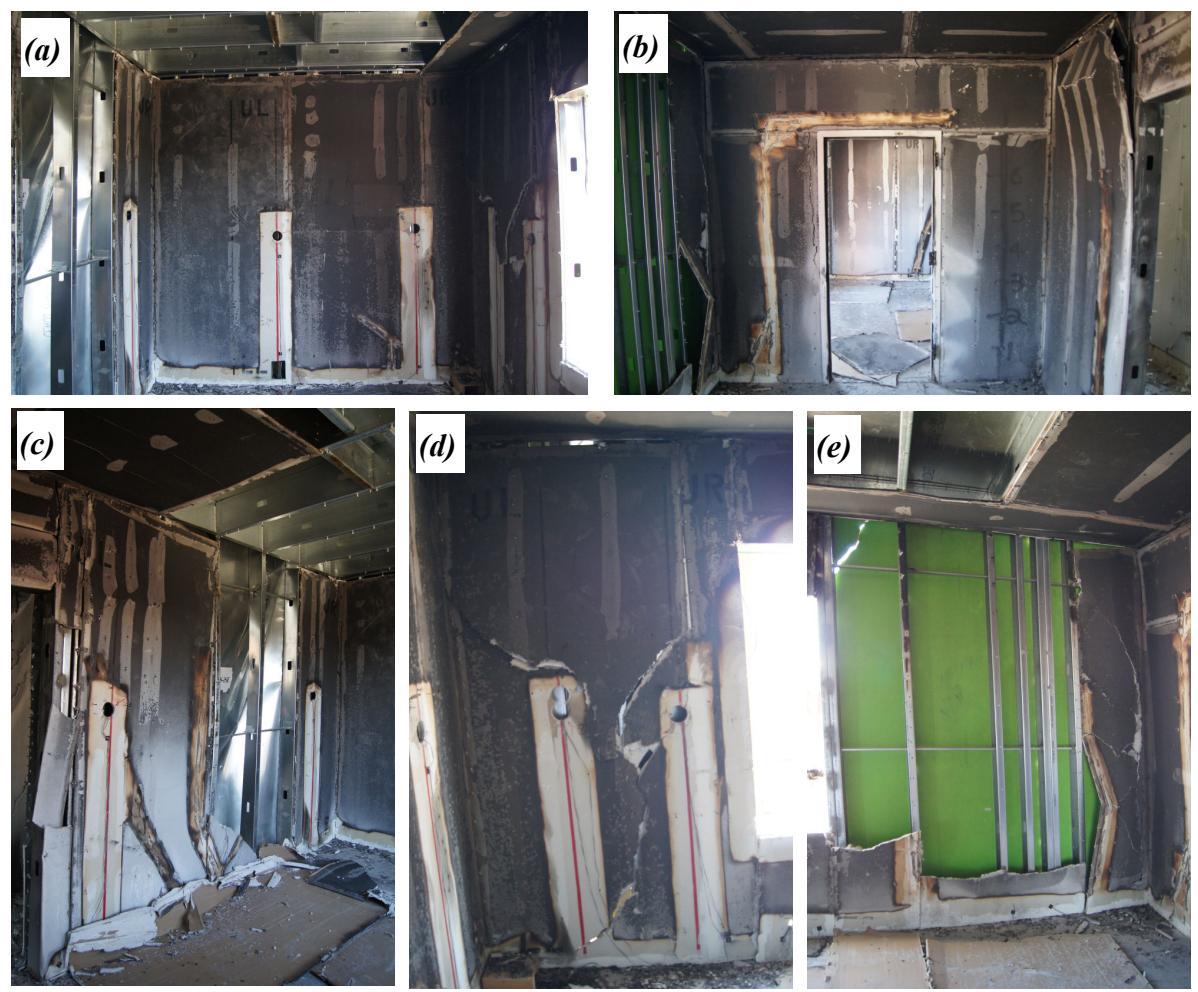
Figure 8.32. Damage to the southeast compartment following the extreme MCE event (EQ9): (a) transverse shear wall on the east side, (b) interior partition wall, (c) corridor shear wall, (d) corner shear wall, (e) gravity wall.

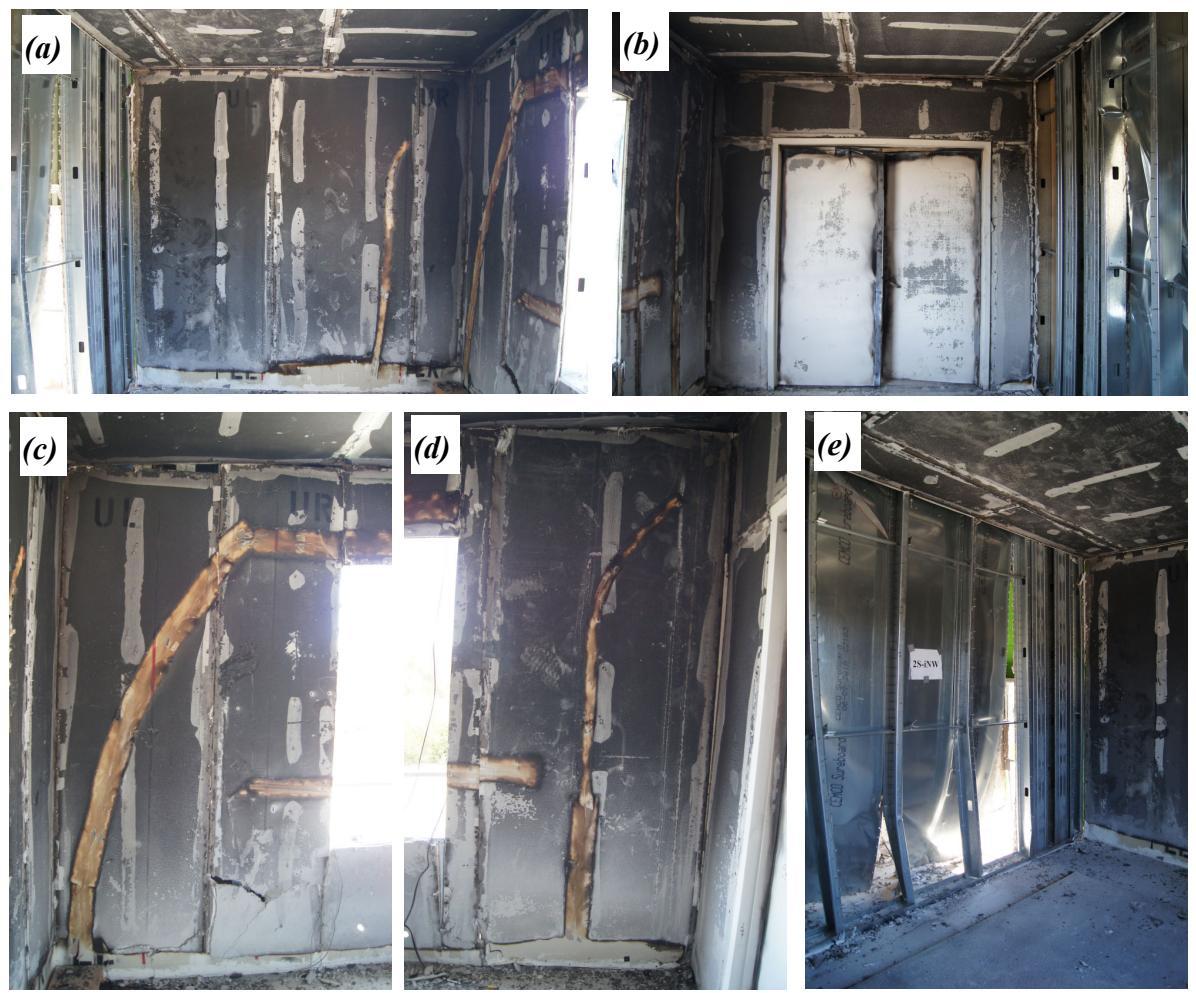
Figure 8.33. Damage to the northwest compartment following the extreme MCE event (EQ9): (a) transverse shear wall on the west side, (b) interior partition wall, (c) corner shear wall, (d) gravity wall, and (e) corridor shear wall.

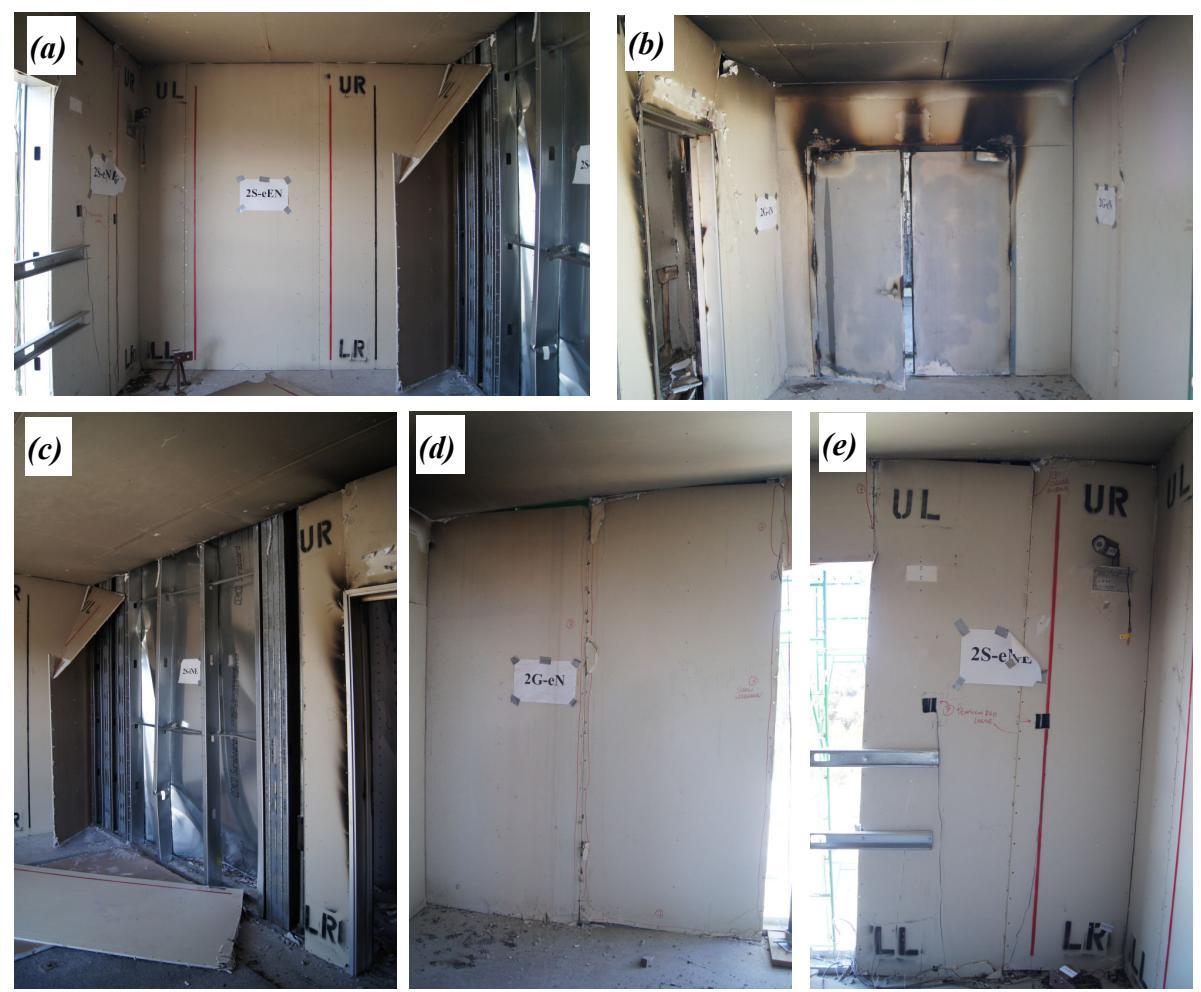
Figure 8.34. Damage to the northeast compartment following the extreme MCE event (EQ9): (a) transverse shear wall on the east side, (b) interior partition wall, (c) (b) corridor shear wall, (d) gravity wall, and (e) corner shear wall.

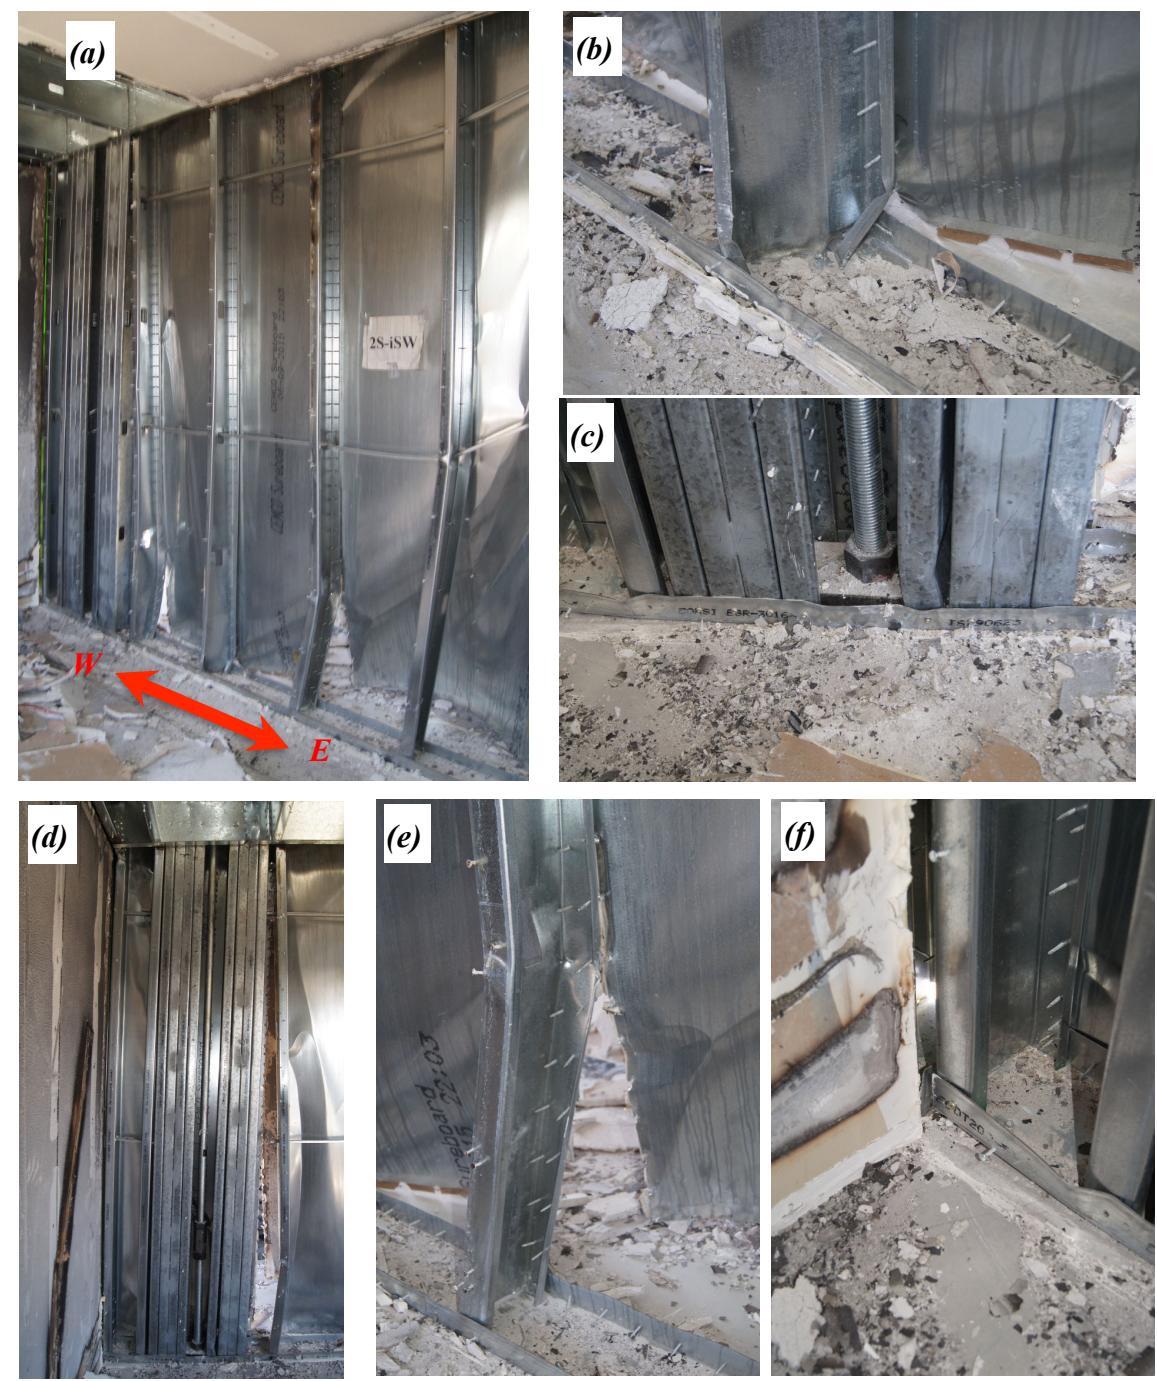
Figure 8.35. Southwest corridor shear wall at level 2 following of the extreme MCE event (EQ9): (a) wall framing, (b) stud local buckling at the base and stud-to-track connection failure, (c) compression post local buckling at the base, (d) tie-down assembly (west side), (e) stud global buckling, and (f) detached bottom track (west end of the wall).
