# STRUCTURAL SYSTEMS RESEARCH PROJECT

Report No. **SSRP-16/08**

CFS Test Program Report #2 Earthquake and fire performance of a mid-rise cold-formed steel framed building – test program and test results: *Final Report*

Xiang Wang, Tara Hutchinson, Gilbert Hegemier, Srikar Gunisetty (UCSD)

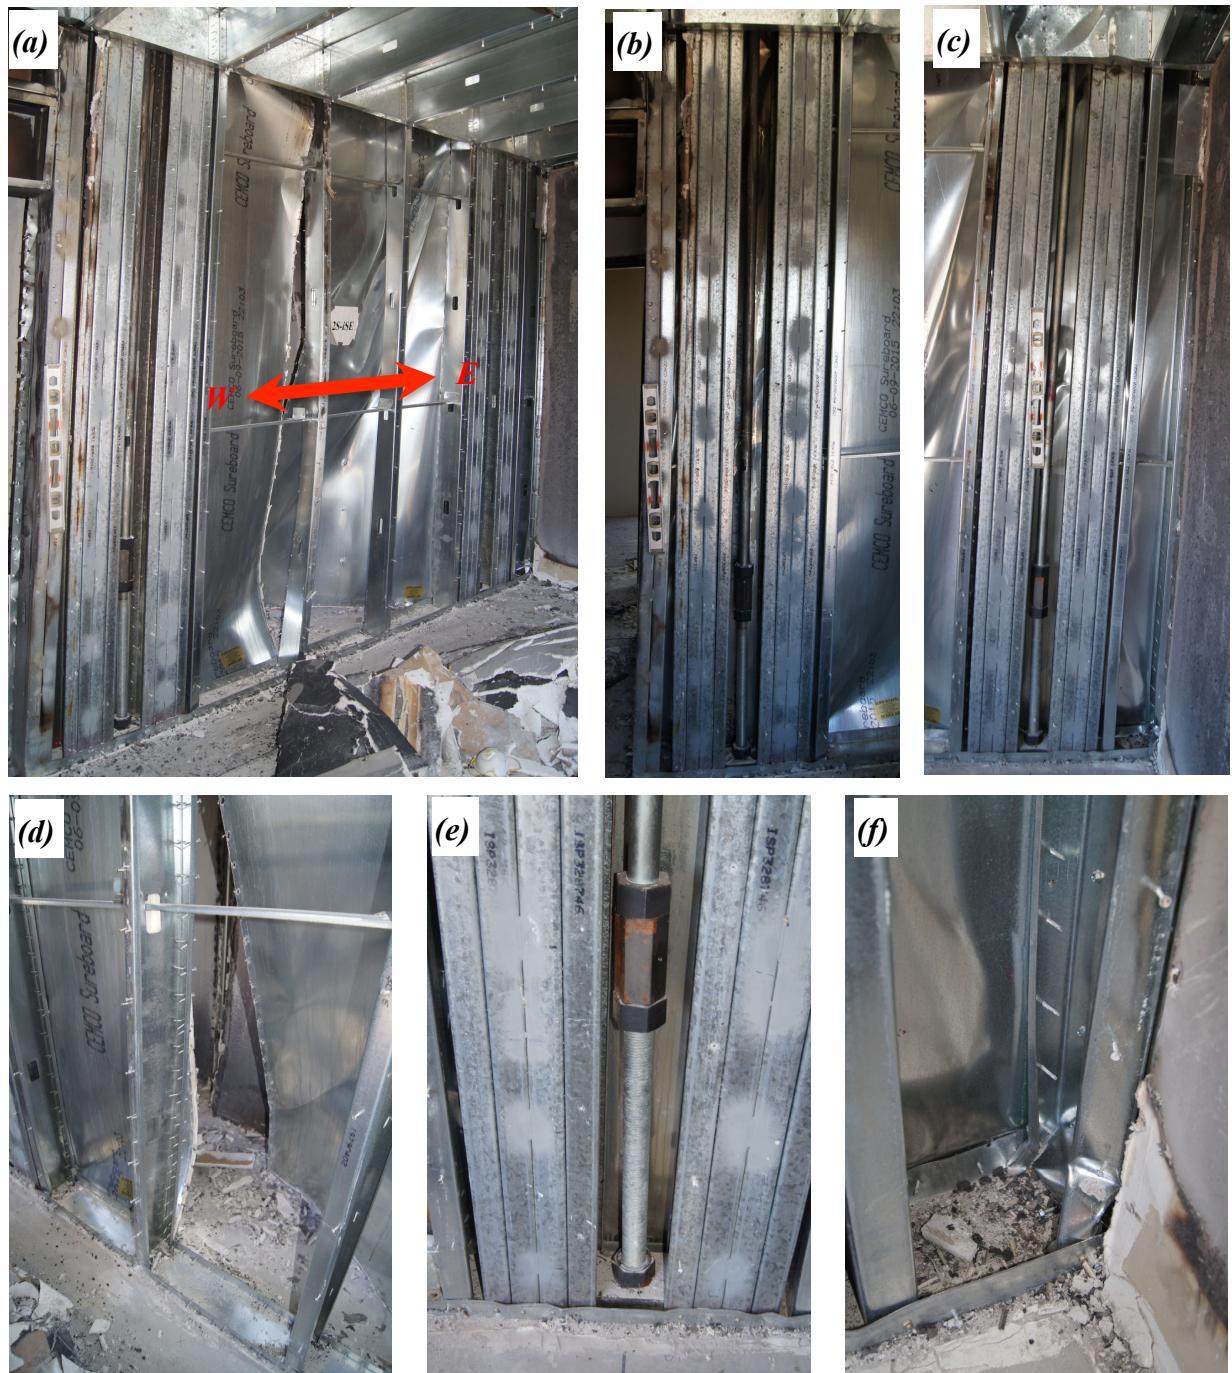
Figure 8.36. Southeast corridor shear wall at level 2 following the extreme MCE event (EQ9): (a) wall framing, (b) tie-down assembly (west side), (c) tie-down assembly (east side), (d) stud global buckling, (e) tie-down rod connection and bottom track flange buckling, and (f) crushed stud at the east end of the wall.

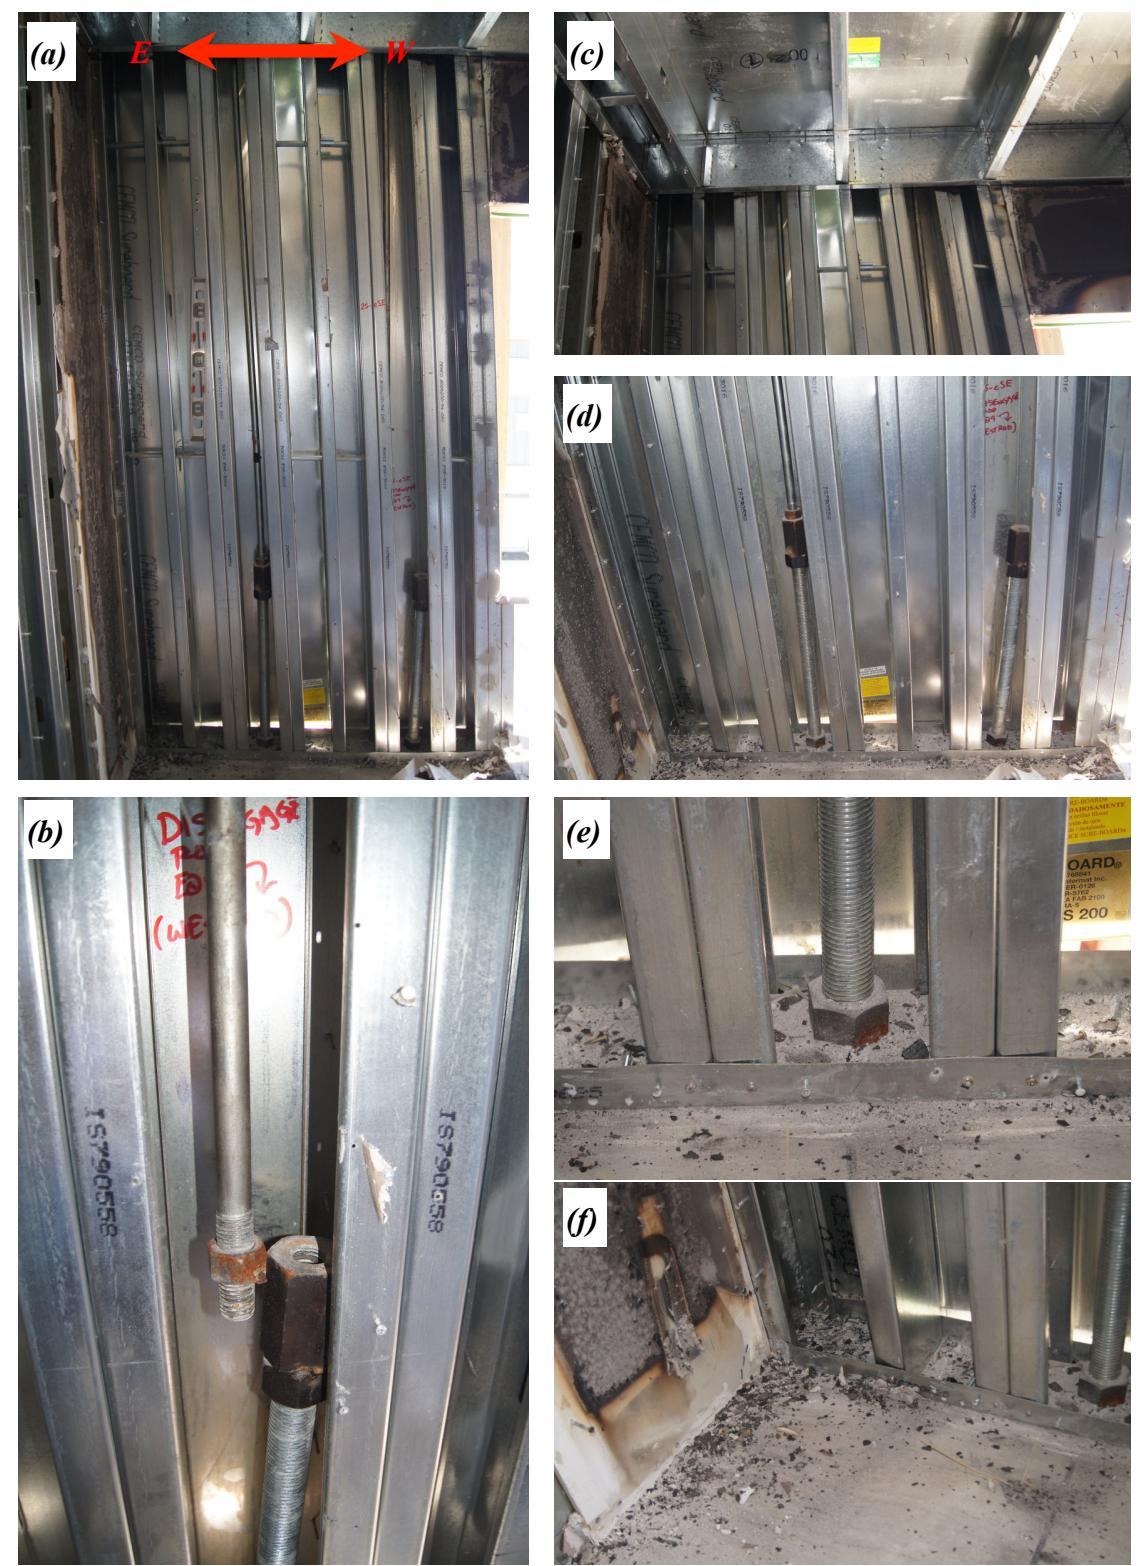
Figure 8.40. Southeast corner shear wall at level 2 following the extreme MCE event (EQ9): (a) wall framing, (b) close-up view of tie-down rod connection failure, (c) upper framing and joist rim track, (d) lower framing and tie-down rods, (e) bearing connection plate of west rod, and (f) bottom track (east end).

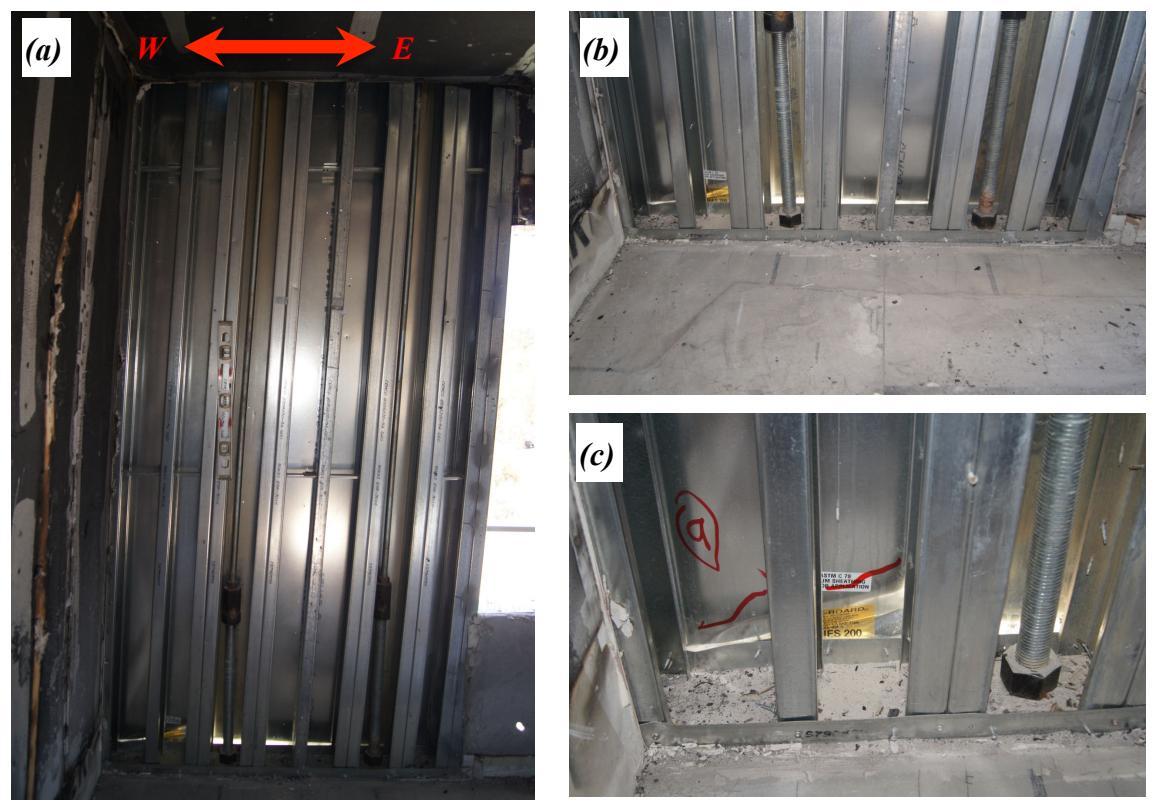
Figure 8.41. Northwest corner shear wall at level 2 following the extreme MCE event (EQ9): (a) wall framing, (b) lower framing and bottom track, and (c) local buckling of exterior steel sheathing at the bottom corner and bottom track flange buckling.

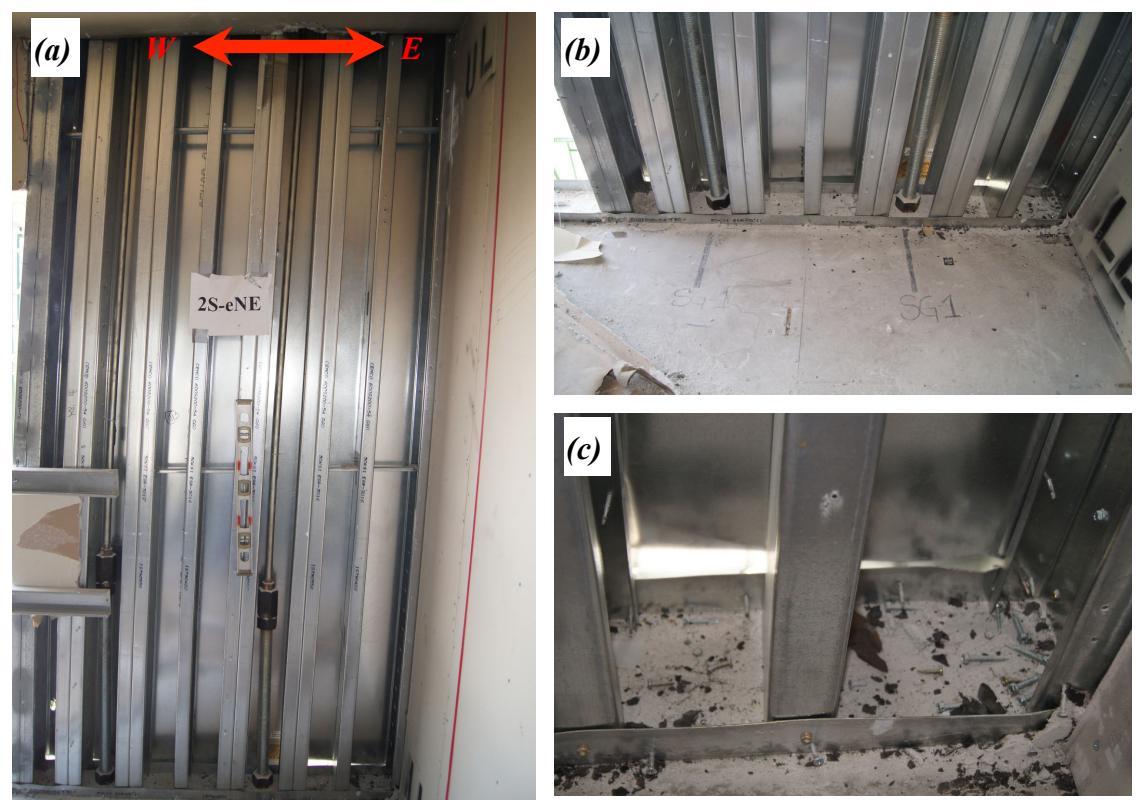
Figure 8.42. Northeast corner shear wall at level 2 following the extreme MCE event (EQ9): (a) wall framing, (b) lower framing and bottom track, and (c) sheathing connection failure.

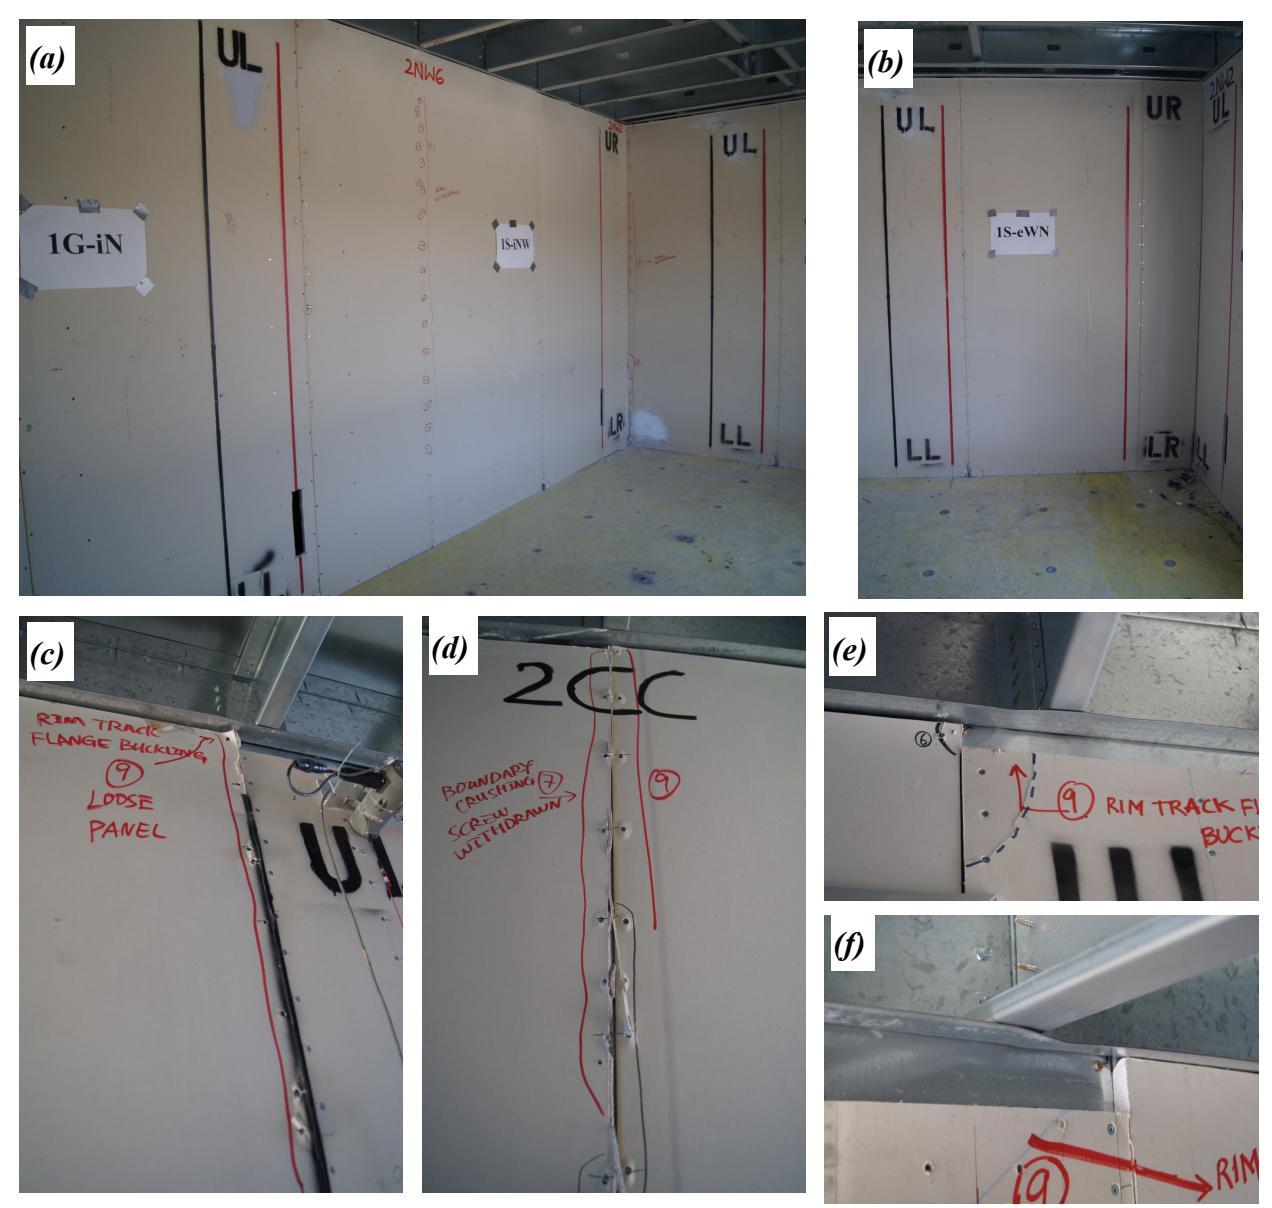
Figure 8.46. Damage to gypsum sheathing and joist rim tracks at level 1 following the extreme MCE event (EQ9).

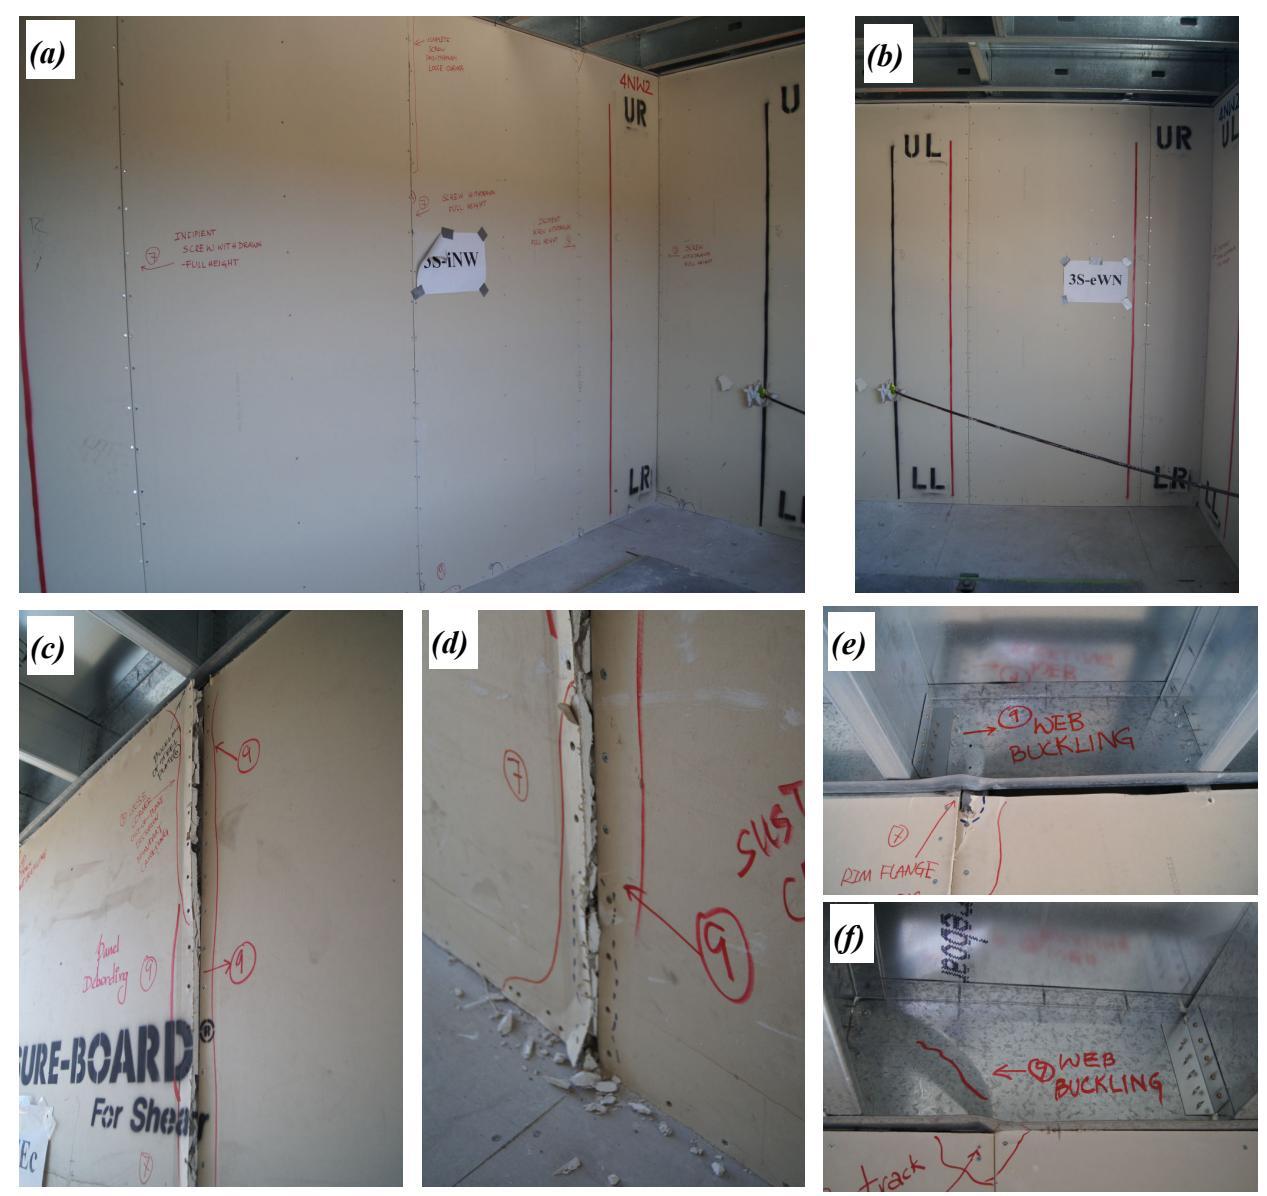
Figure 8.47. Damage to gypsum sheathing and joist rim tracks at level 3 following the extreme MCE event (EQ9).

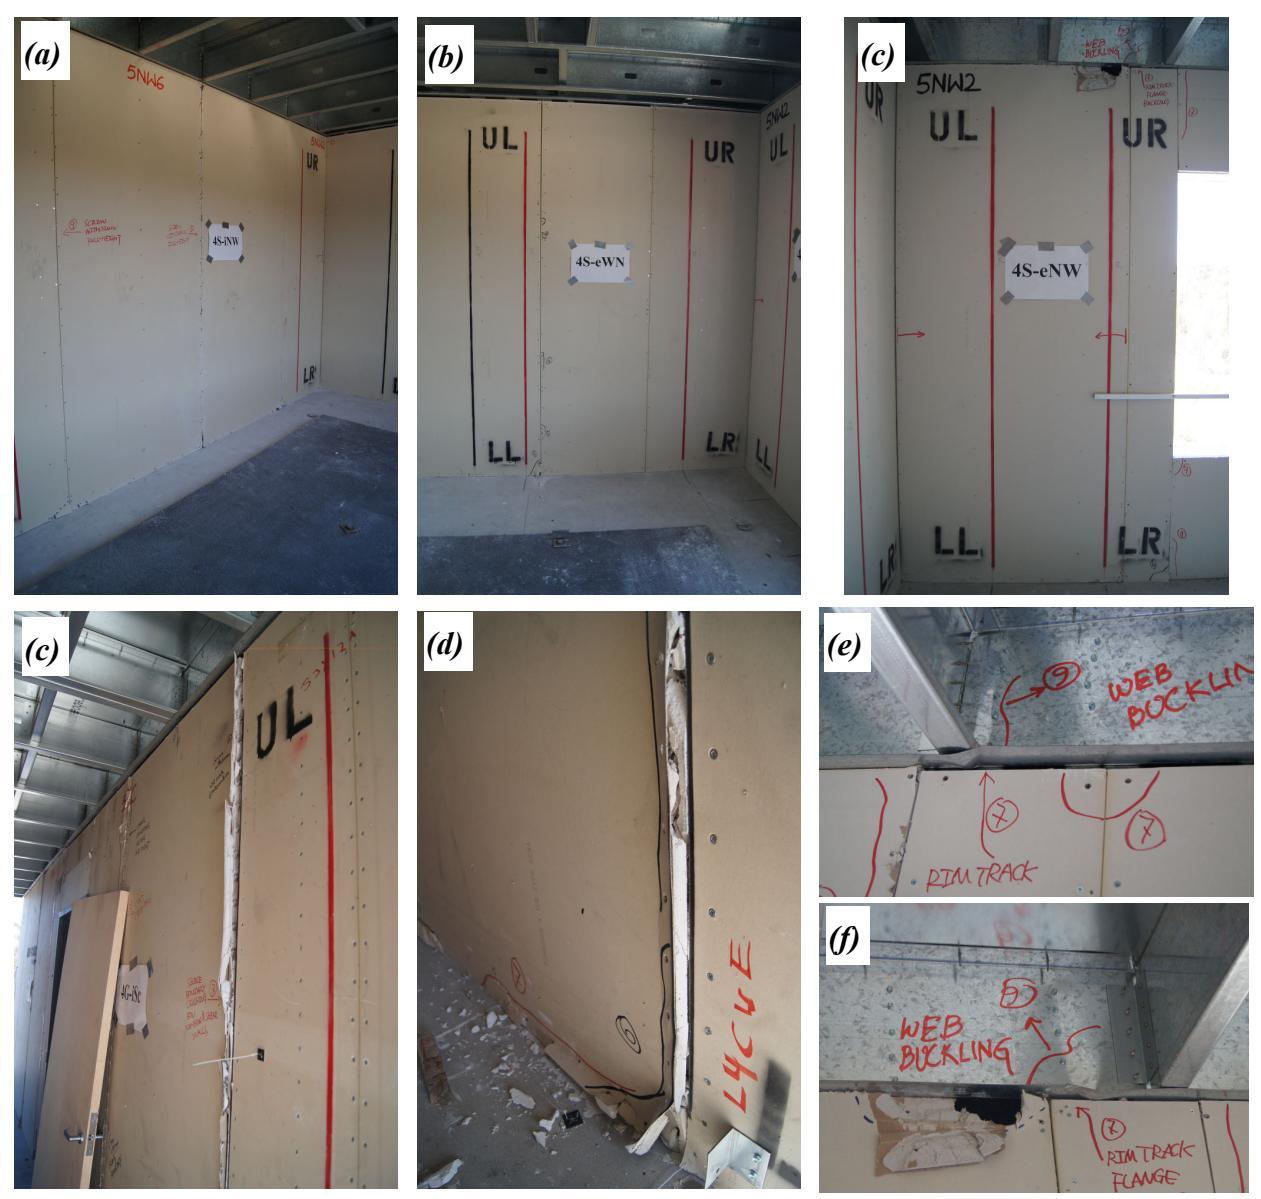
Figure 8.48. Damage to gypsum sheathing and joist rim tracks at level 4 following the extreme MCE event (EQ9).

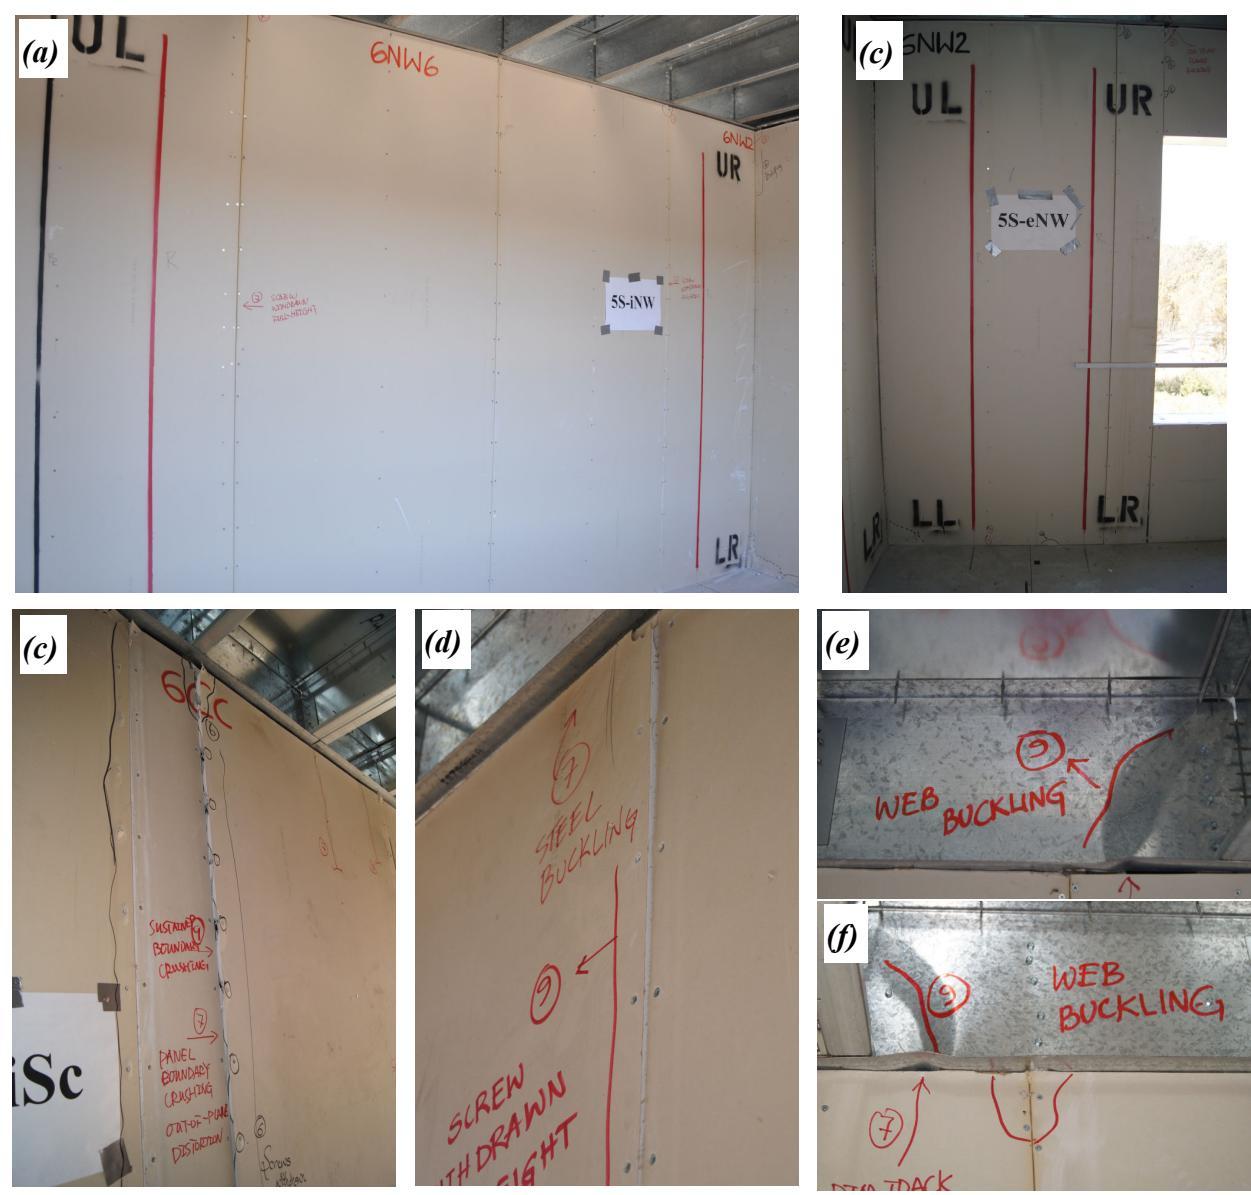
Figure 8.49. Damage to gypsum sheathing and joist rim tracks at level 5 following the extreme MCE event (EQ9).

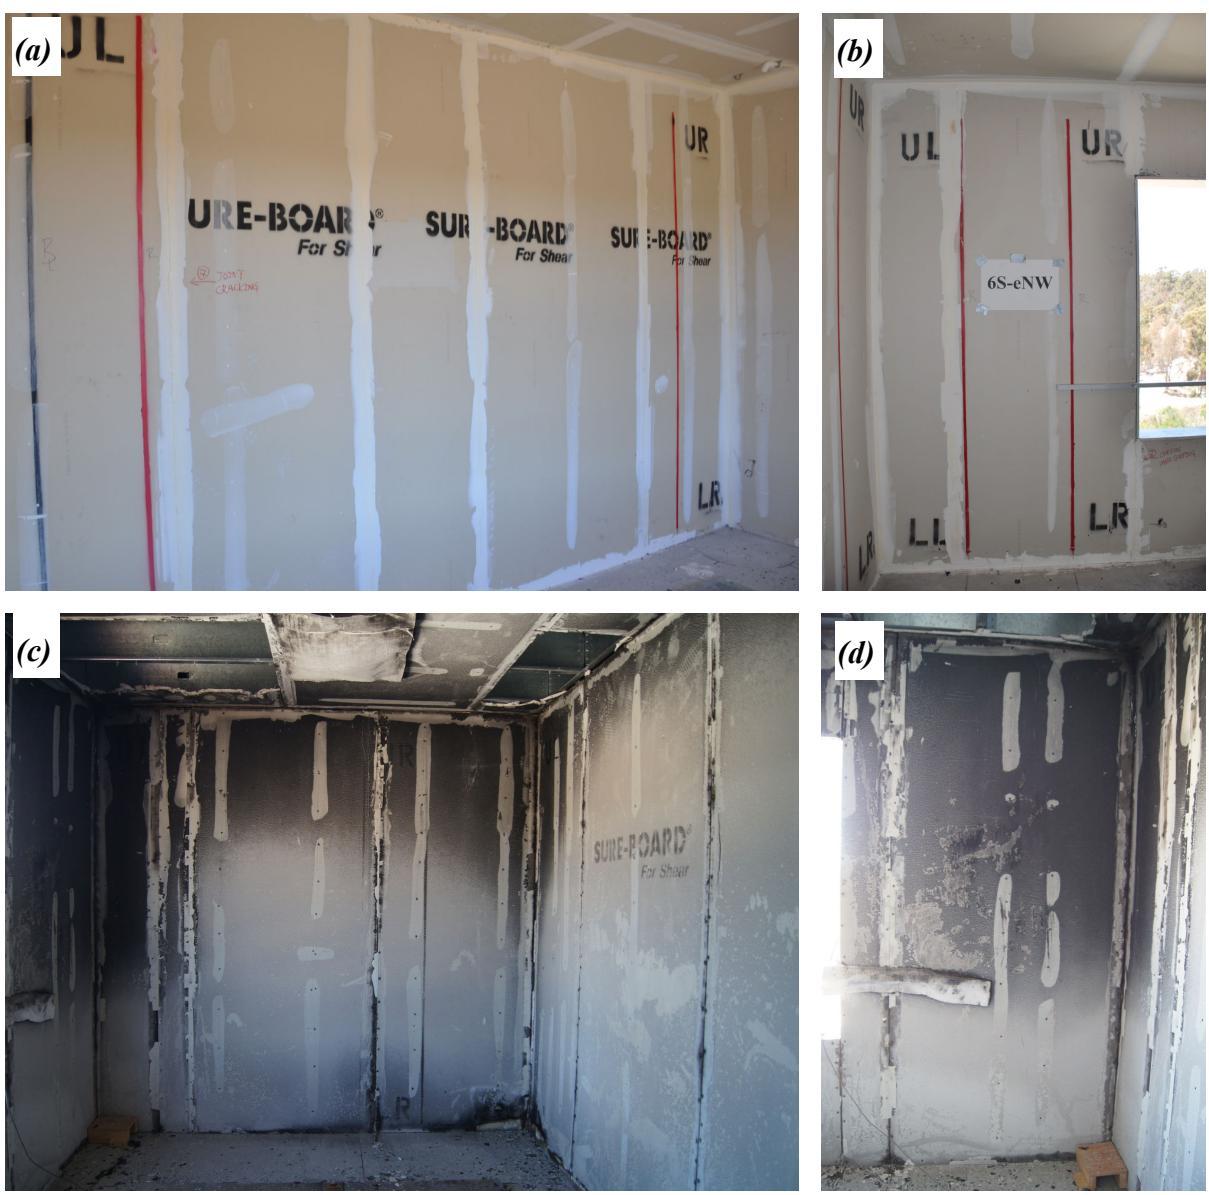
Figure 8.50. Damage to gypsum sheathing and joist rim tracks at level 6 following the extreme MCE event (EQ9).

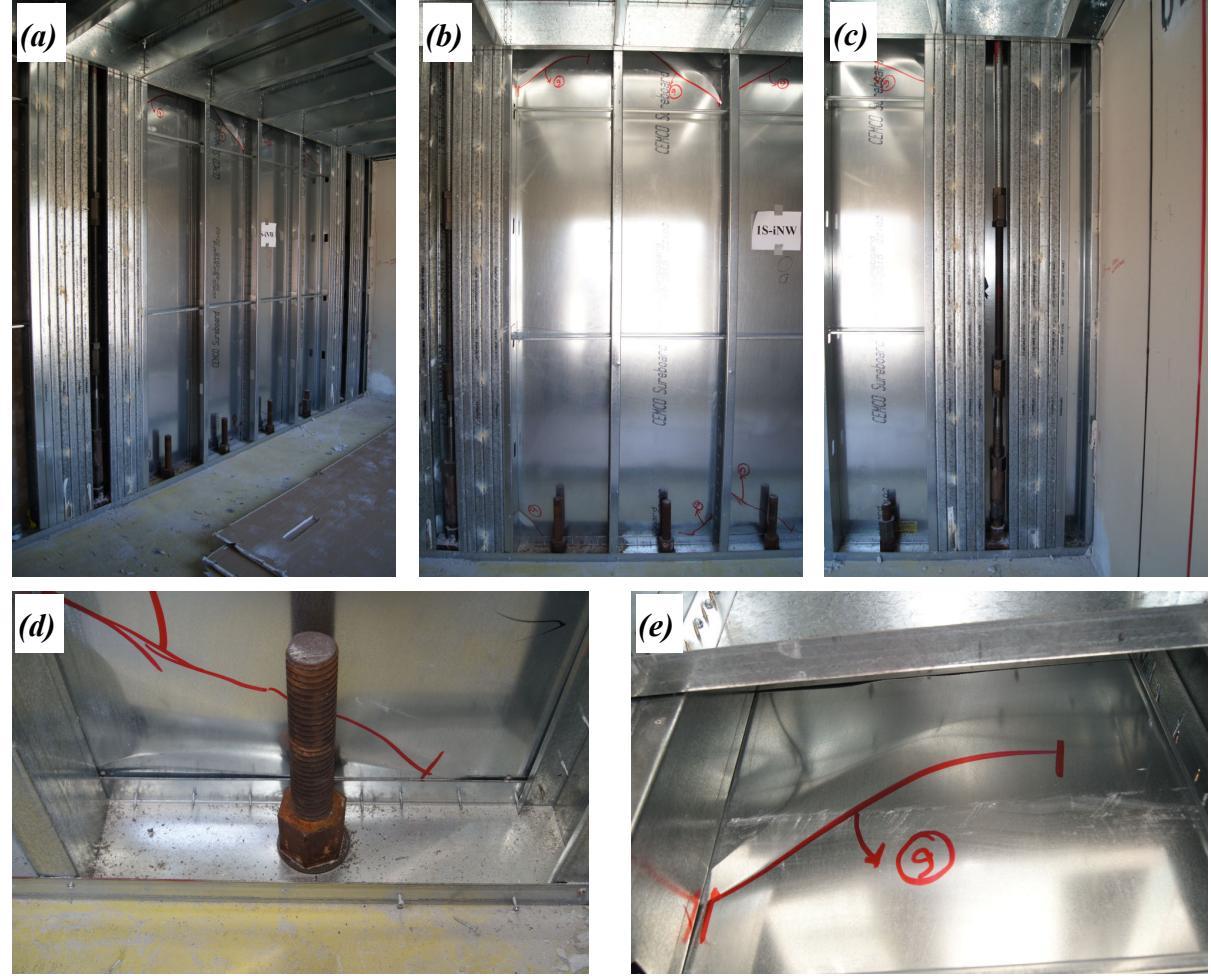
Figure 8.51. Northwest corridor shear wall at level 1 following the extreme MCE event (EQ9): (a) wall framing, (b) steel sheathing, (c) tie-down rod assembly (west side), (c) local buckling of steel sheathing at the bottom, and (e) local buckling of steel sheathing at the top.

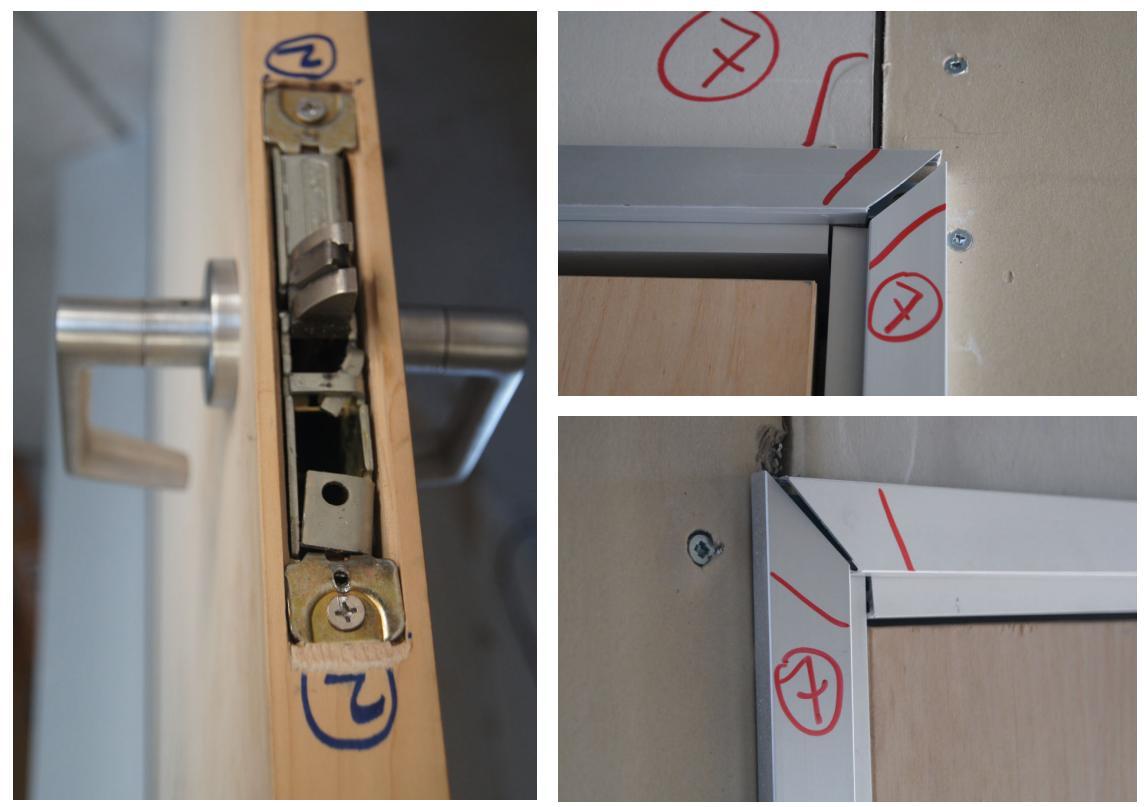
Figure H.9. Door 3-NC: Door latch failure and door frame corner gapping following the MCE event (EQ7).

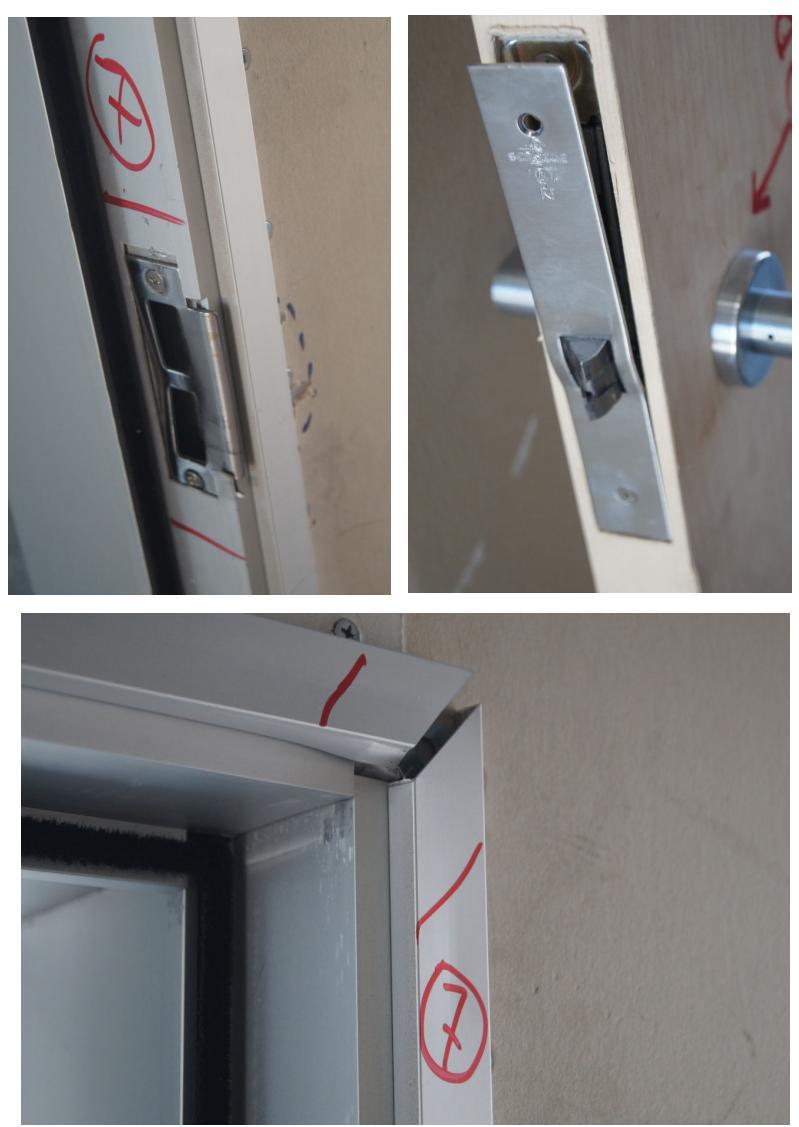
Figure H.11. Door 4-NC: Door latch failure and door frame corner gapping following the MCE event (EQ7).

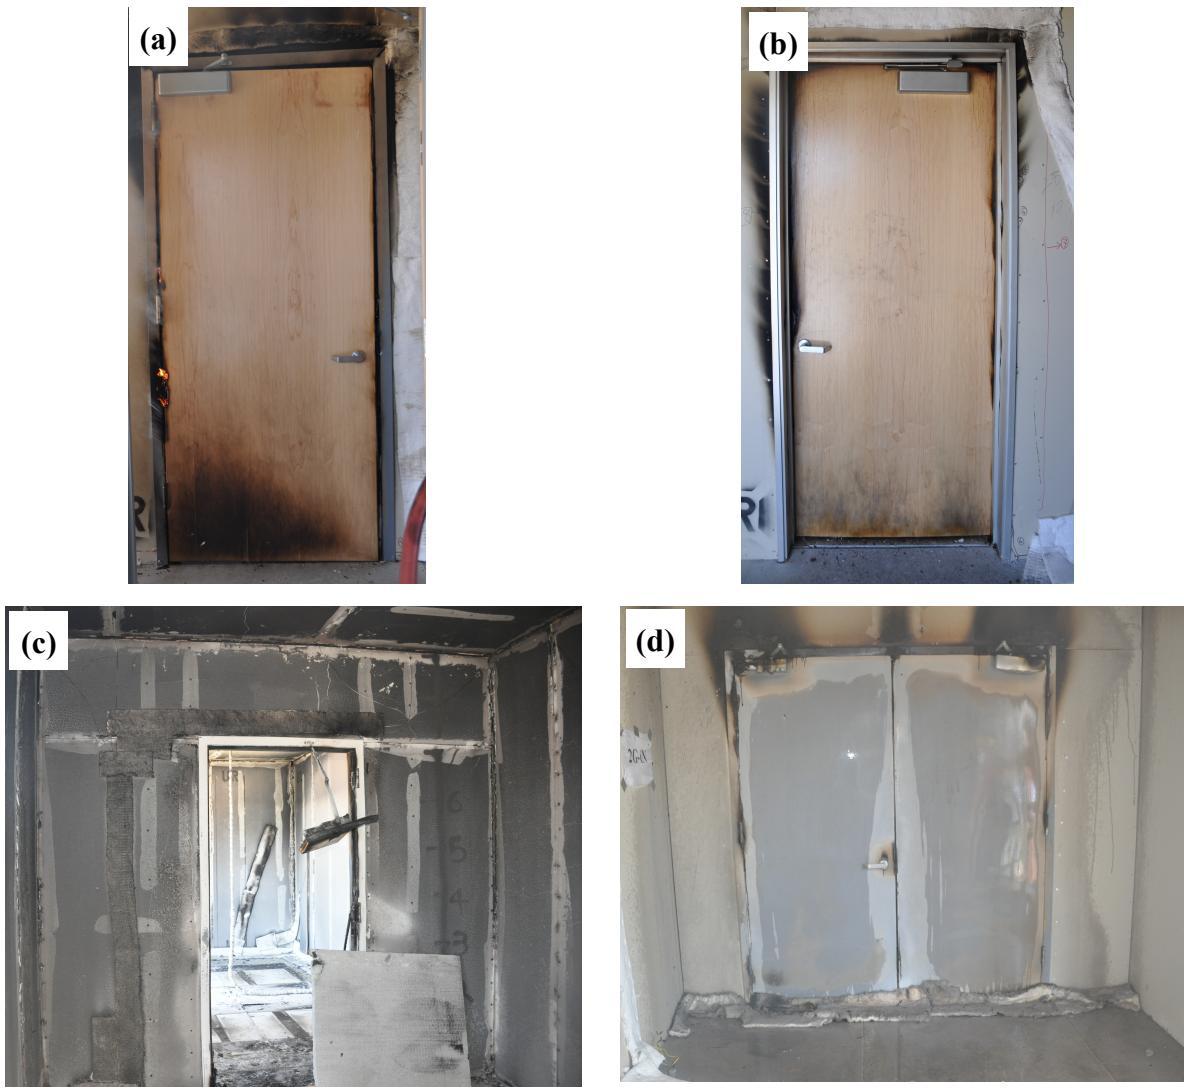
Figure H.16. Level 2 door damage following the fire tests: (a) 2-SC, (b) 2-NC, (c) 2-SR, and (d) 2-NR.
