PHYSICAL DAMAGE EVOLUTION DURING EARTHQUAKE AND POST-EARTHQUAKE FIRE TESTING OF A MID-RISE COLD-FORMED STEEL FRAMED BUILDING

T.C. Hutchinson¹, X. Wang², Hegemier, G.³, Meacham, B.⁴, and Kamath, P.⁵

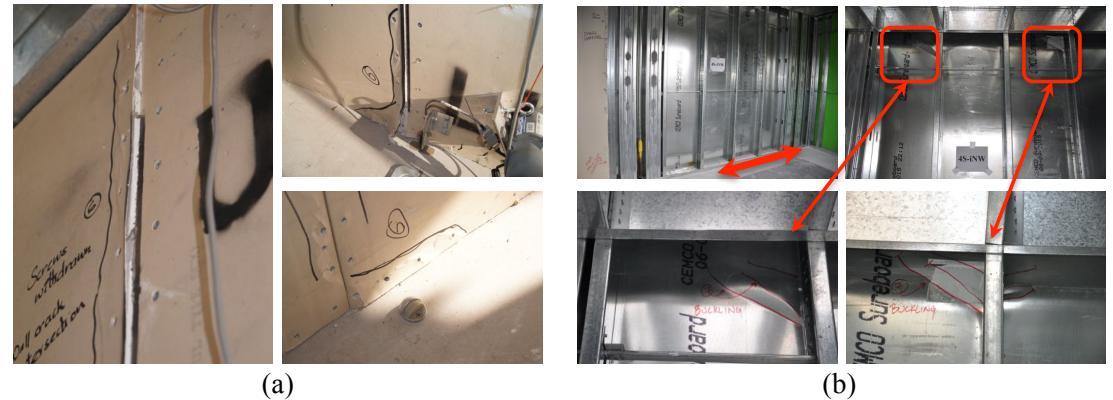
Due to the low seismic demands during the service level tests at all levels of the test building (PFA < 0.5 g, PIDR < 0.1%), the interior sheathing sustained only a few instances of minor damage in the form of incipient screw withdrawal and localized gypsum crushing at bulging at level 3 and 4, while no visible damage to interior sheathing occurred at all other levels. The extant of sheathing damage, however, was considered inadequate to classify the walls into an appreciable damage state. Damage to the interior sheathing however did continue to develop as the seismic drift demand increased during the 50% design event (EQ5) and design event (EQ6). Screw withdrawal and gypsum crushing of the corridor shear walls and gravity walls became more pervasive at all levels (except level 6), in particular at the corridor shear wall-gravity wall boundaries as well as the window and door openings (Fig. 6a). In contrast, damage to the corner shear walls remained minor, as they occurred only in the form of localized gypsum crushing at the corner and formation of gaps between gypsum panels. Following the completion of the prefire earthquake test sequence, the gypsum panels of the northwest compartment at level 4 (the level with the largest drift demands during the pre-fire test sequence) were removed to allow for inspection of the shear wall framing and sheathing steel. As shown in Fig. 6b, localized buckling of the sheathing steel was detected at the top of corridor shear wall, while the framing studs and tracks did not sustained apparent damage. In contrast, the wall framing and sheathing steel of the corner shear wall in the same compartment sustained no apparent damage. In addition, loosening of the bolts at the floor bearing connections was detected, resulting in very loose tie rods at the end of the pre-fire sequence.

Figure 6. Shear wall damage during the pre-fire earthquake test sequence: (a) sheathing damage following the design level test (EQ6), and (b) corridor shear wall framing following the MCE test (EQ7).

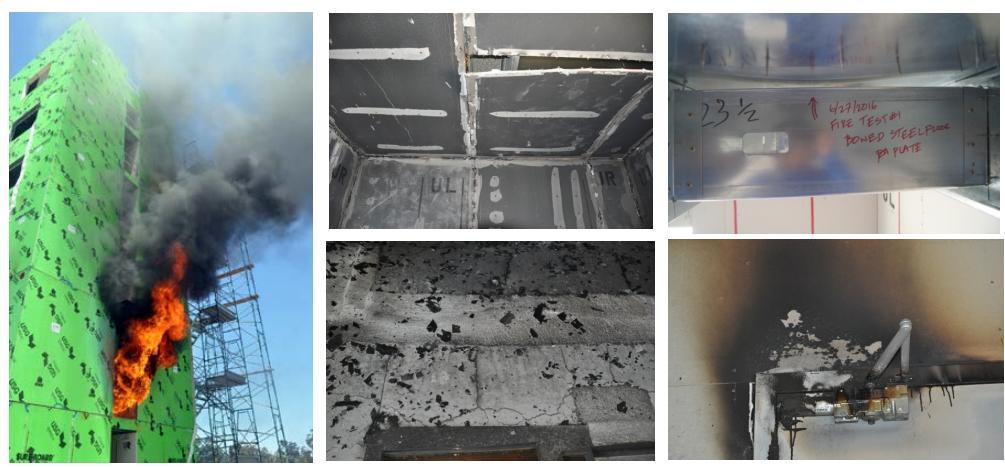
Following the pre-fire earthquake tests, live fire tests were conducted at the six pre-determined compartments at level 2 and 6. The elevated temperature caused dehydration and shrinkage of the wall and ceiling gypsum boards and fiber-reinforced cement boards on the floor. The damage to the shear wall and floor sheathing resulted in significant strength and rigidity loss of these structural components. As shown in Fig. 7, the fire-induced structural damage occurred in the form of: (1) partial detachment of gypsum ceilings, and (2) significant deflections (about 1.5 cm) of the floor diaphragm at the second floor as a result of deteriorated cement boards on top of the sheet steel. In addition, the building egress was compromised following the fire tests as a result of loss of functionality of the doors due to the fire-induced damage to the door components.

Figure 7. Flame and smoke extension during the corridor fire test (left) and fire-induced damage: partially detached ceiling gypsum board (top middle), shrinkage and cracking of the cement board on the floor (bottom middle), excessive floor deflection (top right), and melted door closer (top bottom).

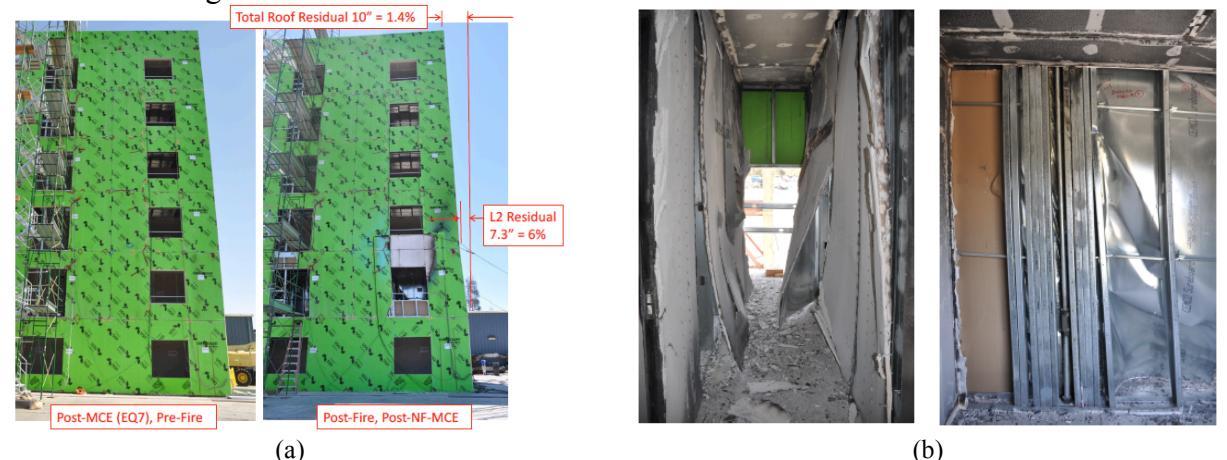
Due to the extremely large drift demands at level 2 of the test building (transient PIDR > 12% and residual IDR ~ 6%) during the post-fire extreme event EQ9, the building developed a soft-story mechanism at the completion of the test program (Fig. 8a). The excessive interstory drift demands are associated with severe damage to the structural components of level 2 and, importantly, revealed the ultimate damage mechanism of the lateral loading resisting system. The test building, however, resisted collapse largely due to redistribution of loads and the framing action of the continuous rod tie-down system. Evident in the post-event physical inspection was the near complete tearing of a large extent of the structural sheathing, partial or full-delamination of sheathing face gypsum and associated detachment of gypsum on the opposing face (Fig. 8b). Consequently, structural components of the wall (framing members) suffered extensive global and local buckling.

Figure 8. Building damage following the extreme event test (EQ9): (a) north elevation, and (b) interior views (corridor and SE room, left and right, respectively, level 2).
