**Structural and Nonstructural Building System Performance During
Earthquake and Post-Earthquake Fire**

Fire Test Program – Full Report

Department of Fire Protection Engineering
Worcester Polytechnic Institute
Worcester, MA 01609 USA
<http://www.wpi.edu/academics/fpe.html>

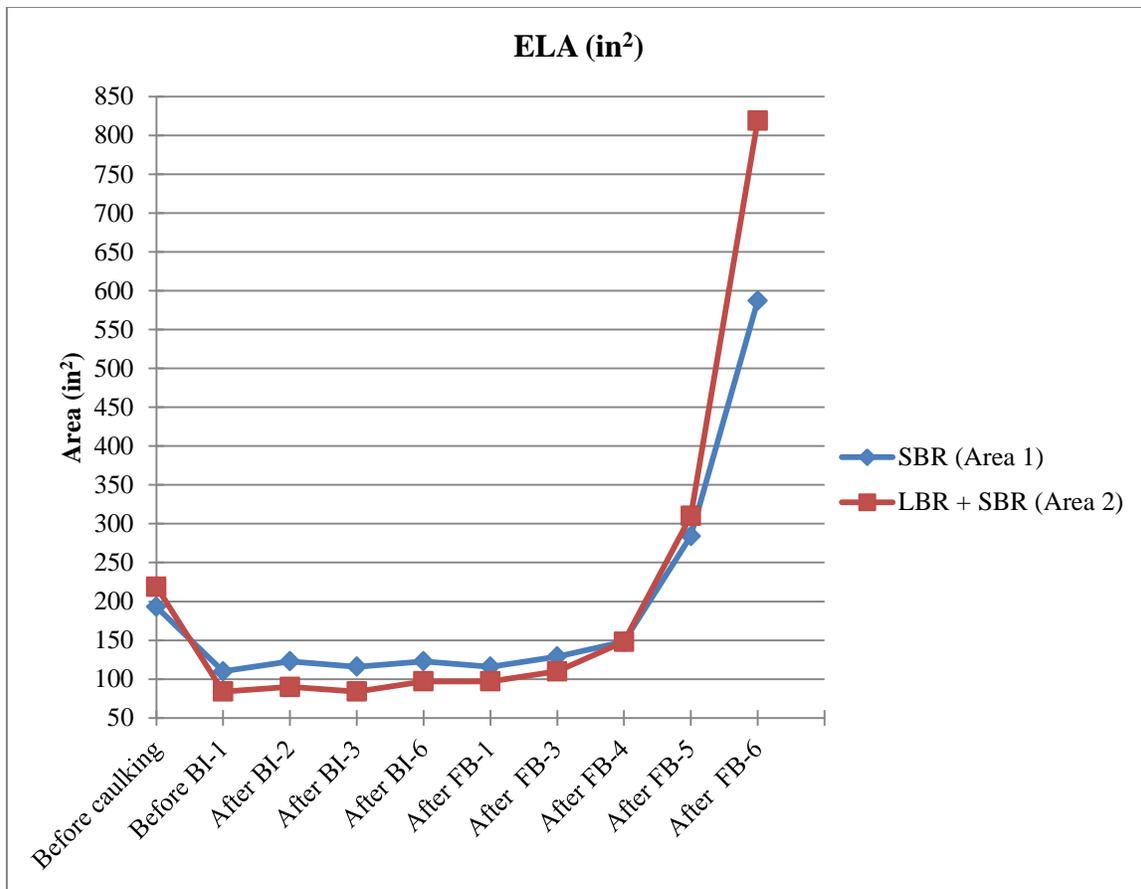
Figure 5.1. Graph of ELA results of both compartments

Figure 5.1 shows a drop in the leakage area for both testing areas after joints were caulked in the testing areas. This showed that caulking helped make the compartment more airtight and reduced significant leakage areas. During the sequence of the BI tests, not much change occurred in the leakage area except for slight variations. During all of the BI tests, the leakage area of Area 1 superseded the leakage area of Area 2.

Figure 5.1 shows the leakage areas of both testing areas increased after all of the FB tests. For all tests prior to FB-5, Area 1 had the larger leakage area compared to Area 2, which was attributed to the leakage areas formed in the partition wall at the edges where the fire door frame was. After FB-4, the leakage area of Area 1 and Area 2 became about the same. Significant leakage area increases were observed after FB-4, FB-5 and FB-6, and Area 2 leakage area became greater than the Area 1 leakage area after FB-4 as more leakage areas were formed in the LBR joint areas and the lighting fixture. The greatest leakage area increase occurred after FB-6. Figure 5.1 shows the steepest slope

from FB-5 to FB-6. While the leakage areas of both areas were relatively similar throughout the entire testing series, Area 2 ended up with a leakage area of about 226cm² (34in²) greater than the leakage area of Area 1 after FB-6.

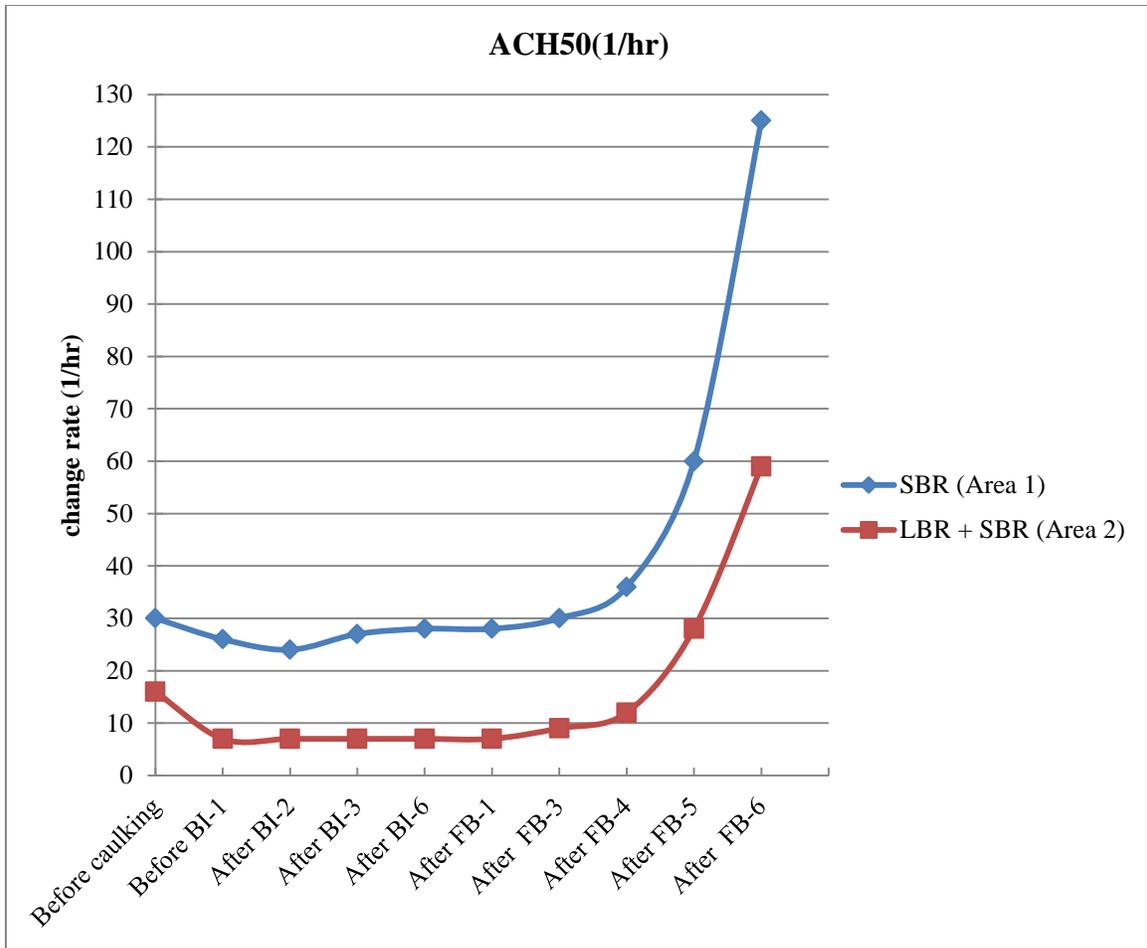
Figure 5.2. Graph of ACH₅₀ test results of both compartments

Figure 5.2 showed similar results to that of the ELA results. The number of air change reduced slightly after the joint areas in both testing areas were caulked. That number stayed relatively similar for both compartments until after FB-1 took place. For all the tests that took place after FB-3, an increase in the number of air change was the trend in both Area 1 and Area 2. The increases were minimal during the FB tests but significant increases were visible from all tests after FB-4. The biggest increase in the number of air change occurred after FB-6. Even though Area 1 started with a very leaky category at 26 air changes per hour after caulking, that number increased almost five times the initial number at 125 air changes per hour after FB-6. Area 2 started off as a fair category at 7 air changes per hour after caulking but increased almost 8 times the initial number at 59 air changes per hour and put into the very leaky category after FB-6. The Area 1 air change rates are significantly higher than the air change rates of Area 2 since

the air change rate calculations take into consideration the overall volume of the space. With Figure 5.1 showing similar ELAs between the two areas, since Area 1 has a smaller volume than the volume of Area 2, the air change rate of Area 1 is significantly higher than the air change rate of Area 2.

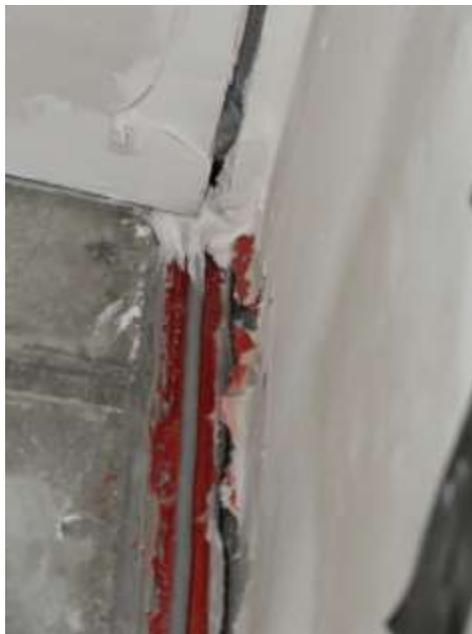
Figure 5.5. Gaps in the joint area of Floor 3

Gaps developed in the joint areas as the building was subject to seismic motions. Figure 5.4 shows the gap in the joint area above the LBR ceiling, allowing for leaks through the balloon framing. Figure 5.5 shows gaps that were formed in the joint areas increasing the overall leakage area.

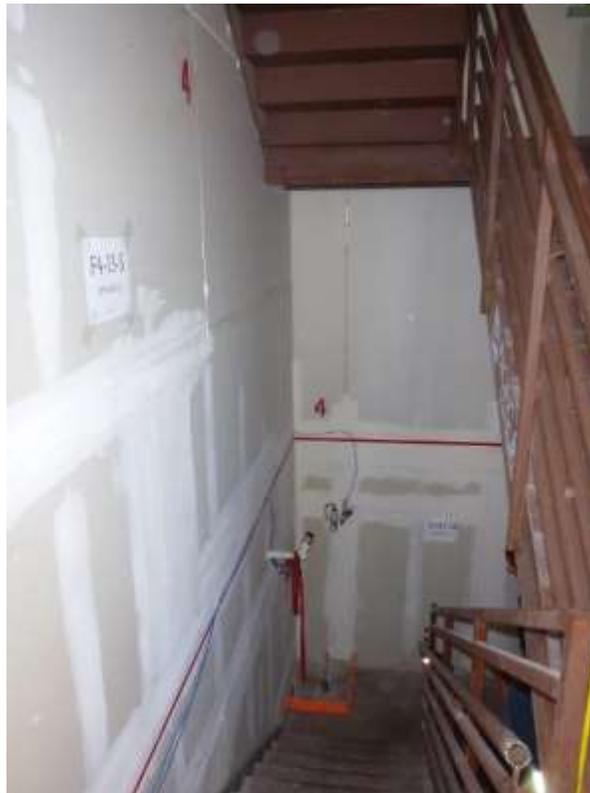
Figure 6.5. Floor 4 stair handrail following FB-5

The stair connection failed and detached off of the stair landing on Floor 3 following FB-6 as shown in Figure 6.4. Handrails had been disconnected following FB-5 as shown in Figure 6.5. Gypsum wallboards detached and fell off around the staircase and landing areas as shown in Figure 6.6 and at multiple locations throughout the building. Such issues as well as the displacement of building contents could hinder the evacuation of occupants during building fires.

After FB-5, the welds connecting the stair to the 2nd floor were broken, and after FB-6, the welds connecting the stair to the 2nd and the 3rd floors were broken. In addition, handrails were broken at the 3rd to 5th floor landings. The broken handrail at the 4th floor is shown in Figure 6.5.

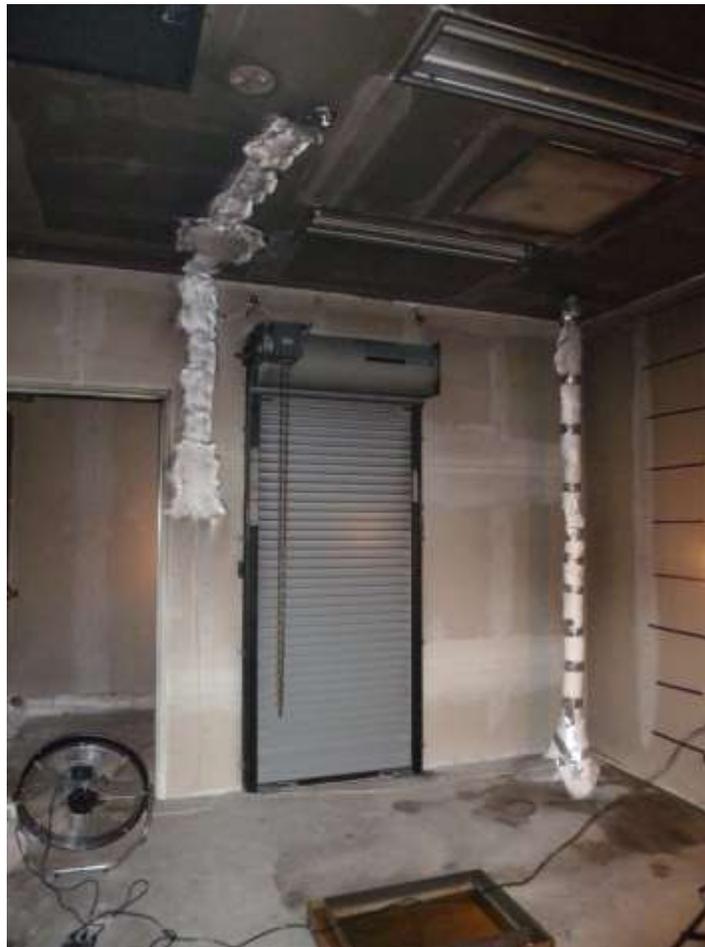
Figure 8.4. LBR after LBR-1 fire test

Figure 8.3 shows the temperatures recorded by the thermocouple trees in the LBR and space above the LBR ceiling. The thermocouple location details are listed in Table 8.1. The condition of the LBR after the LBR-1 fire test is shown in Figure 8.4.

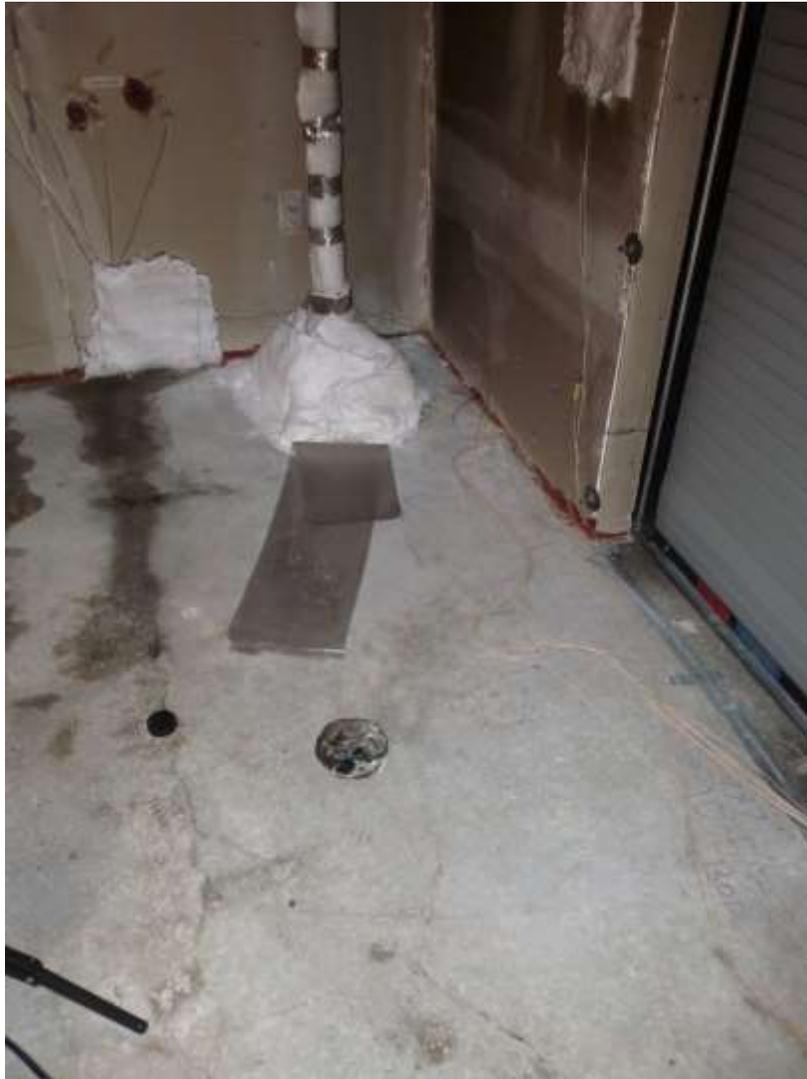
Figure 8.6. SBR after LBR-1 fire test

The SBR temperature increased via smoke spread through openings and the temperature was high enough to melt smoke detector 10 and the plastic cover of the SBR lighting fixture as shown in Figure 8.6. Figure 8.7 shows soot that was produced on the LBR northwest column as a result of the LBR-1 fire test. Figure 8.8 shows the north wall in the space above the ceiling with soot at locations where smoke leaked. Figure 8.9 substantiates for smoke spread to the SBR compartment through these openings.

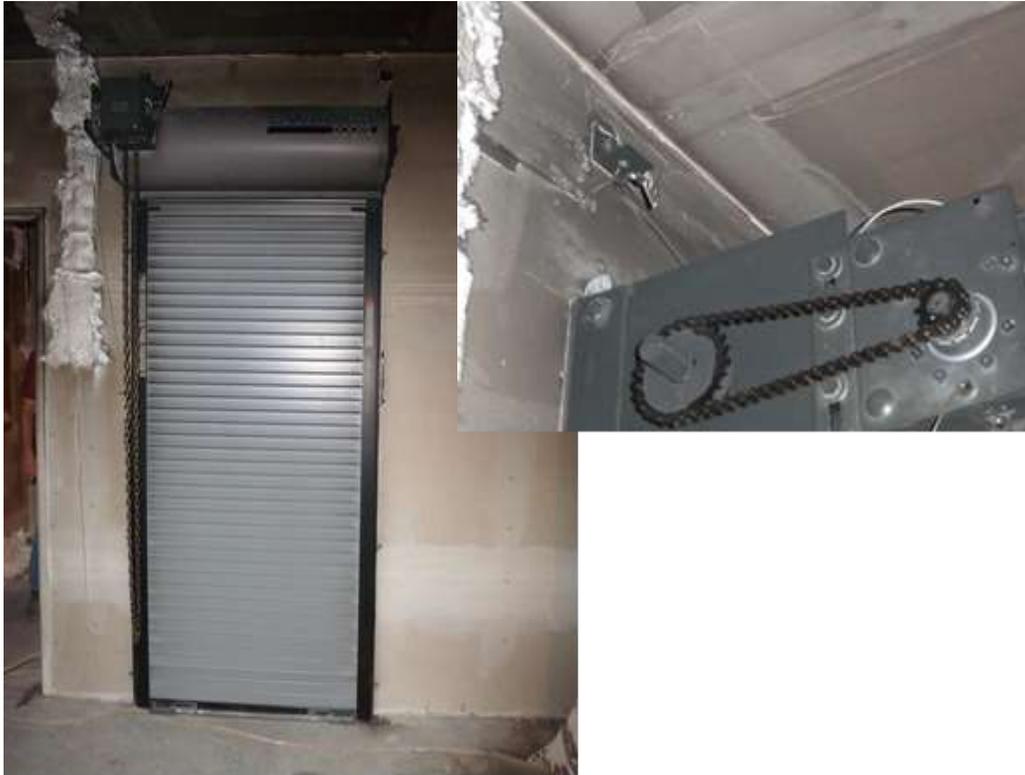
Figure 8.12. Fire door activation during LBR-1 fire test

Figure 8.11 shows the temperatures of the fire door and the SBR sprinkler. The SBR sprinkler activated at 66 seconds at 109 °C (228 °F), as Figure 8.13 shows the activated sprinkler head. The fire door activated at 79 seconds at 108 °C (226 °F), as Figure 8.12 shows the fusible link melted and the fire door rolled down automatically. The thermocouple locations are listed in details in Table 8.3. There was no data available on the LBR sprinkler as the thermocouple malfunctioned during the test, but post-test visual inspection confirmed that the LBR sprinkler head activated during the LBR-1 fire test as shown in Figure 8.14.

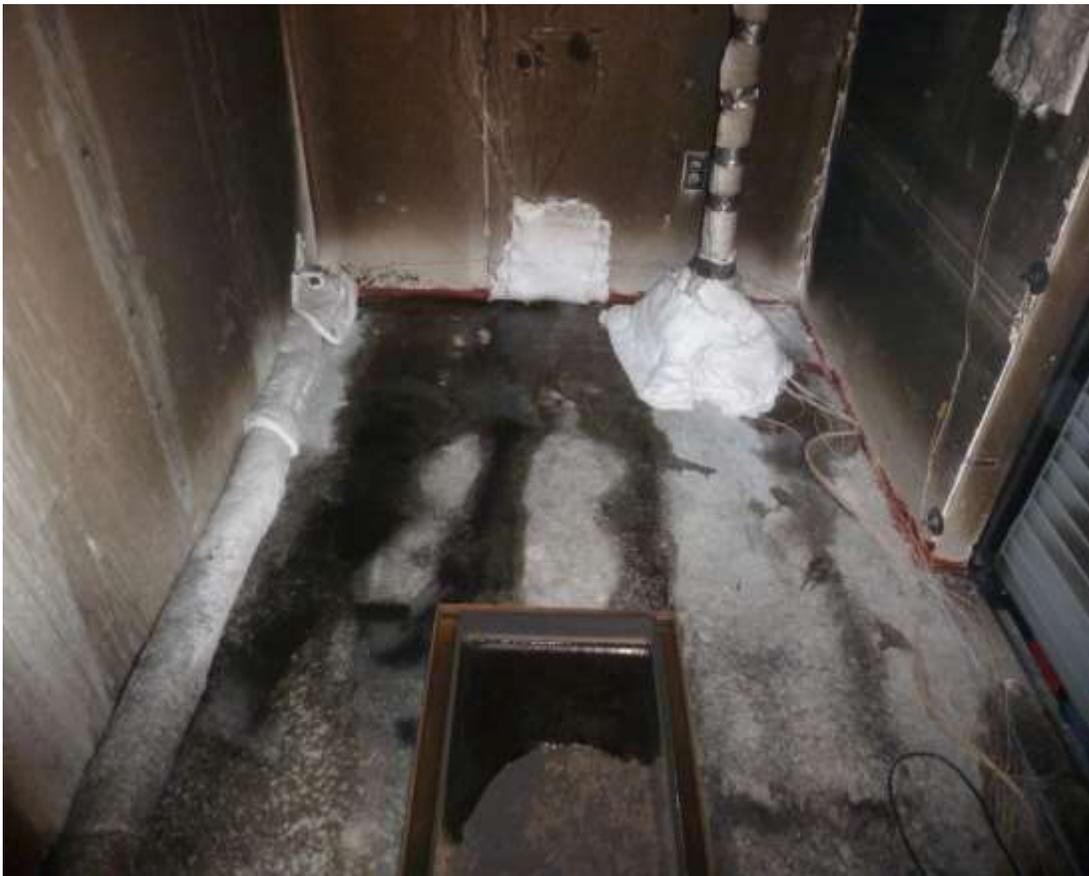
Figure 8.18. SBR after SBR fire test

Figure 8.17 shows the temperatures recorded by the thermocouple trees in the SBR and space above the SBR ceiling. The thermocouple location details are listed in Table 8.4. It is seen from the overall view of the SBR in Figure 8.18, that due to limited ventilation, the fire extinguished before all the heptane fuel was used up with a portion of the heptane fuel remaining in the pan.

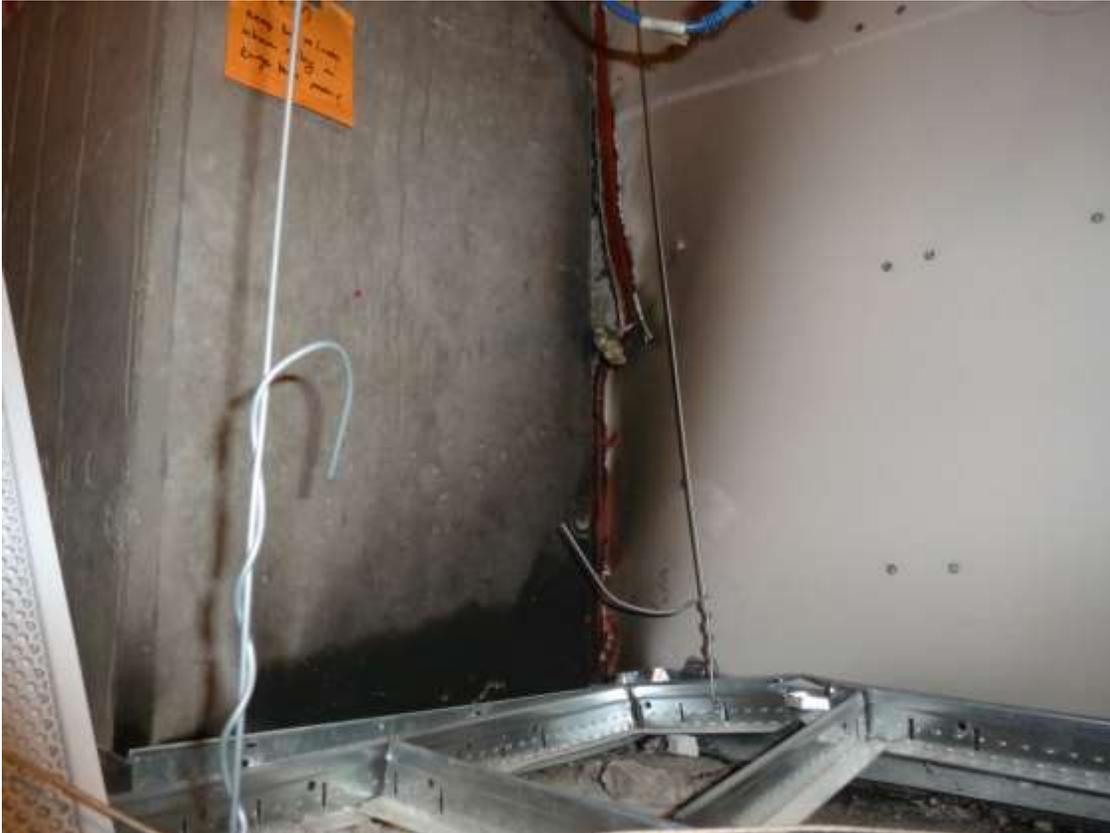
Figure 8.20. Northeast corner in space above SBR ceiling after SBR fire test

Figure 8.20 shows soot on the northeast corner above the ceiling of the SBR as openings allowed for smoke leak. A 'V' shape soot pattern was produced as shown in Figure 8.21, on the northeast corner of the LBR as the smoke leaked through the partition wall to the LBR.

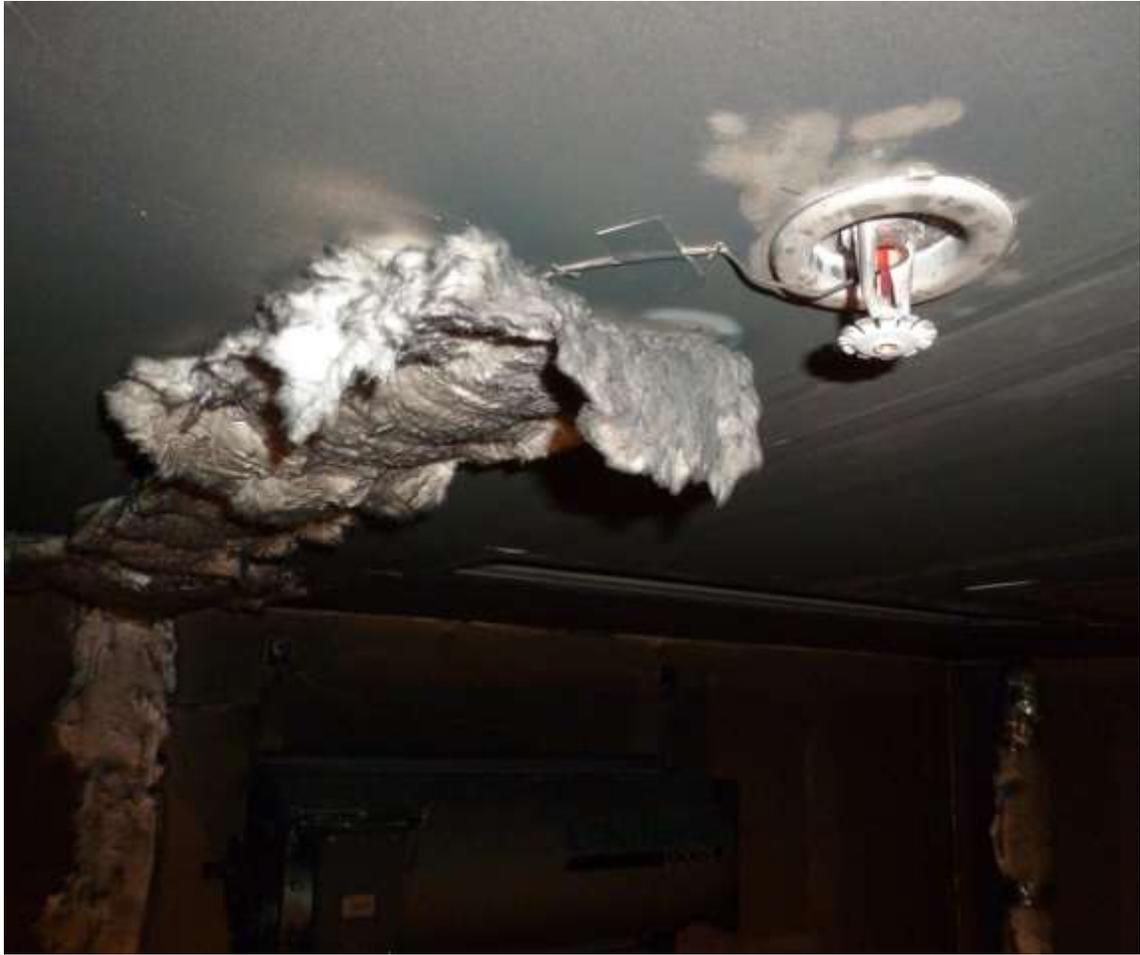
Figure 8.23. LBR sprinkler head after SBR fire test

Figure 8.22 shows the temperature of the SBR sprinkler. The graph indicates the SBR sprinkler activated at 21 seconds at 100C (212F). Although thermocouple 4-7 malfunctioned, post fire test visual inspection revealed the LBR sprinkler did not activate as shown in Figure 8.23. The thermocouple locations can be seen on Figure 6.32. The thermocouple location is listed in detail in Table 8.6.

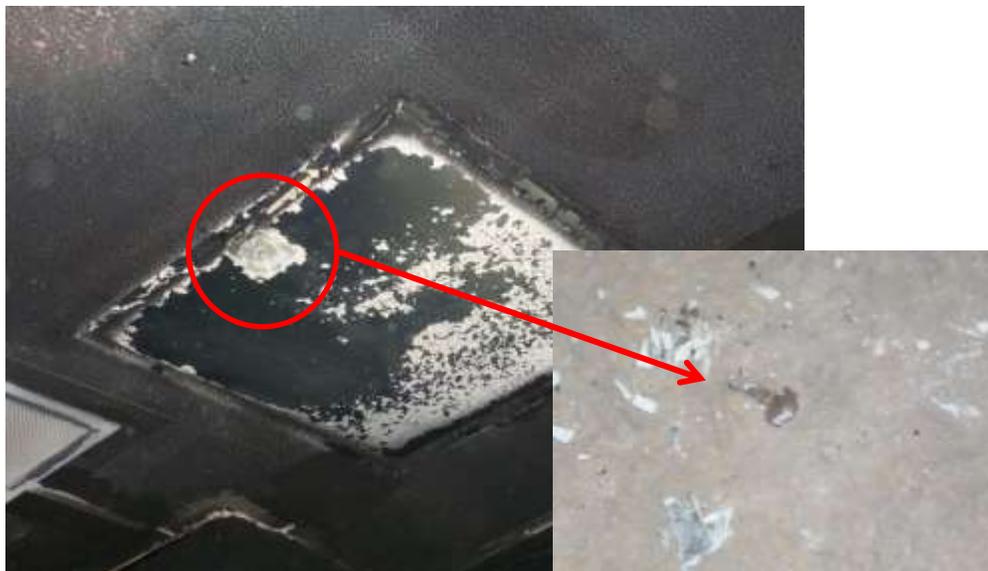
Figure 8.29. LBR access panel after LBR-2 fire test

Flashover occurred during the LBR-2 fire test. Besides the thermocouple temperature data, post fire test visual inspection provided evidence of how high the temperatures got. Figure 8.28 shows door 1 had burned and the door knob melted as well as the pressure differential leaving the door open slightly. Figure 8.29 shows the key to the access panel had melted and fallen to the ground. The area around the north wall of the LBR above the ceiling of the room area after the LBR-2 fire test is shown in Figure 8.30.

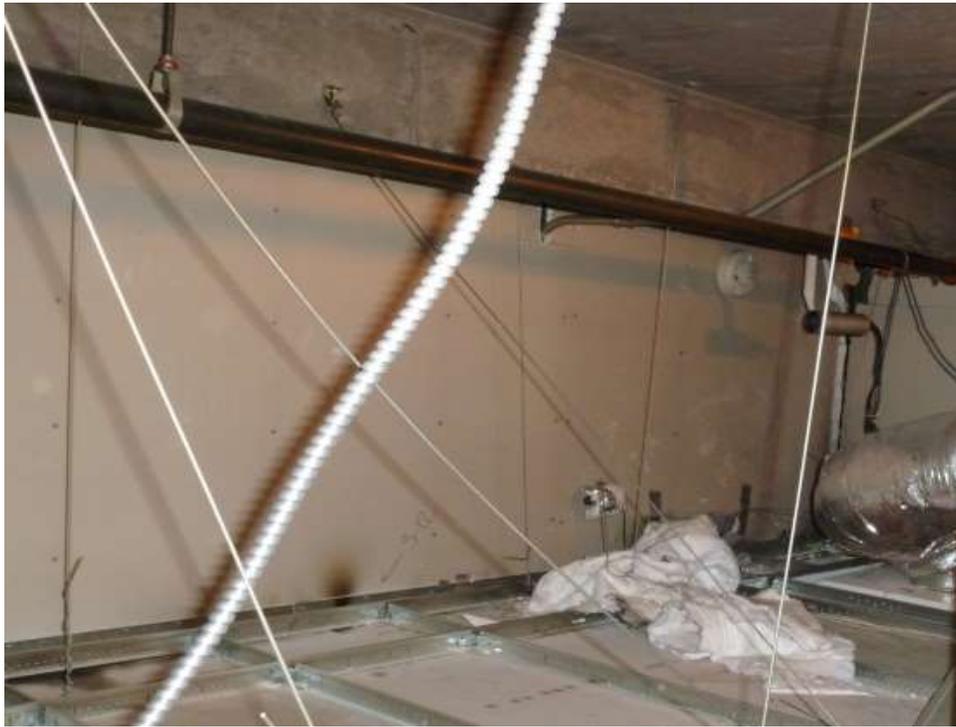
Figure 8.30. North wall of LBR above the ceiling after LBR-2 fire test

During fire tests, smoke spread through this gap beyond the room of origin was observed. Figure 8.30 shows soot pattern on the north wall of the LBR above the ceiling as smoke leaked through the gaps formed on the joint area between the ceiling and the north wall of the LBR during the LBR-2 fire test. For the LBR-2 fire test when full room involvement occurred, even flames were intermittently observed from the SBR. In addition, the empty space between the steel brackets became a channel for the smoke spread such that smoke came out in the joint area between the exterior walls and concrete cladding for the 4th floor where the vertical steel bracket ended. Temperature data in the joint area are available in Appendix C.3.8.

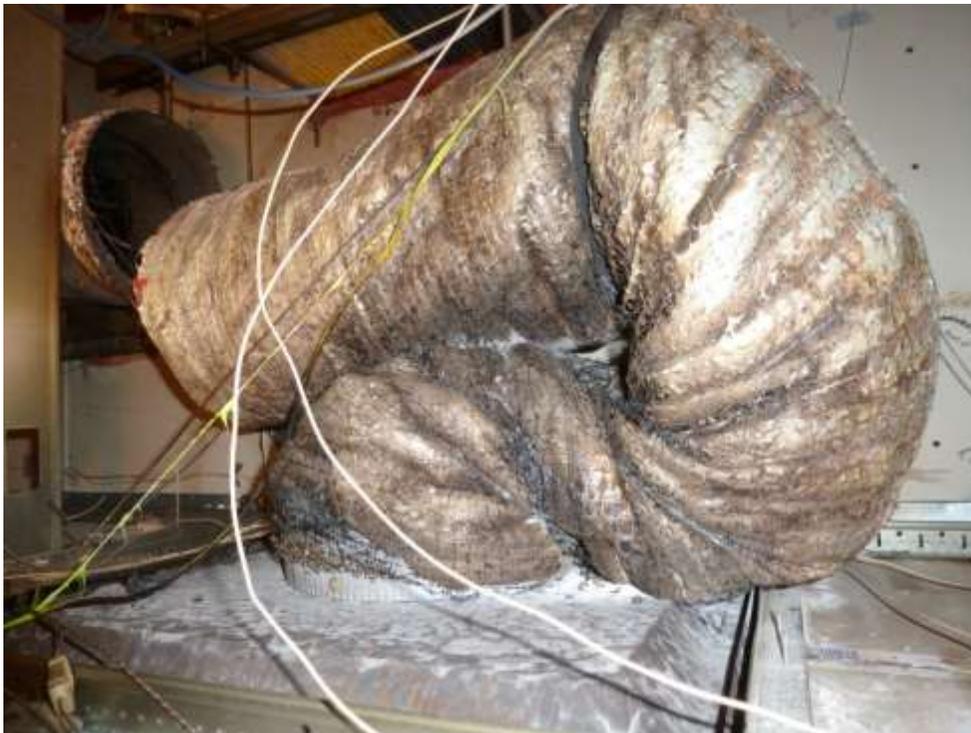
Figure 8.31. HVAC line connecting to the northwest vent of the LBR after LBR-2 fire test

proper protection measures were provided to ceiling assemblies including the lighting and the joint areas of the ducts above ceiling. However, flexible duct between the HVAC louvers and metal duct were not fire-rated and ruptured during the fire test as shown in Figure 8.31. Although all other fire-rated assemblies showed a good performance, the space above ceiling was exposed to hot smoke due to the failure of one item, the flexible duct. This is a good lesson for fire safety, which shows that just one item failure could lead to a poor performance of the entire system.

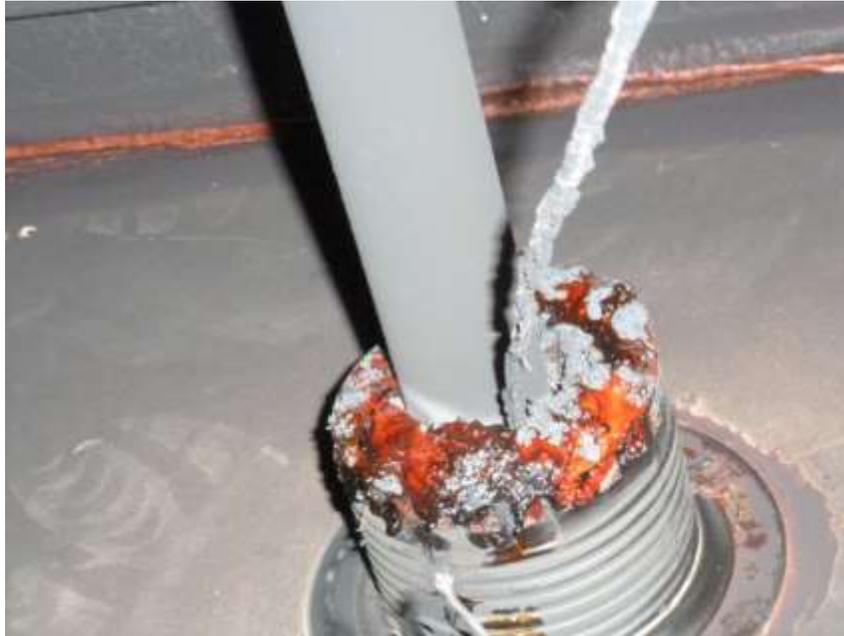
Figure 8.36. Horizontal pipe firestop in corridor after ES fire test

Figure 8.36 and Figure 8.37 shows horizontal firestops in the corridor area that intumesced. A vertical PVC pipe melted in the north of the elevator shaft as shown in Figure 8.38.

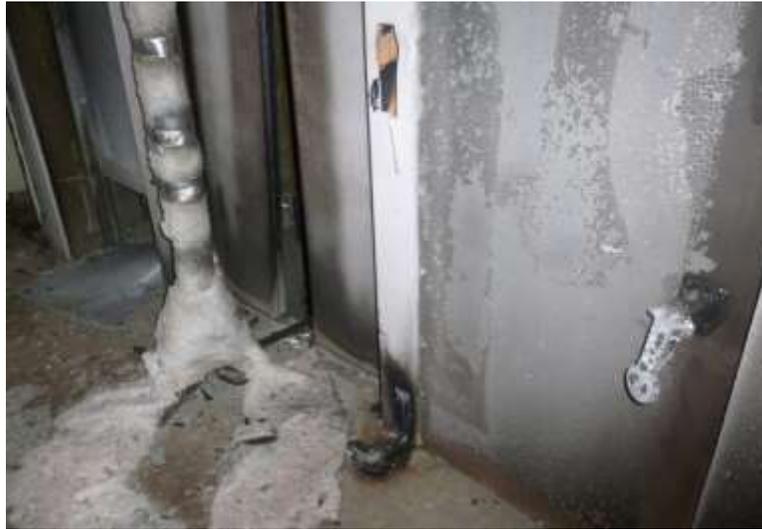
Figure 8.42. Elevator shaft wall after EL-1 fire test

Figure 8.41 shows the temperature of the SW corner of the EL. These thermocouple locations are listed with details in Table 8.13. The camera mount and elevator switch panel melted off of the south wall of the elevator shaft as shown in Figure 8.42. Spalling occurred on the concrete slab near the pans as shown in Figure 8.43.

The elevator was not operational after FB-6 due damage to the elevator doors, which was observed from the 2nd to the 5th floors. The elevator door in the 3rd floor is shown Figure 5.8. In addition, the fire test EL-1 revealed that fire melted the elevator button panel which may cause the electrical shorts and make elevator unavailable.

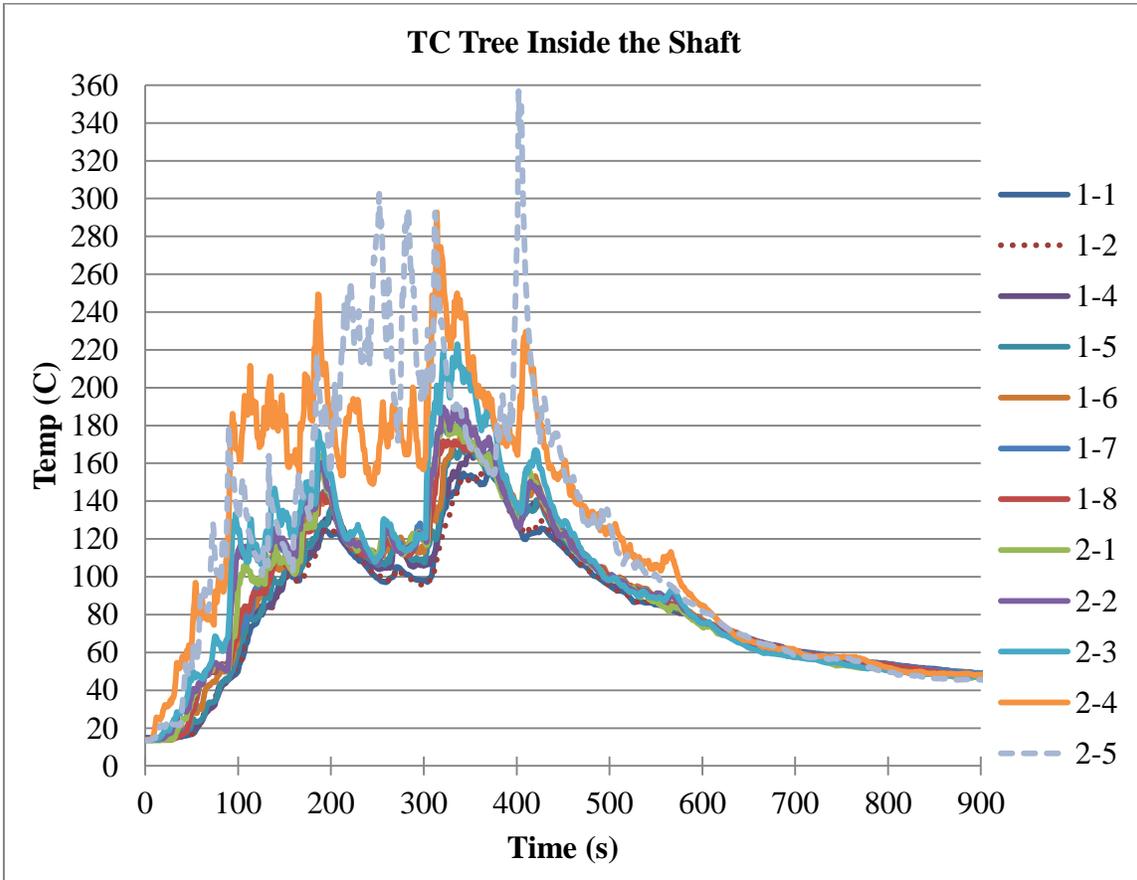
Figure 8.48. Inside the shaft temperature

Also, if elevator doors are failed open on multiple floors, such as with the FB-6 test, smoke spread to non-fire floors through the elevator shaft is highly possible, especially given the stack effect and buoyancy of hot smoke. In these tests, even the possibility of fire spread through the elevator shaft is confirmed as the internal gas temperature was increased up to 300°C as shown in Figure 8.48, which is high enough to ignite some materials.

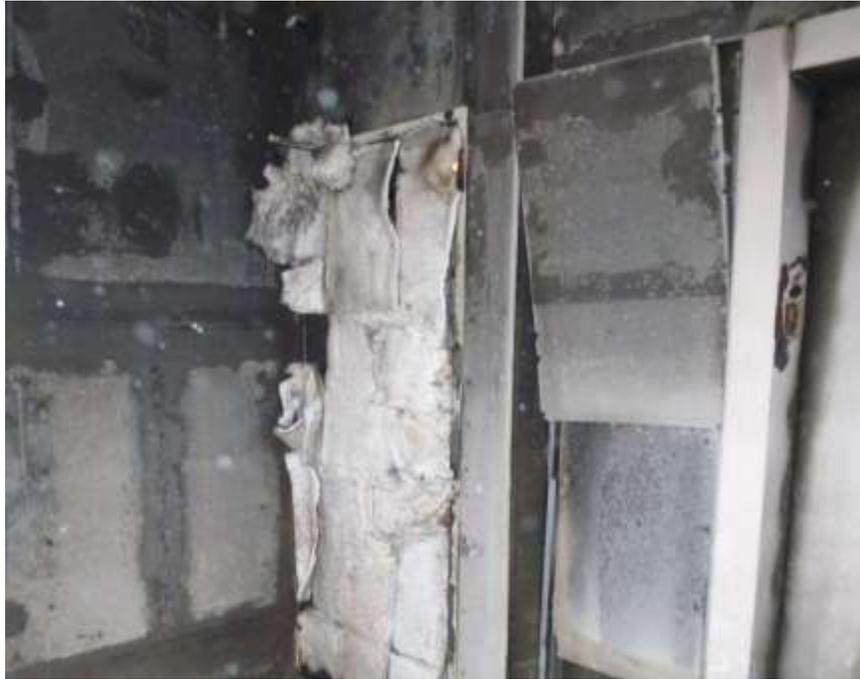
Figure 8.52. South wall of elevator shaft after EL-2 fire test

Figure 8.51 shows the temperature of the SW corner of the EL. These thermocouple locations are listed with details in Table 8.18. The gypsum wallboard got detached as shown in Figure 8.52. Door 3 was on fire as shown in Figure 8.53, and had to be extinguished using a water hose.
