# STRUCTURAL SYSTEMS RESEARCH PROJECT

Report No. **SSRP-16/08**

CFS Test Program Report #2 Earthquake and fire performance of a mid-rise cold-formed steel framed building – test program and test results: *Final Report*

Xiang Wang, Tara Hutchinson, Gilbert Hegemier, Srikar Gunisetty (UCSD)

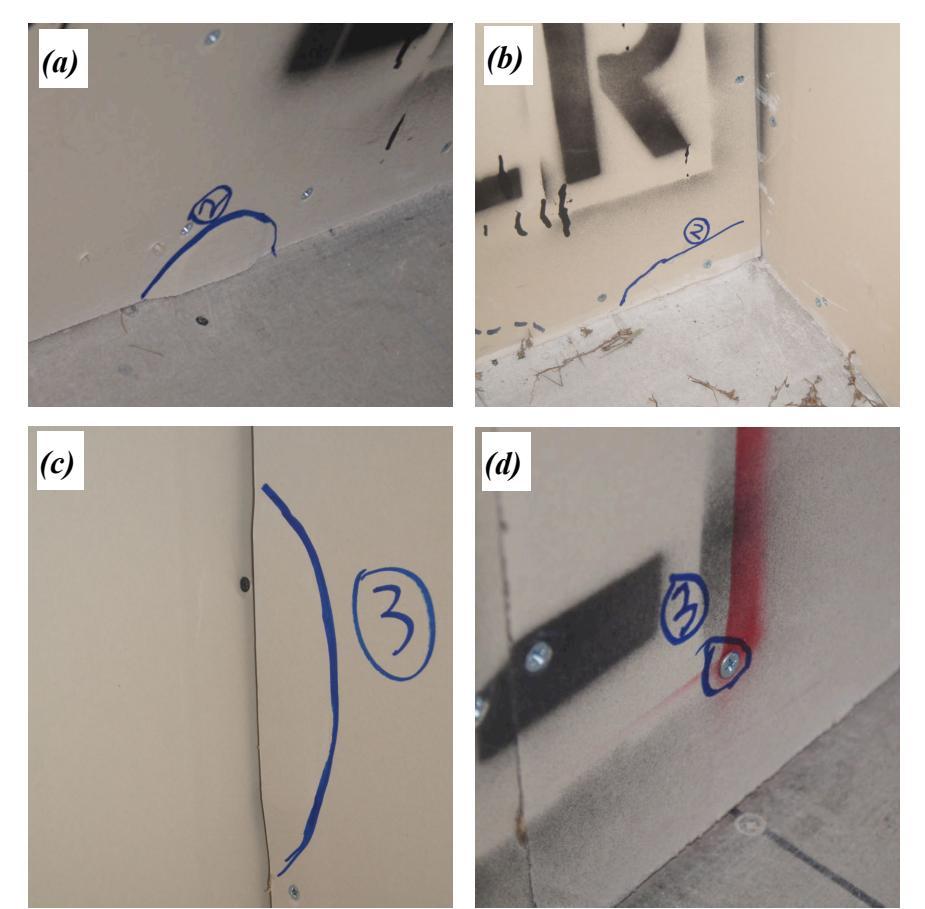
Due to the low seismic demands during the service level tests at all levels of the test building (PFA < 0.5 g, PIDR < 0.1%), interior sheathing sustained only a few instances of minor damage (DS-1) in the form of incipient screw withdrawal and localized gypsum crushing at bulging at level 3 and 4 (Figure 6.75), while no visible damage to interior sheathing occurred at all other levels. The extant of sheathing damage, however, was considered inadequate to classify the walls into any damage states.

Figure 6.72. Interior sheathing damage during the service level earthquake tests: (a) bulged gypsum on the bottom edge (EQ2), (b) bulged gypsum at the bottom corner (EQ2), (c) bulged gypsum on the vertical edge (EQ3), and (d) incipient screw pull out (EQ3).

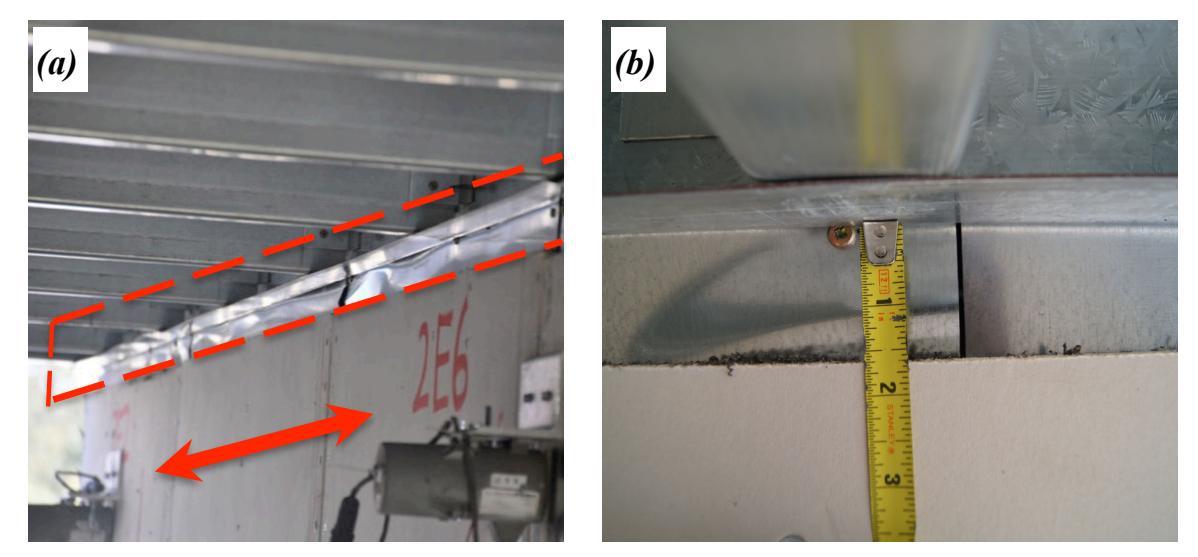
Additionally, buckling of sheathing sheet steel (below the joist rim tracks) occurred in particular on the corridor shear walls at level 1 (Figure 6.74a) following the design event (EQ6). This type of damage was primarily due to the large unbraced gap height (> 4 cm) between the rim tracks and gypsum (Figure 6.74b), compared with the typical gap height of ~1.5 cm in common construction practice. This unintended effect was due to the inconsistency of the dimension of the in-situ installation of the wall framing height at level 1 and that of the prefabricated sheathing panels.

Figure 6.74. Buckled sheet steel of corridor shear wall structural panels at level 1 at the completion of the design level test (EQ6): (a) global view, and (b) close up view of gap.

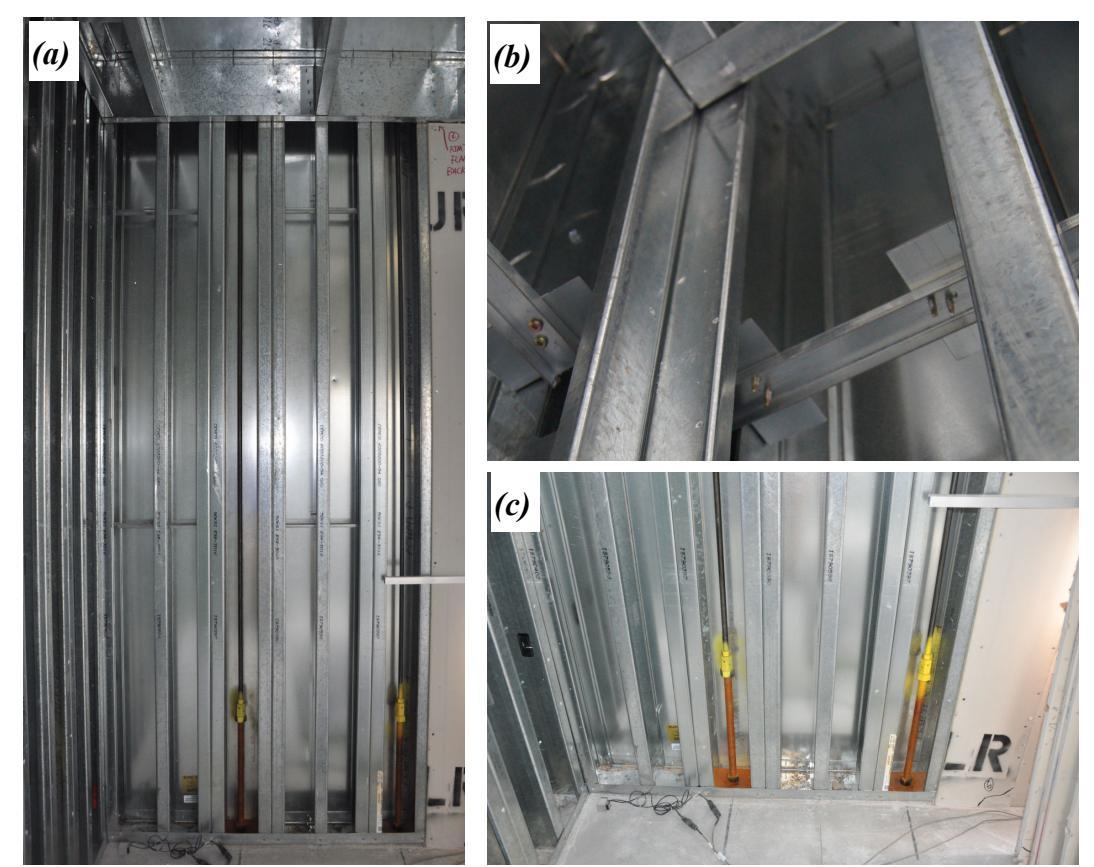
Following the completion of the pre-fire earthquake test phase, the interior gypsum panels of the northwest compartment at level 4, which represented the level with the largest drift demands during the pre-fire test phase, were removed to allow for inspection of the shear wall framing and sheathing steel. As shown in Figure 6.78b-d, localized buckling of the sheathing steel was detected at the top of the corridor shear wall, while the framing studs and tracks did not sustained visible damage (Figure 6.78e). In addition, loosening of the bolts at the floor bearing connections was detected at the end of the pre-fire test sequence, resulting in very loose tie-down rods. In contrast, the wall framing and sheathing steel of the corner shear walls in the same compartment sustained no apparent damage (Figure 6.79).

Figure 6.79. Longitudinal corner shear wall framing following the pre-fire MCE test (EQ7): (a) wall framing, (b) upper corner, and (c) bottom track and studs.

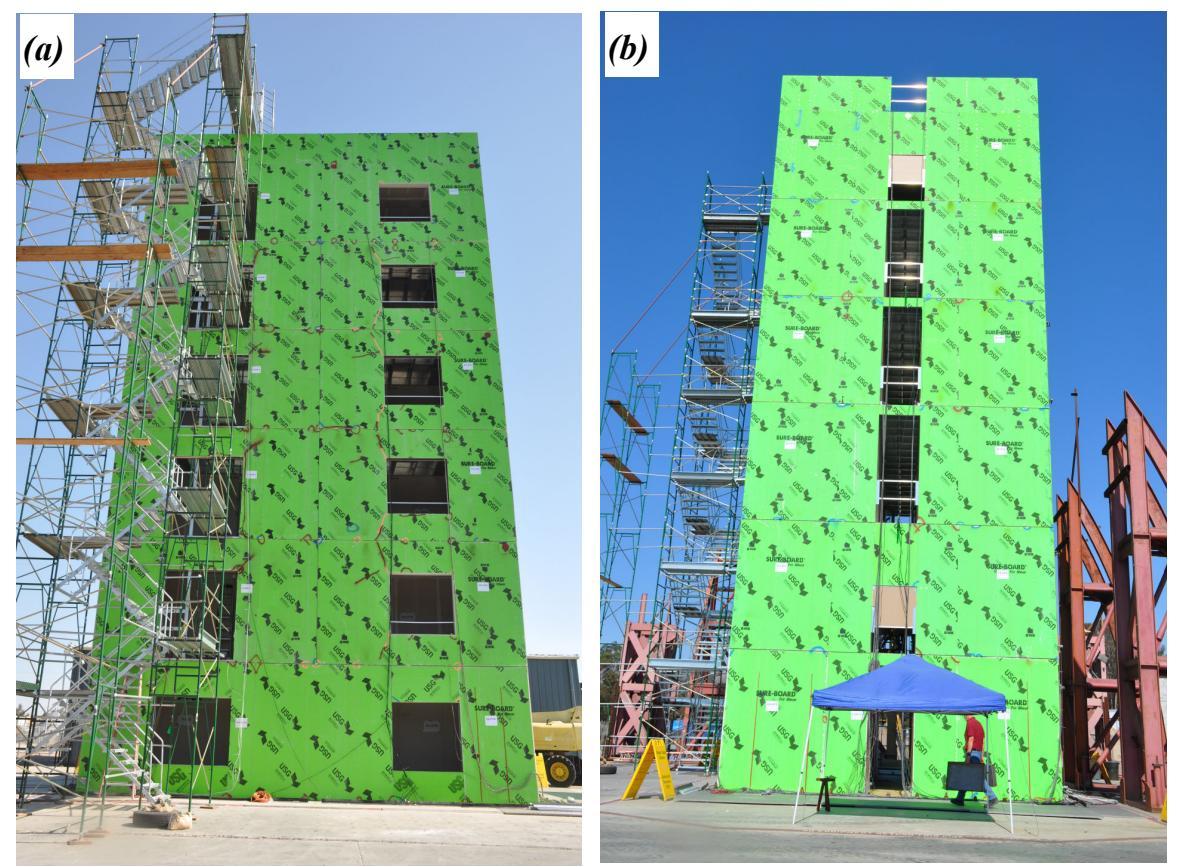
No apparent damage to exterior sheathing was observed during the service level tests (EQ1-EQ3). Damage to exterior sheathing initiated following the design event (EQ6) and continued to propagate and became more pervasive during the MCE event (EQ7). Figure 6.80 illustrates the north and west faces of the building following the MCE event (EQ7). It is observed that the exterior sheathing damage was located primarily on the exterior gravity walls (between the

window openings) and around the window openings (Figure 6.81a). In contrast, the corner shear walls (Figure 6.81b) and the east and west faces (Figure 6.80b) sustained very limited damage. Typical damage occurred in the form of gypsum crushing or bulging at the panel edges and corners as well as diagonal cracks around the window openings (Figure 6.81c-e).

Figure 6.80. Exterior sheathing following the pre-fire MCE event (EQ7): (a) north face, and (b) west face.

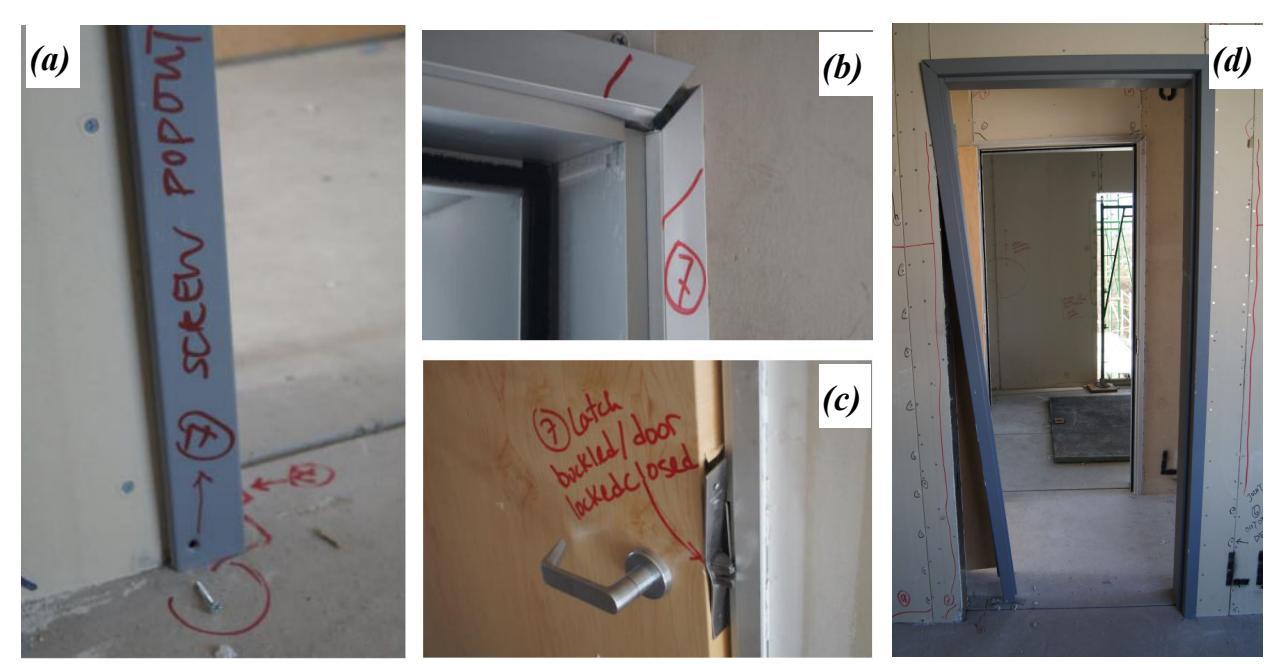
Figure 6.82. Examples of door damage: (a) door frame screw popping (DS-1), (b) door frame gapping (DS-2), (c) buckled door latch (DS-2), and (d) detached door frame (DS-3).

tests, while the doors on the partition walls sustained only limited damage. As the drift demands remained very low (PIDR < 0.1%) during the service level tests (EQ1-EQ3), the doors all functioned well with no apparent damage. Damage initiated on the corridor doors during the design event (EQ6, PIDR reached ~1.0%), which remained essentially minor (DS-1) (e.g., door frame screw popping (Figure 6.82a) and corner gapping (Figure 6.82b)). Damage continued to progress and became extensive during the MCE event (EQ7, PIDR > 1.5%). All the corridor doors expect those at level 1 suffered substantive damage in the form of latch plate failure (Figure 6.82c) as well as door frame distortion or even detachment (Figure 6.82d). Interested readers are referred to Appendix H for detailed photographic documentation of the physical door damage at different inspection stages.

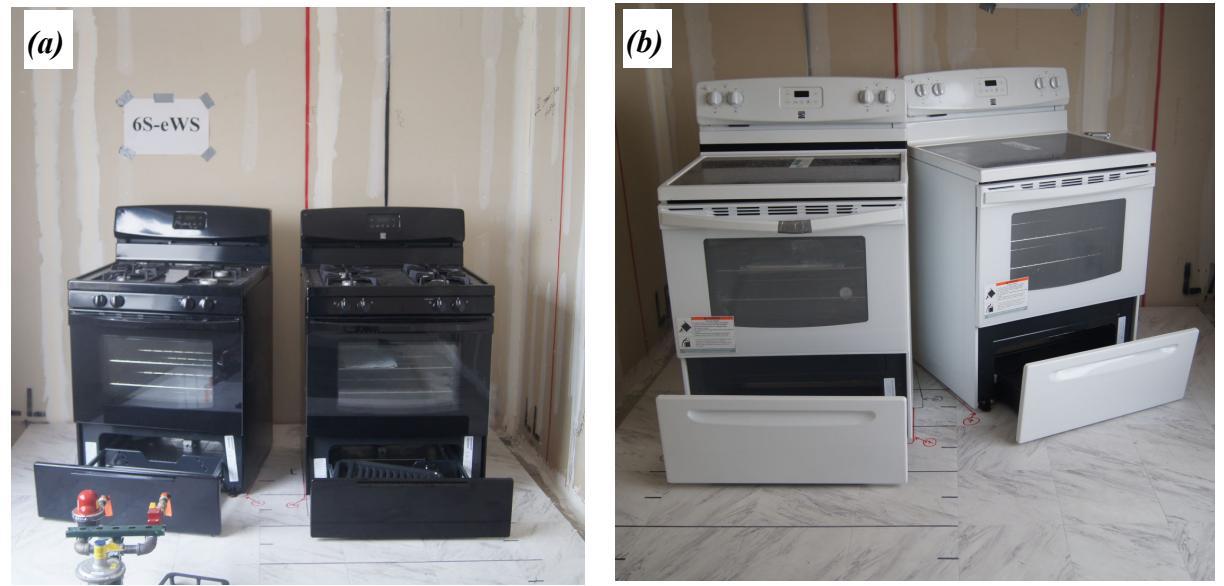
Table 6.10 summarizes the performance of the range units during the pre-fire earthquake test sequence. Regardless of the presence of restraints, none of the units observed any movement up to and including the 50% design level motion (however the drawer of a gas range unit at level 6 opened). During the design level motion (with a peak floor acceleration of  $\sim 0.7$  g at the first floor and ~2.0 g at the sixth floor), one restrained unit at level 6 moved slightly due to restraint failure, while all the remaining three restrained units sustained no restraint failure and remained in position. In contrast, all the unrestrained units underwent substantive movement in the form of combined sliding and rotation (the observed displacement offsets reached as much as 8 cm for the units at level 1 and 50 cm for the units at level 6). During the maximum considered earthquake motions, the measured peak floor accelerations were >1.0 g at the first floor and  $\sim3.0$ g at the sixth floor. While no failure to the restraints occurred for the units at level 1, both restrained units at level 6 detached from their restraints and displaced (Figure 6.83). The unrestrained units at level 1 and level 6 observed significant movement (the displacement reached as much as 0.7 m for a unit at level 6). Although not observed during the tests, excessive sliding of a gas (or electric) range poses the potential risk of breaking the gas pipes and connections (or electrical cords and connectors) as a result of excessive pulling.

Figure 6.83. Performance of range units following MCE test (EQ7): (a) gas range units at level 6, (d) electric range units at level 6.

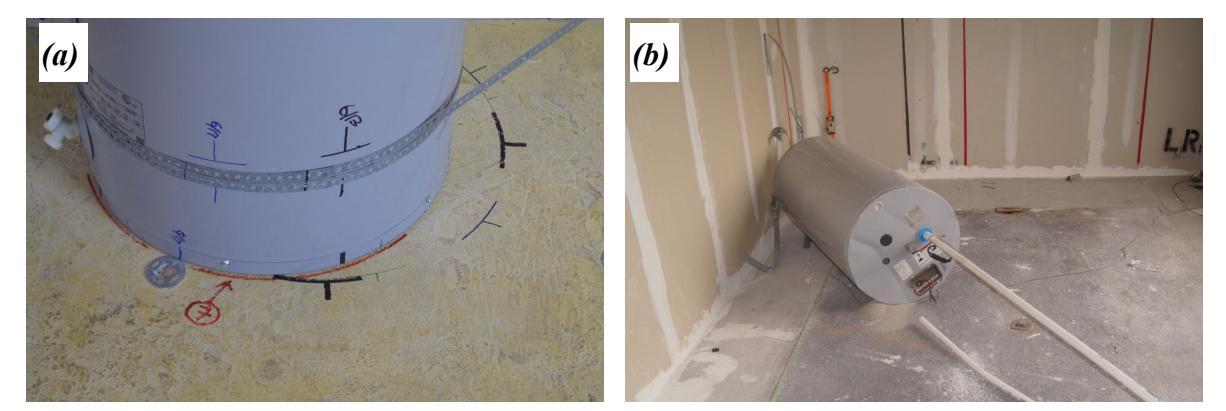
Table 6.11 summarizes the performance of the water heaters during the pre-fire earthquake test sequence. As discussed previously, the four braced water heaters each utilized a different bracing strategy to attach the unit to the adjacent wall framing (e.g., plumbers tape, off-the-shelf strap, and combined conduit and plumbers tape). During the service level motions, the water heaters observed no or only slight movement (< 2 cm) due to the relatively low floor acceleration demands (< 0.15 g at floor 1 and < 0.5 g at floor 6). As the floor acceleration demands increased significantly during the DE and MCE events, the water heaters performed poorly as a result of larger slenderness ratio and concentrated mass compared to the range units. The observed undesired effects included excessive movement (translation and rotation) (Figure 6.84a), bracing strap and fastener failure, and three instances of tipping over (the unbraced water heaters at level 1 and level 6, and the one at level 6 using off-the-shelf straps (Figure 6.84b)) with the ensuing water or gas leakage from the broken or disconnected pipes. The drywall screw disengaged and broke the plumber's strap. The tipped-over water heater level 6 even punched into the adjacent gypsum boards and caused a  $\sim 0.5$  m wide opening on the interior wall. From a fire safety perspective, damage of this kind may be considered as the loss of thermal barrier by directly exposing the CFS framing to fire hazards. In an event of post-earthquake fire, this may increase the risk of flame impingement and severely jeopardize the structural integrity of the light-gauge framing. From a structural perspective, this undesired performance (in spite of good-quality wall installation) necessitates further research to identify robust seismic bracing details for nonstructural components.

Figure 6.84. Performances of the water heaters: (a) base movement of the strapped water heater at level 1 following the MCE test (EQ7), and (b) toppling of the strapped water heater at level 6 following the DE test (EQ6).

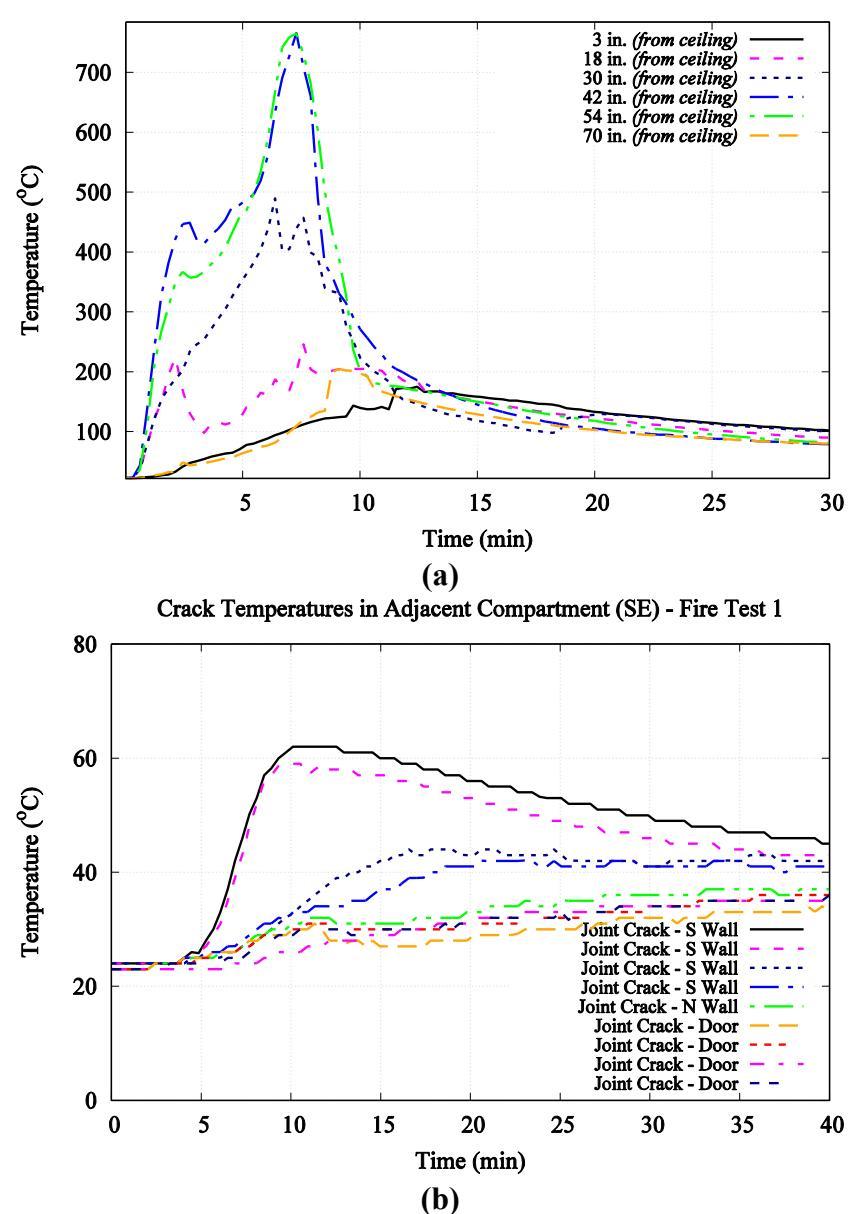
Figure 7.4 shows the temperature responses of the crack locations. The cracks were induced by the previous earthquake tests. Figure 7.4a shows the temperature in the cracks on the North wall of southwest (burn) compartment, whereas Figure 7.4b represents the temperatures measured in the southeast (adjacent) compartment, on the unexposed side of the partition wall, and the cracks on North and South walls that were formed closer to the partition wall. It is observed from Figure 7.4a that the crack temperatures in the mid-height of the compartment were as high as 750 °C. This is consistent with the peak cavity temperatures, which were also recorded at the mid-height of the North wall. However, the temperatures in the cracks on the upper layers remained within 350 and 400 °C. Lower temperatures were reported by the TCs embedded in the cracks near the ceiling. It should be noted that the temperatures were measured at different heights of the same crack that was formed between gypsum boards. However, the crack temperatures in the adjacent compartments did not increase significantly (Figure 7.4b). A peak temperature of around 60 °C was measured in the cracks, which may be attributed to the accumulation of smoke and heat in the southeast compartment.

Figure 7.4. Crack temperatures: (a) southwest (burn) compartment (b) southwest (adjacent) compartment (Fire Test 1).

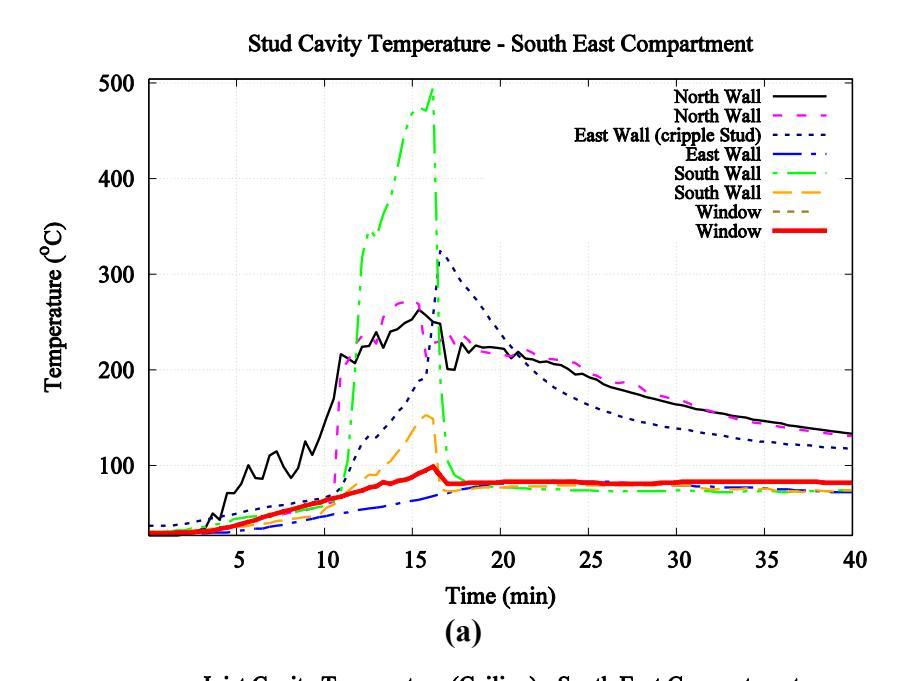
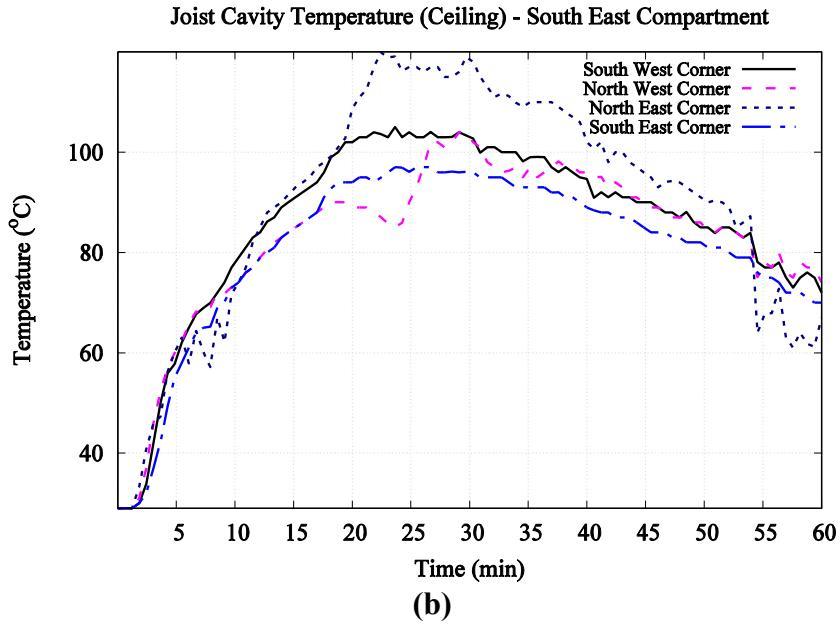
Figure 7.7.Cavity temperatures in the southeast (burn) compartment: (a) stud cavity, (b) joist cavity (Fire Test 2).

Figure 7.7a presents the temperatures in the stud cavities in the southeast (burn) compartment, whereas Figure 7.7b presents the temperatures in the ceiling joist cavities within the floor diaphragm on Floor 3. The temperatures in the cavities of North and South walls show different trends. A peak temperature of  $\sim$ 500 °C was observed on the South wall of the compartment. The temperature in the stud cavities of the South wall did not change during the first 600 seconds from ignition. Thereafter, the temperature escalated for about 300 seconds before it dropped to under 100 °C and remained constant for the cooling cycle. This is attributed to the loss of thermal barrier (16 mm thick gypsum drywall) and heat propagation through the gypsum wallboards. Similar trends were observed on the North and East walls, indicating the failure of the gypsum wallboards. A peak temperature of 300 °C was recorded on the East wall. However, the stud cavities on the window header showed no significant temperature rise. Figure 7.7b indicates that the average joist cavity temperatures reached ~100 °C (similar to Fire Test 1) and a peak temperature of 120 °C in the stud cavity on the northeast corner.

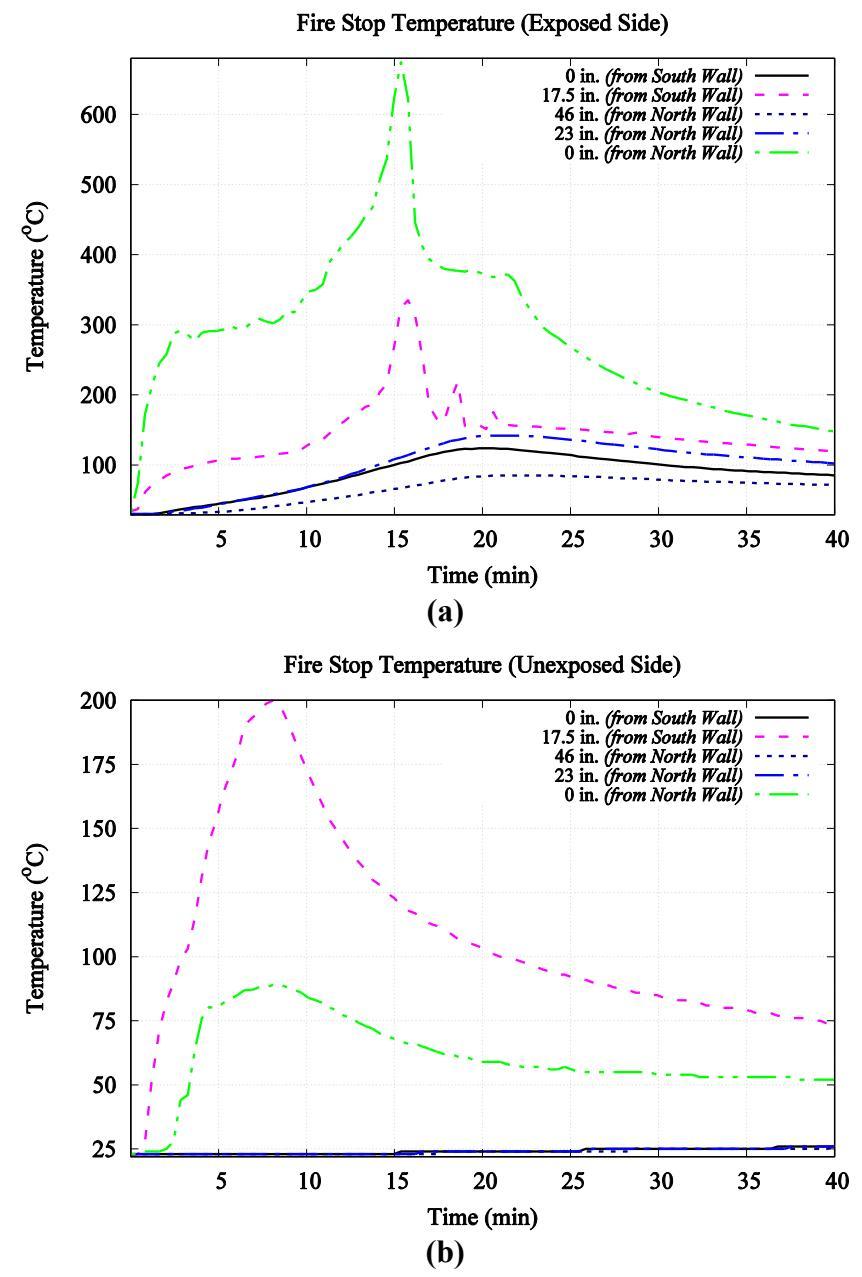
Figure 7.8.Temperatures of the fire and smoke track, a fire stop material: (a) exposed face (b) unexposed face (Fire Test 2).

Figure 7.8 shows the temperature responses in the fire and smoke track, which is a fire stop material used for the top track on the partition walls. Similar to Fire Test 1, temperatures were obtained on both the exposed side in the southeast (burn) compartment (Figure 7.8a) and the unexposed side (Figure 7.8b). As shown in Figure 7.8a, the temperatures of the exposed face were highly non-uniform, which may be attributed to the sources that include unequal burning of fuel in the pans, ventilation conditions and compartment size, time to reach fully developed fire and compartment burn dynamics. However, a temperature over 650 °C was observed near the North wall. The temperature near the South wall was almost half of that on the North wall (300 °C). The temperatures at other measurement locations were ~100 °C, which may be due to the radiant heat in the compartment. The temperatures of the unexposed side ranged between 85 °C and 200 °C (Figure 7.8b), which is indicative of significant heat transfer through the fire stop track. It should be noted that the fire stop track of the unexposed side in Fire Test 2 was previously exposed to a fully developed fire in Fire Test 1.

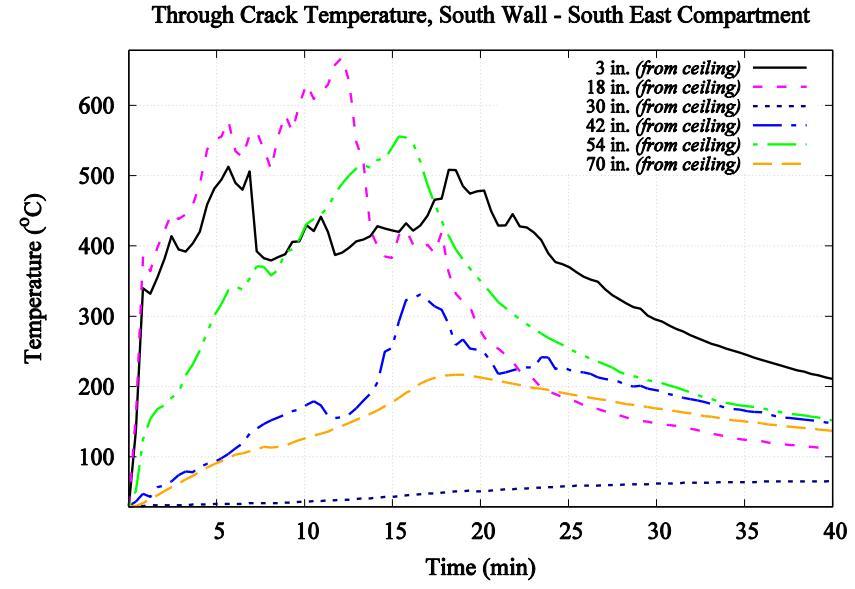
Figure 7.9. Crack temperatures of the southeast (burn) compartment (Fire Test 2).

Figure 7.9 shows the temperature responses of a through crack formed due to boundary crushing between the gypsum wallboards in the southeast (burn) compartment. The temperatures were measured by a TC tree mounted on the ceiling and the TC beads inserted into the crack at different heights. Note that TC embedded into the crack 762 mm (30 in.) from the ceiling malfunctioned during the test. The crack temperatures reached peak values at different time instances. The variation of the temperatures measured at different locations demonstrates the existence of a hot upper layer. Temperatures measured 457 mm (18 in.) from the ceiling reached a peak value of over 650 °C as the maximum temperature measured in the through crack. The TC located at 76 mm (3 in.) from the ceiling showed a double peak behavior, which was due to the circulation of cooler air within the compartment ceiling level. The time instance at which the first temperature drop coincided with the time when a cold draft of air was drawn in from the window opening. Since the burn continued for a longer duration with a lower intensity, the duration of the cooling (decay) phase was much longer than other compartment fire tests conducted on the second floor.

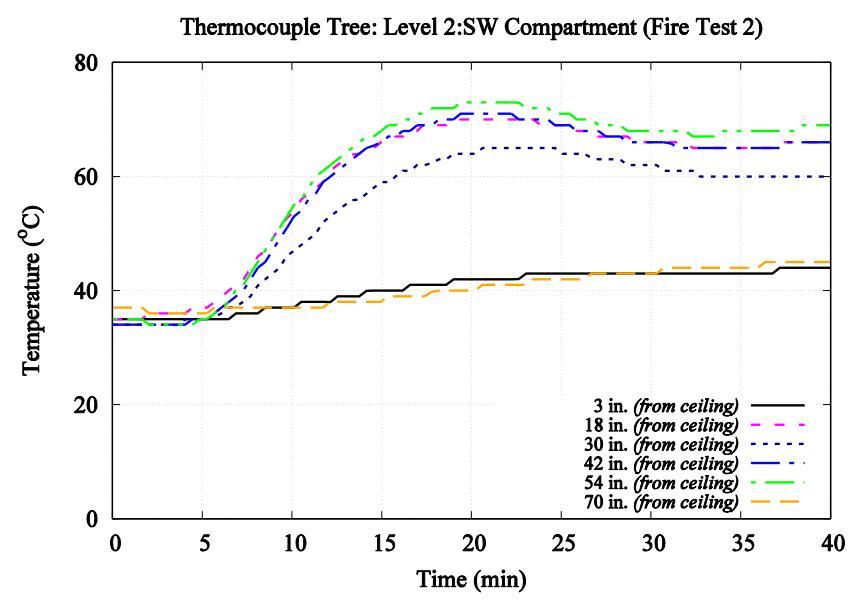
Figure 7.10. Temperatures of the southwest (adjacent) compartment (Fire Test 2).

Figure 7.10 shows the temperature responses of the southwest (adjacent) compartment. The intent of measuring the temperatures within the adjacent compartment was to observe the flow of heat through the burning door (or door frame) on the partition wall, which initiated the flame and smoke spread through the southwest compartment. The temperatures were measured at the different heights from the TC tree mounted at the center of the compartment. The trends show an average increment of 30 °C in the middle third measurement locations. This was further corroborated by the visually observed layer of smoke propagating from the southeast compartment to the southwest compartment before exiting from the window opening of the southwest compartment. The low temperatures in the southwest (adjacent) compartments may provide an environment with low discomfort level and benefit the evacuation and fire-fighting activities.

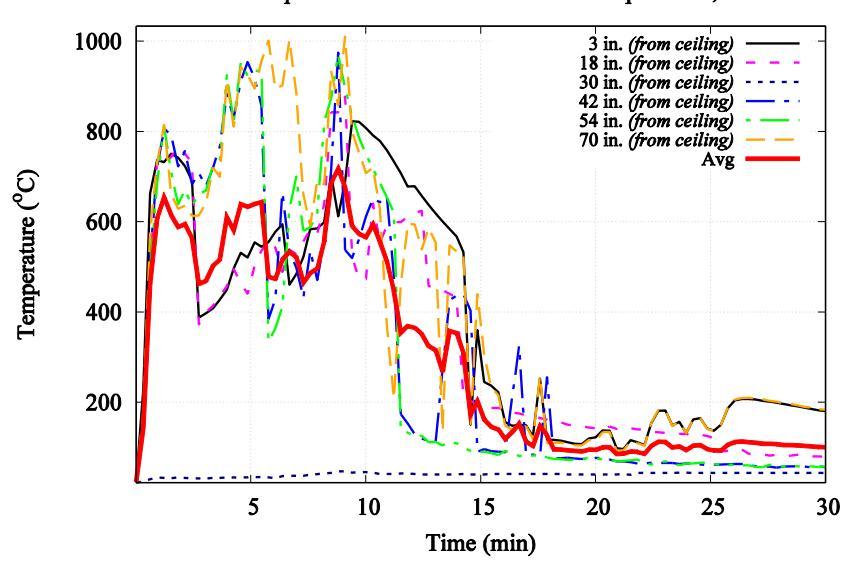
Figure 7.11. Temperatures of the northwest (burn) compartment (Fire Test 3)

Figure 7.11 shows the temperature responses of the northwest (burn) compartment at Level 2. The temperature at 76 mm (3 in.) from the ceiling was lower than the temperatures at all other measurement locations. The temperature responses involved multiple peaks, indicating a non-uniform distribution of temperature in a fully developed fire at the various heights. In addition, the temperature trends of several locations appeared comparable.

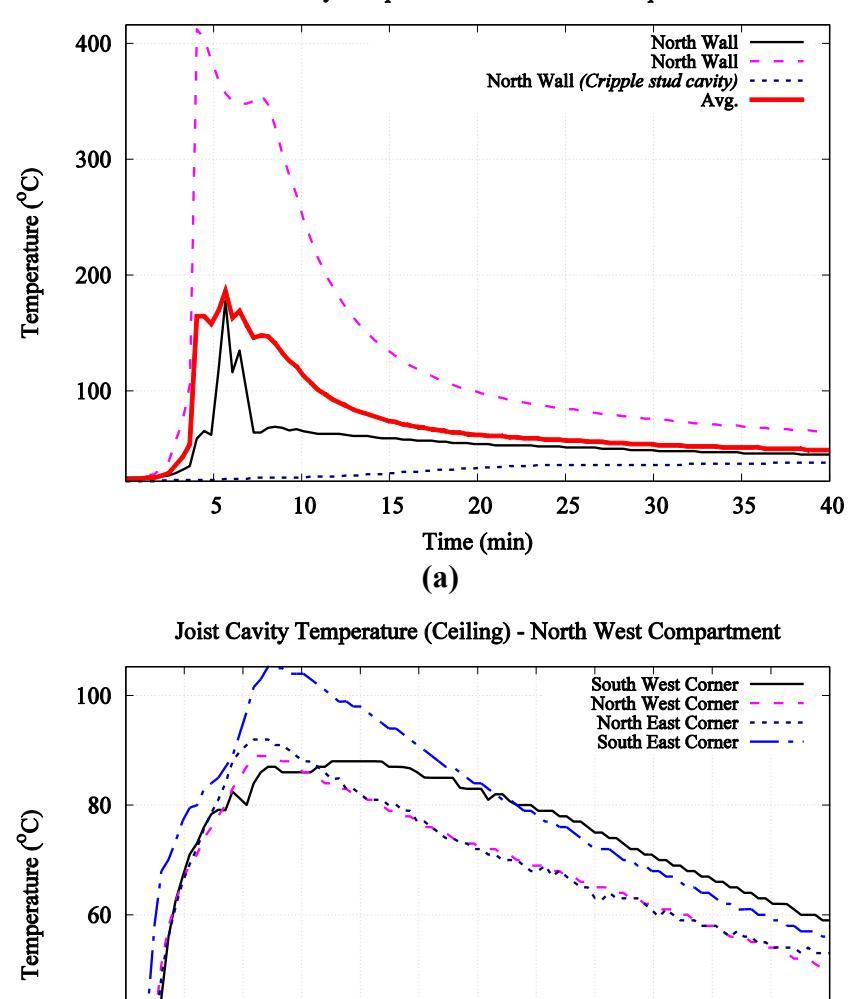
Figure 7.12. Cavity temperatures in the northwest (burn) compartment: (a) stud cavity, and (b) joist cavity (Fire Test 3).

Figure 7.12 shows the cavity temperature responses of the stud and joist cavities in the northwest (burn) compartment. Figure 7.12a shows the temperatures of the stud cavities on the North wall. It is observed that the stud cavity closer to the window opening reached temperatures over 400 °C and the adjacent cavity close to 200 °C (note that slight increase of the cripple stud cavity temperature may be due to TC malfunctioning). The trends indicate the loss of thermal barrier in the compartment at 300 seconds following the onset of ignition. Figure 7.12b shows the temperatures of the joist cavities within the floor diaphragm at Floor 3. An average

temperature of 93 °C was recorded in the joist cavities, which suggests that the ceiling gypsum wallboards provided adequate thermal barrier to contain the heat penetration.

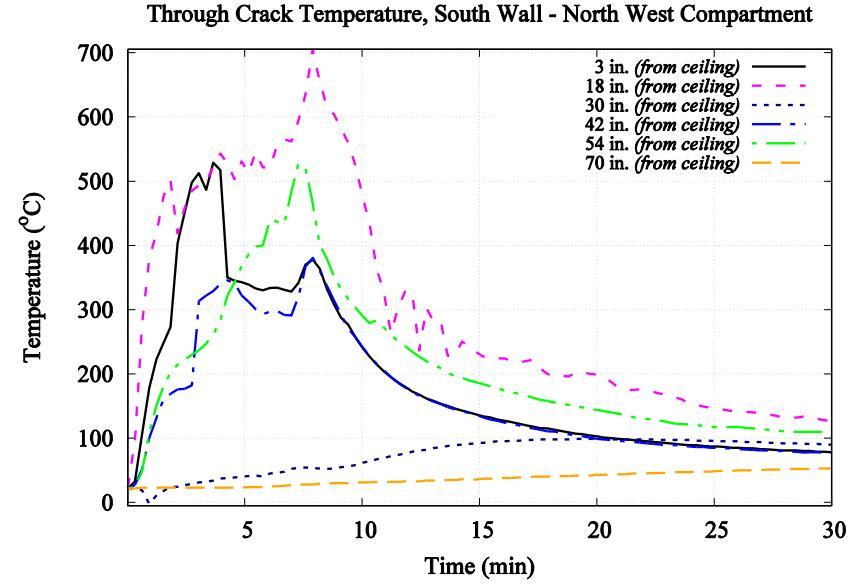
Figure 7.13. Crack temperatures of the northwest (burn) compartment (Fire Test 3).

Figure 7.13 shows the temperature responses of a through crack on the South wall formed due to boundary crushing between the gypsum wallboards in the northwest (burn) compartment. The TC beads were embedded at various depths dependent on the crack widths. The crack temperatures reached as high as 700 °C. The crack temperatures were higher near the ceiling

than those at the bottom of the wall. This is consistent with the crack depths based on crude visual observation (accurate measurements of the crack depths were unavailable). It should be noted that the duration of the peak temperatures of the crack were consistent with the peak compartment temperatures.

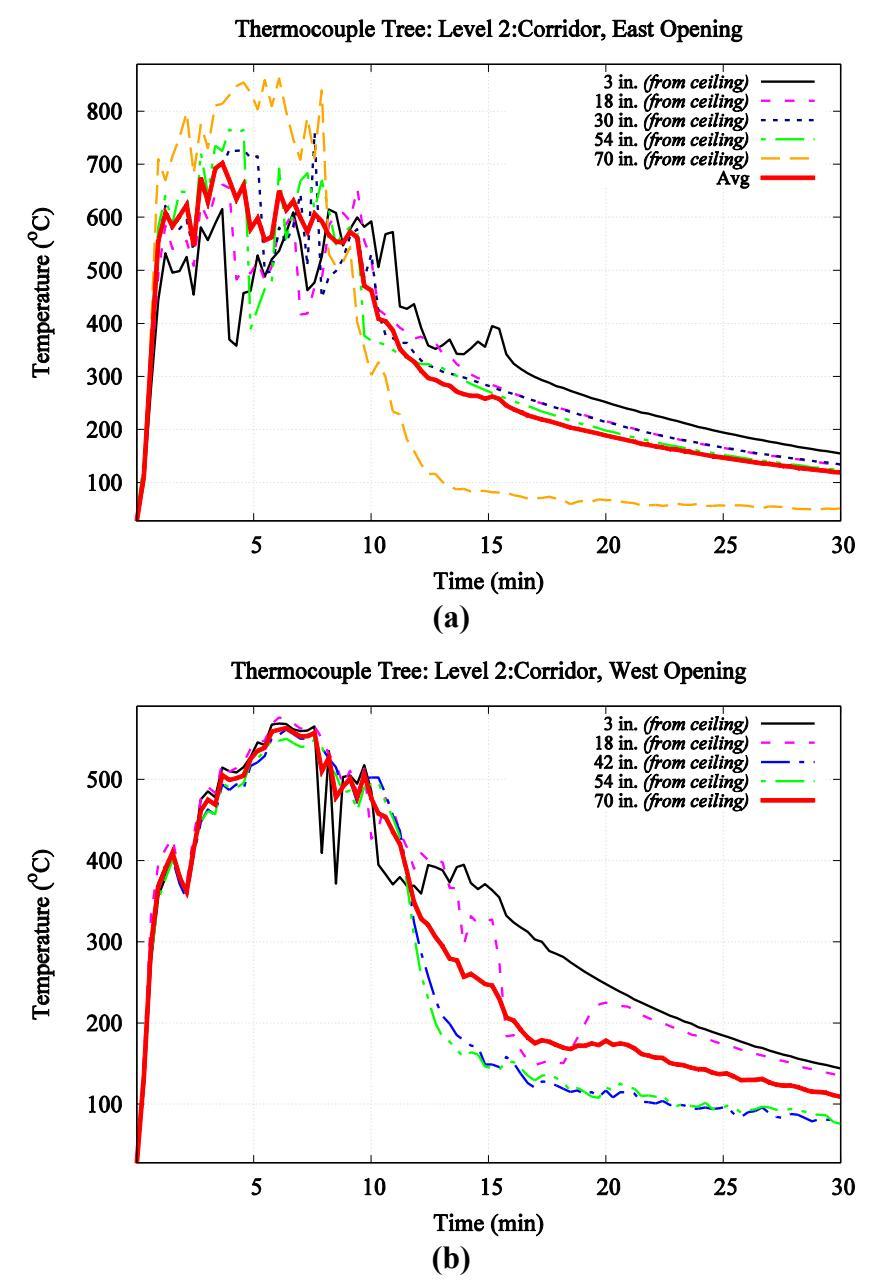
Figure 7.14. Temperatures of the corridor (burn) compartment: (a) east opening, and (b) west opening (Fire Test 4).

Figure 7.14 shows the temperature responses of the East and West ends of the corridor (burn) compartment at Level 2. The temperatures of the East opening were much higher than those of the West opening, which was governed by the eastward wind direction. Visual observations indicated a large flame and smoke extension from the West opening of the corridor. All the thermocouples reported a similar trend during their growth phase. However, the temperatures at different heights within the compartment showed a non-uniform distribution after the full development of fire. Due to the geometry of the corridor (length much larger than width), the existence of a hot upper layer was not observed. The thermocouples closer to ceiling measured temperatures lower than those closer to the floor. The peak temperatures of the West opening reached over 800 °C, whereas the temperatures of the East opening were only slightly over 500 °C. Uniformly distributed temperatures over the height was observed at the West opening in the growth phase, while the temperature distributions were characterized with marked dissimilarities during the cooling phase.

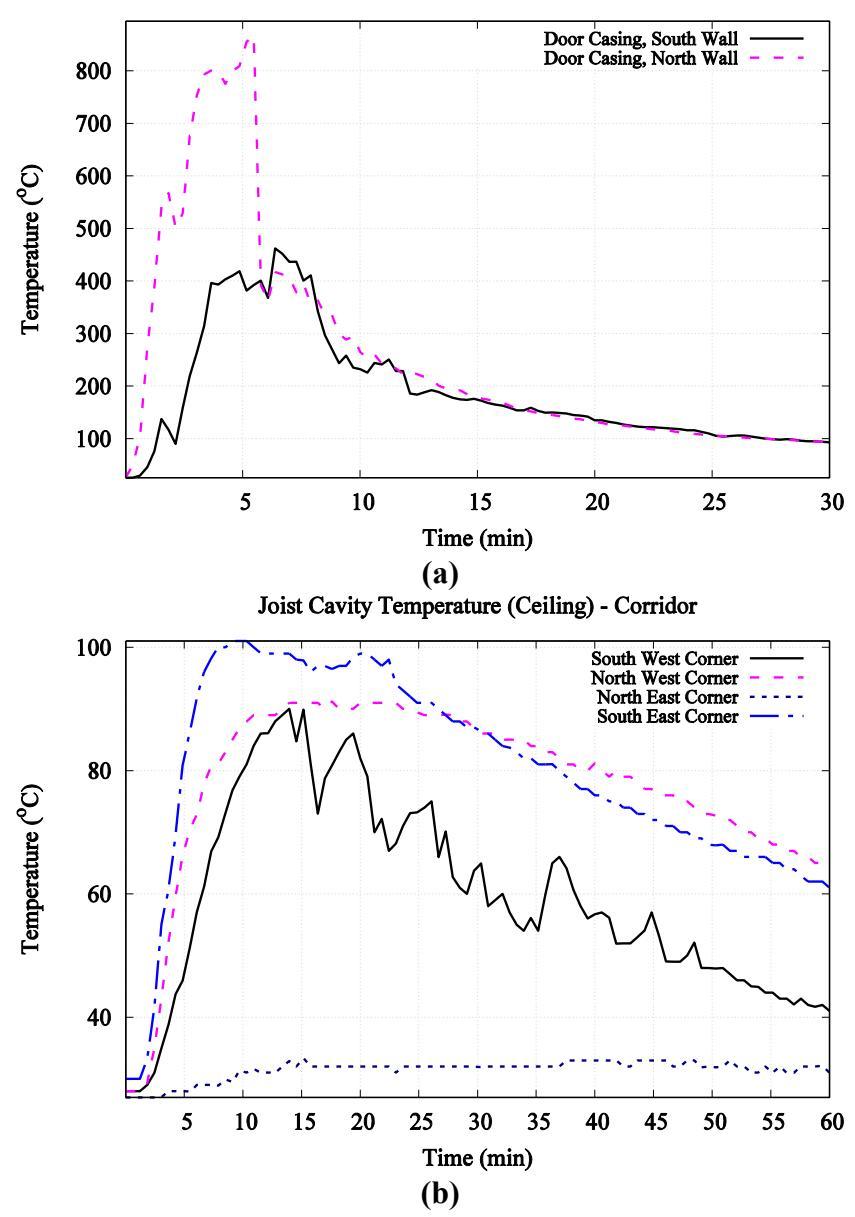
Figure 7.15. Cavity temperatures in the corridor (burn) compartment: (a) door frame cavity (b) joist cavity (Fire Test 4).

Figure 7.15 shows the temperature responses of the door frame and joist cavities in the corridor (burn) compartment. Since the pre-existing crack found on the corridor wall that would provide access to the stud cavities, the temperatures of stud cavities was not measured. However, the earthquake tests induced severe door frame distortion to the Level 2 corridor doors and created several gaps between the horizontal and vertical jambs. Figure 7.15a shows the temperatures of the cavities in the door jambs on both the North and South walls. The peak temperature attained over 850 °C for the door frame cavity of the North wall but ~450 °C for that of the South wall. This is attributed to the fact that the aluminum door casing on the North wall melted and exposed the TCs to direct flames, whereas the steel door frame on the South wall remained intact with minor deformation. Figure 7.15b shows the temperatures of the joist cavity locations, the temperatures of the joist cavity above the corridor were below 100 °C. This indicates a nominal heat transfer through the ceiling gypsum wallboards.

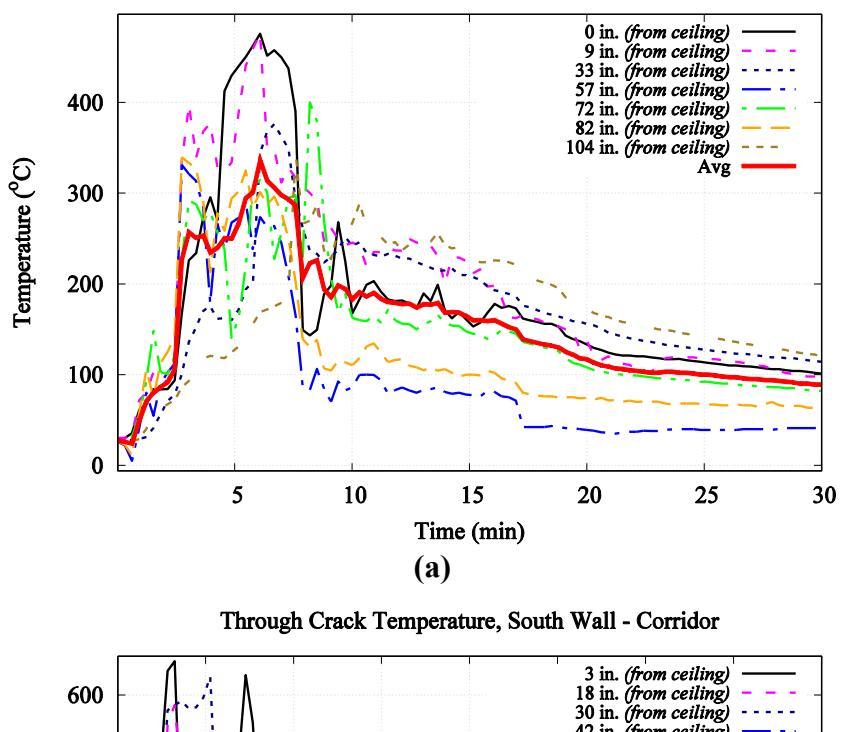
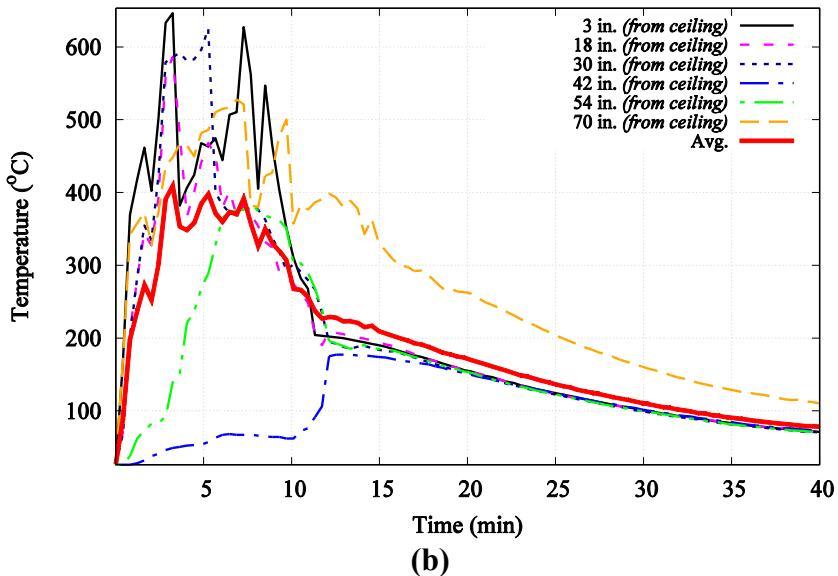
Figure 7.16. Crack temperatures in the corridor (burn) compartment: (a) joint crack (b) through crack (Fire Test 4).

Figure 7.16 shows the temperature responses of the cracks in the corridor (burn) compartment. Figure 7.16a shows the temperatures measured in the crushed boundary gap on the North wall. It is observed that the peak temperature reached 475 °C at the ceiling height and 230 mm (9 in.) from the ceiling at a nearly identical time instance. The temperature responses were all characterized with multi-peak behavior that affirms the effect of wind on the compartment fire dynamics. Figure 7.16b shows the temperatures along the through crack on the South wall as measured by a TC tree. Similar to those of the North wall, the peak temperatures occurred near the ceiling (76 mm) and a depth of 460 mm from the ceiling. The peak temperatures attained ~ 650 °C.

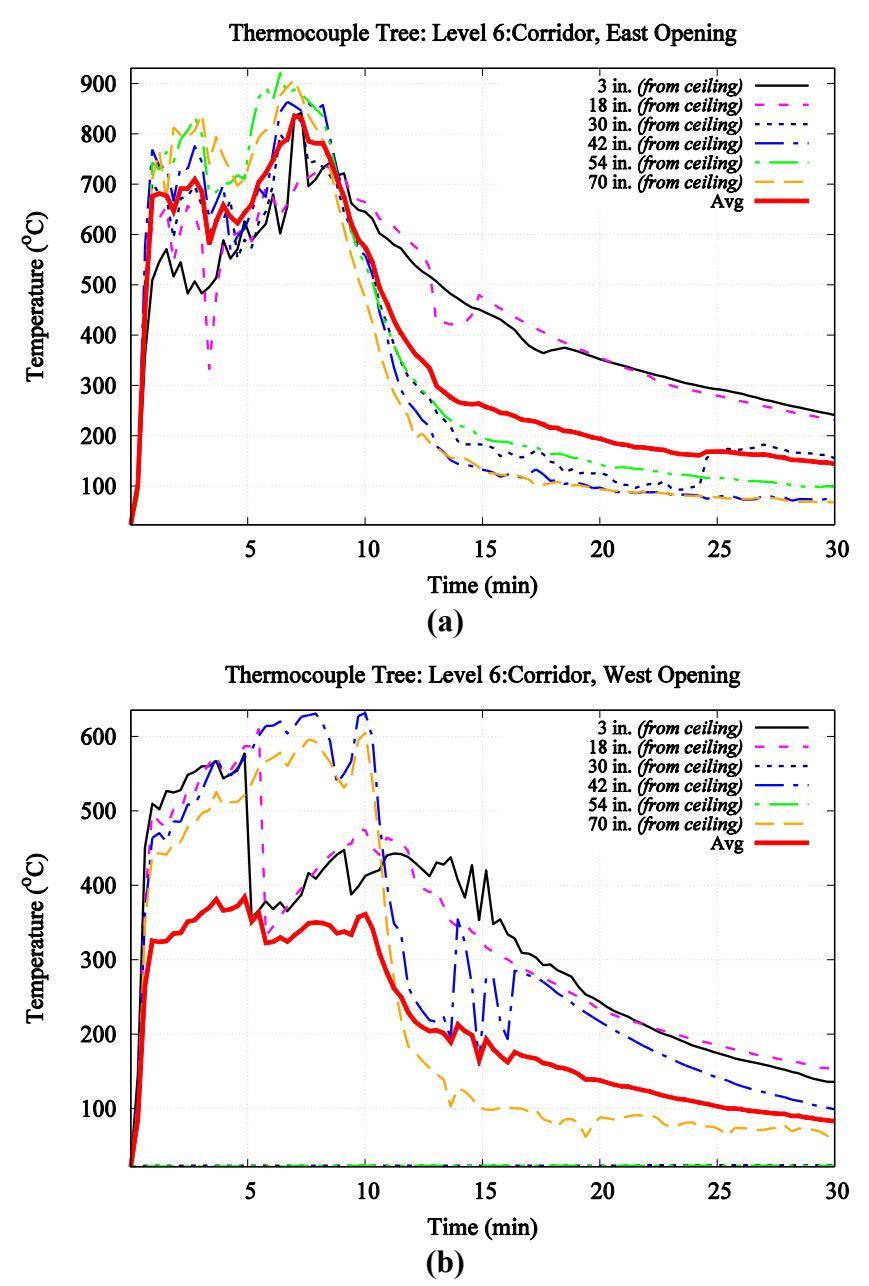
Figure 7.17. Temperatures of the corridor (burn) compartment: (a) east opening, and (b) west opening (Fire Test 5).

Figure 7.17 shows the temperature responses of the East and West ends of the corridor (burn) compartment at Level 6. The temperatures measured near the West corridor opening were lower than those rest of the compartment since it was the only source of air inlet, which propagated through the narrowly confined corridor space towards the East corridor opening, which served as an exit for flame and smoke. This was consistent with the ambient West-to-East wind direction. Figure 7.17a shows the temperatures of the East corridor opening. A large flame and smoke extension was observed at the East corridor opening within a few seconds from the onset of ignition. The temperatures all contained double-peak behavior, which indicates the heat redistribution within the compartment. The first peak was lower than the second peak. This may be attributed to an enhanced rate of heat release within the corridor due to the burning door and frame. Peak temperatures reach 800 °C - 900 °C, which were significantly higher than the temperatures recorded at the West opening. The highest temperatures were observed at the midheight of the compartment. Figure 7.17b shows the temperatures of the West corridor opening. The peak temperatures were slightly over 600 °C at the mid-height of the compartment. An abrupt drop of temperature near the ceiling around 300 seconds was attributed to the untimely fuel burn out in the eastward pans (as captured by the internal cameras). The TC located at 1372 mm (54 in.) from the ceiling malfunctioned. Only the bottommost thermocouple (1778 mm) on the TC tree showed a consistent data throughout the burn.
