# STRUCTURAL SYSTEMS RESEARCH PROJECT

Report No. **SSRP-16/08**

CFS Test Program Report #2 Earthquake and fire performance of a mid-rise cold-formed steel framed building – test program and test results: *Final Report*

Xiang Wang, Tara Hutchinson, Gilbert Hegemier, Srikar Gunisetty (UCSD)

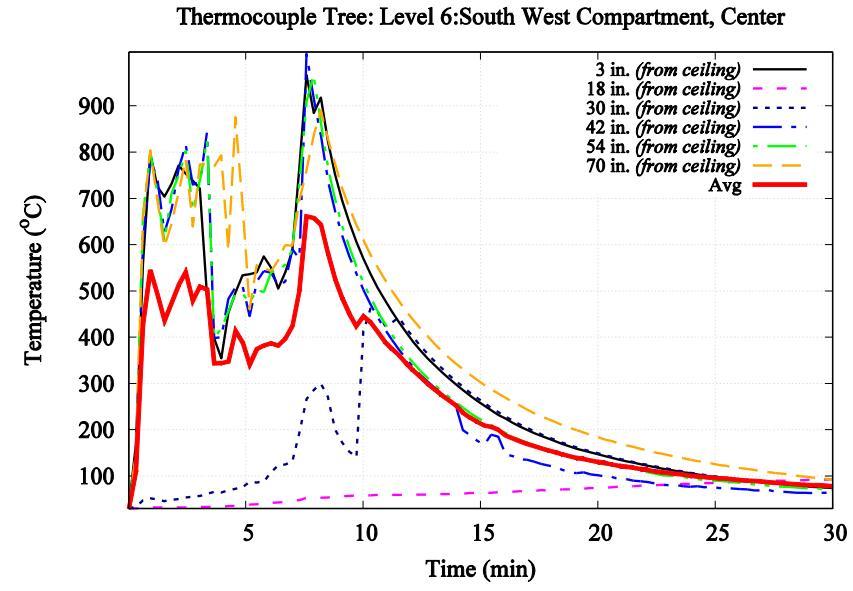
Figure 7.18. Temperatures of the southwest (burn) compartment (Fire Test 6).

Figure 7.18 shows the temperature responses of the southwest (burn) compartment at Level 6. During this test, the post-flashover condition was reached rapidly and the temperatures attained as high as 1000 °C. Similar to those of the corridor fire tests (Fire Test 5), the temperatures in southwest compartment involved a double peak behavior which a higher second peak indicating the combustion of the door triggering a higher rate of heat release. The temperatures at different

measurement locations were consistent (except the one at the height of 457 mm (18 in.) due to sensor malfunctioning). Higher wind velocity associated with a higher building height of Level 6 contributed to higher peak temperatures within the burn compartment.

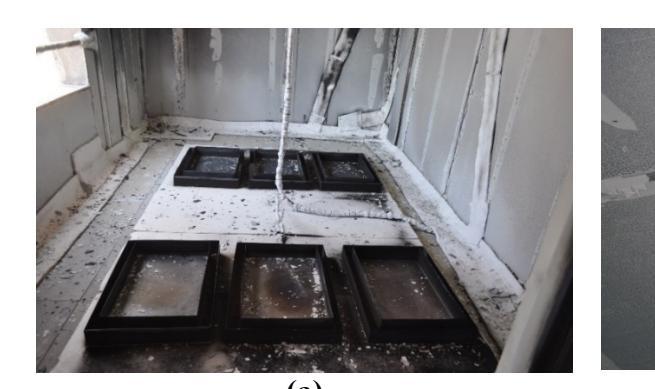
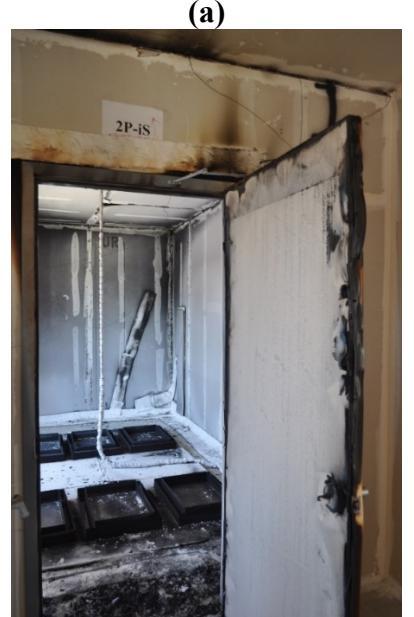
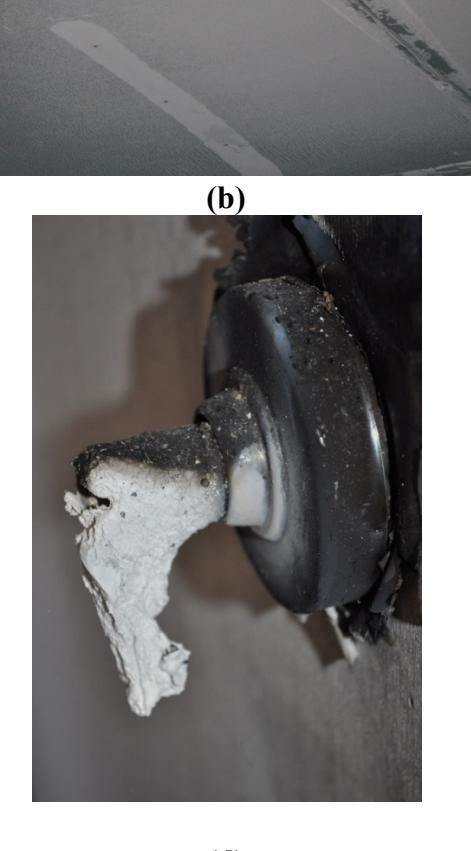
Figure 7.25 shows the fire-induced damage to the southwest (burn) compartment at Level 2 as observed following the fire test. Figure 7.25a shows the view of the compartment floor with the empty burners and retention pans. The figure also shows the gypsum wall debris and ceiling on the floor. It is observed that the TC tree remained intact and the insulation protection was adequate. Figure 7.25b shows the partially detached gypsum from the ceiling joists, which indicates the loss of its integrity and failure of fasteners. Figure 7.25c shows the exposed side of the door with a completely charred layer. The door closer was damaged by fire and the automatic

operation of the door was disrupted. Figure 7.25d shows the melted door handle on the exposed side after the fire test.

(c) (d) Figure 7.25. Damage to the burn compartment following Fire Test 1: (a) overall view of the damaged compartment, (b) ceiling damage, (c) exposed side of the fire rated door, and (d) melted door lock.

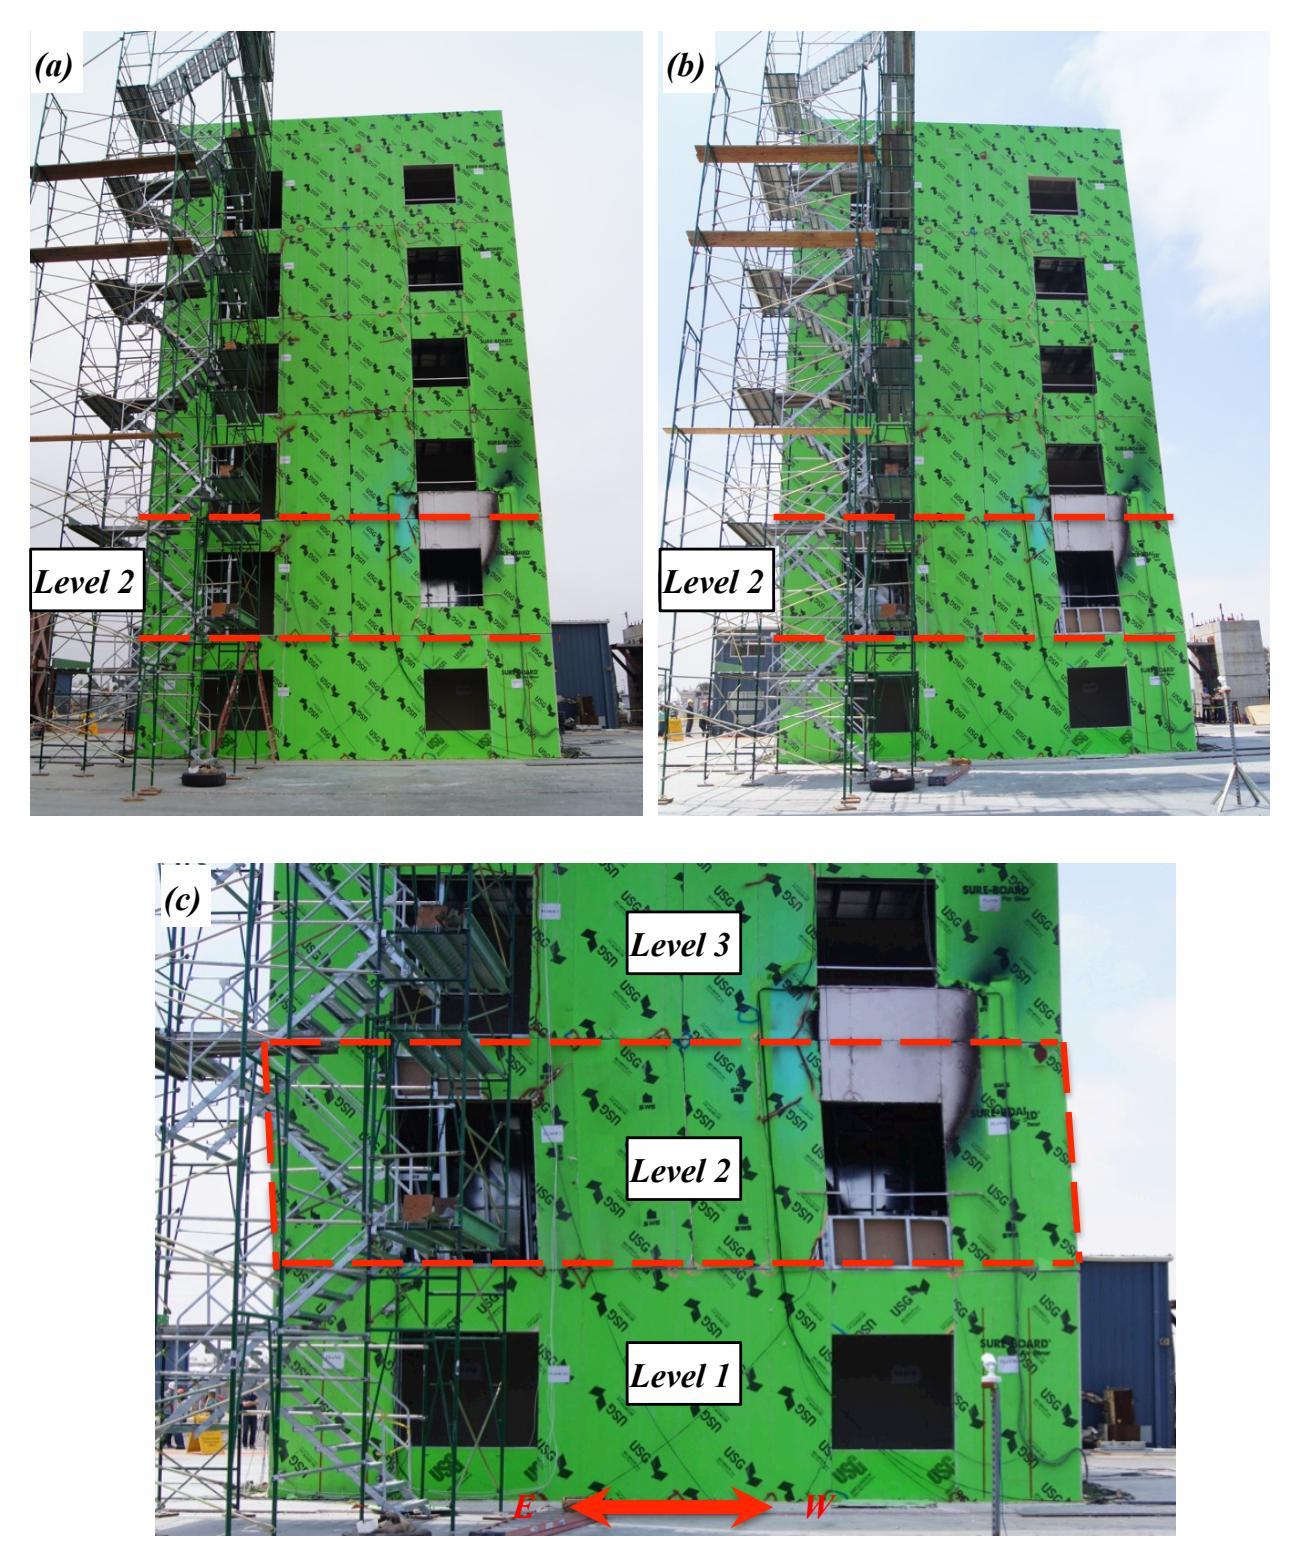
Due to the extremely large drift demands at level 2 of the building (transient PIDR exceeded 12% and residual IDR reached ~6%) during the final earthquake test (EA9), the building developed a soft-story mechanism at the completion of the test (Figure 8.29). The excessive interstory drift demands inflicted extremely severe damage on the structural components of level 2 and, importantly, revealed the ultimate damage mechanism of the lateral loading resisting system. The test building, however, resisted collapse largely due to redistribution of loads and the framing action of the continuous rod tie-down system. Damage to the remaining levels of the test building remained similar to those observed in the pre-fire test sequence, despite the continued increase of the interstory drift demands. In this regard, this section first summarizes the observed structural damage of level 2 and subsequently the structural damage of the remaining levels.

Figure 8.29. North elevation of the test building: (a) pre-EQ9 condition, and (b) post-EQ9 condition, and (c) post-EQ9 condition at the lower three levels.

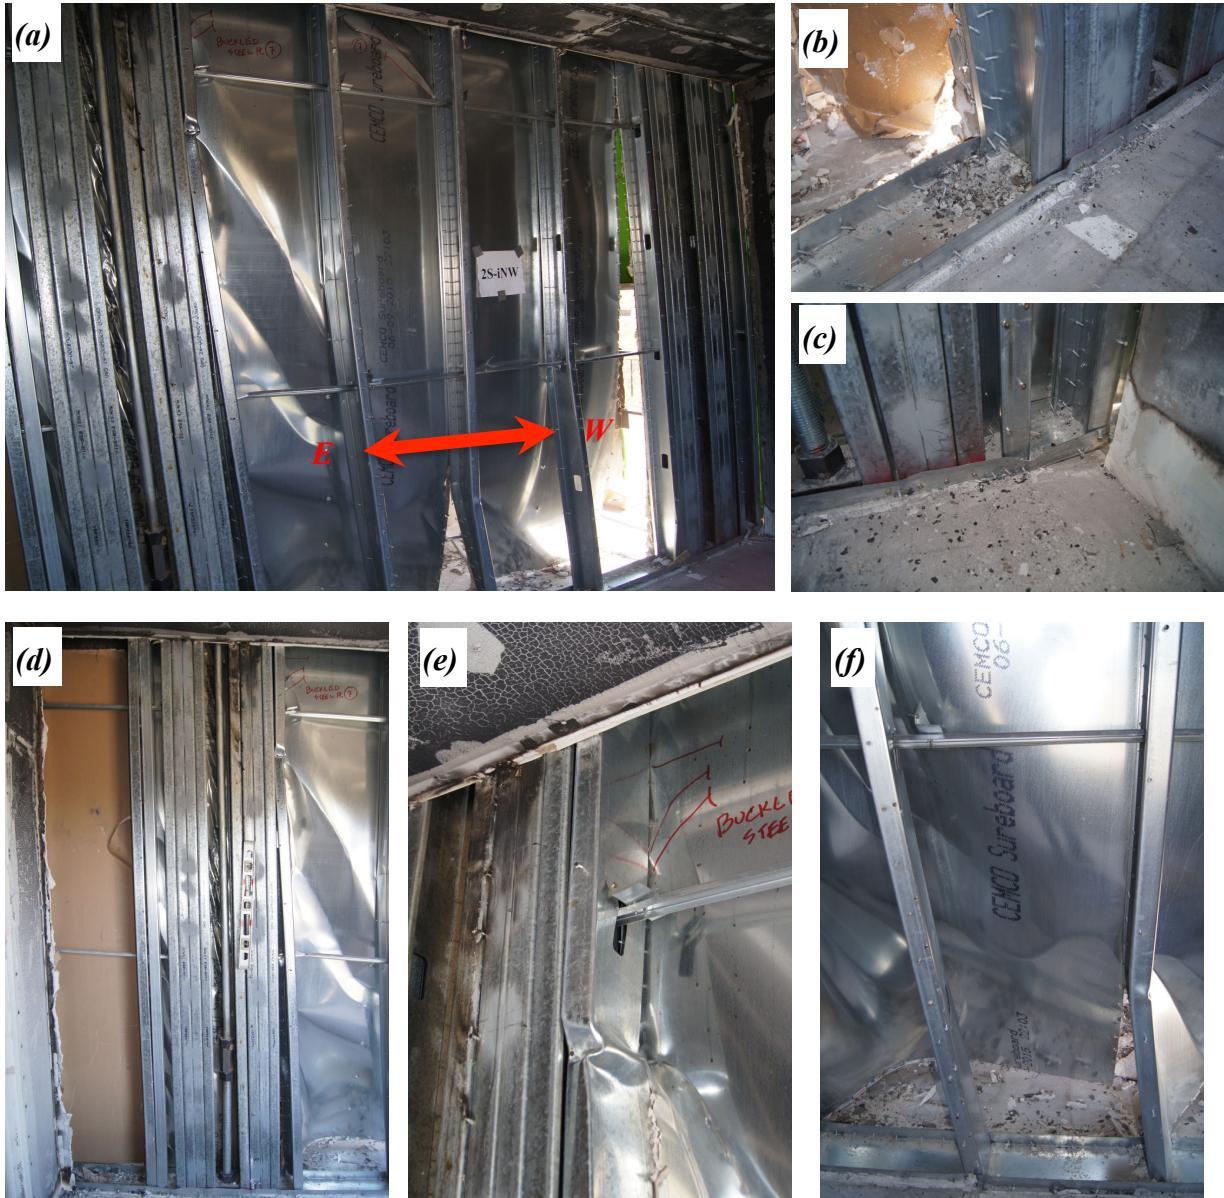
Figure 8.37. Northwest corridor shear wall at level 2 following the extreme MCE event (EQ9): (a) wall framing, (b) stud and track local buckling, (c) buckled and detached bottom track (west end of the wall), (d) tie-down assembly (east side), (e) crushed stud, and (f) stud global buckling.

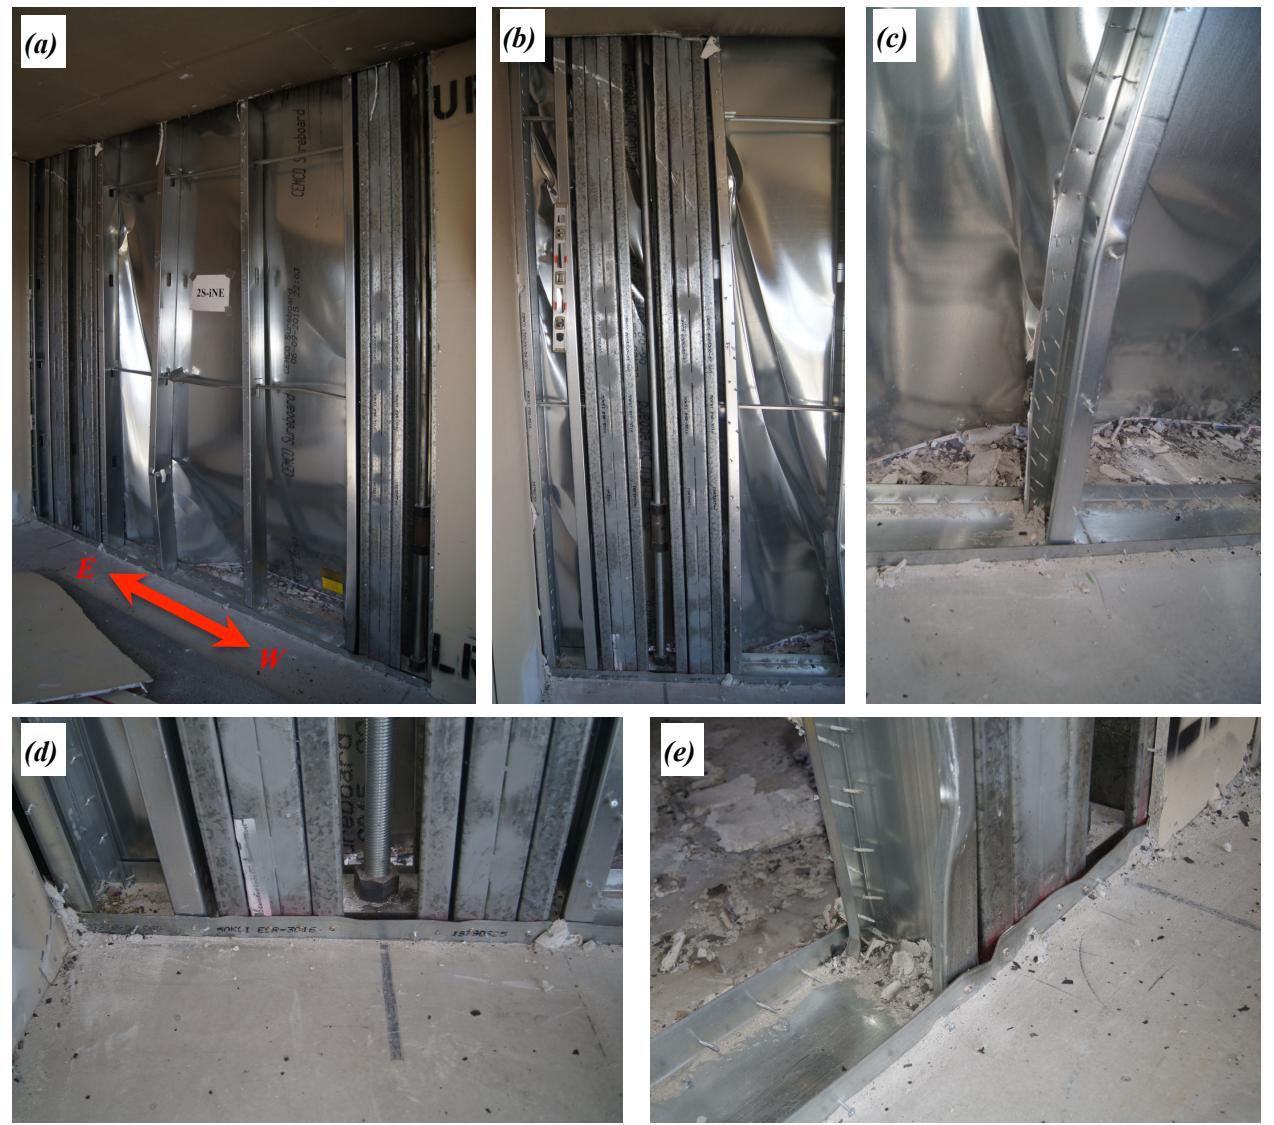
- <u>Corridor Shear Walls</u>: Due to the increase of unbraced length of the framing studs as a result of loss of sheathing panels on both sides of the wall, the vertical studs sustained extensive damage in the form of both global torsional buckling and local flange buckling (Figure 8.38c and e). In addition, local flange buckling of the bottom tracks also occurred at several locations. In contrast, the compression posts (stud packs) did not experience global buckling as a result of much larger strength and stiffness compared to the wall studs (spaced at 0.6 m), although a few instances of local flange buckling occurred at the base of the stud packs. All corridor shear wall tie-down rods performed well without connection failures.

Figure 8.38. Northeast corridor shear wall at level 2 following the extreme MCE event (EQ9): (a) CFS framing, (b) tie-down assembly (east side), (c) stud global buckling, (d) bottom track and tie rod bearing connection, and (e) vertical study and bottom track flange buckling.

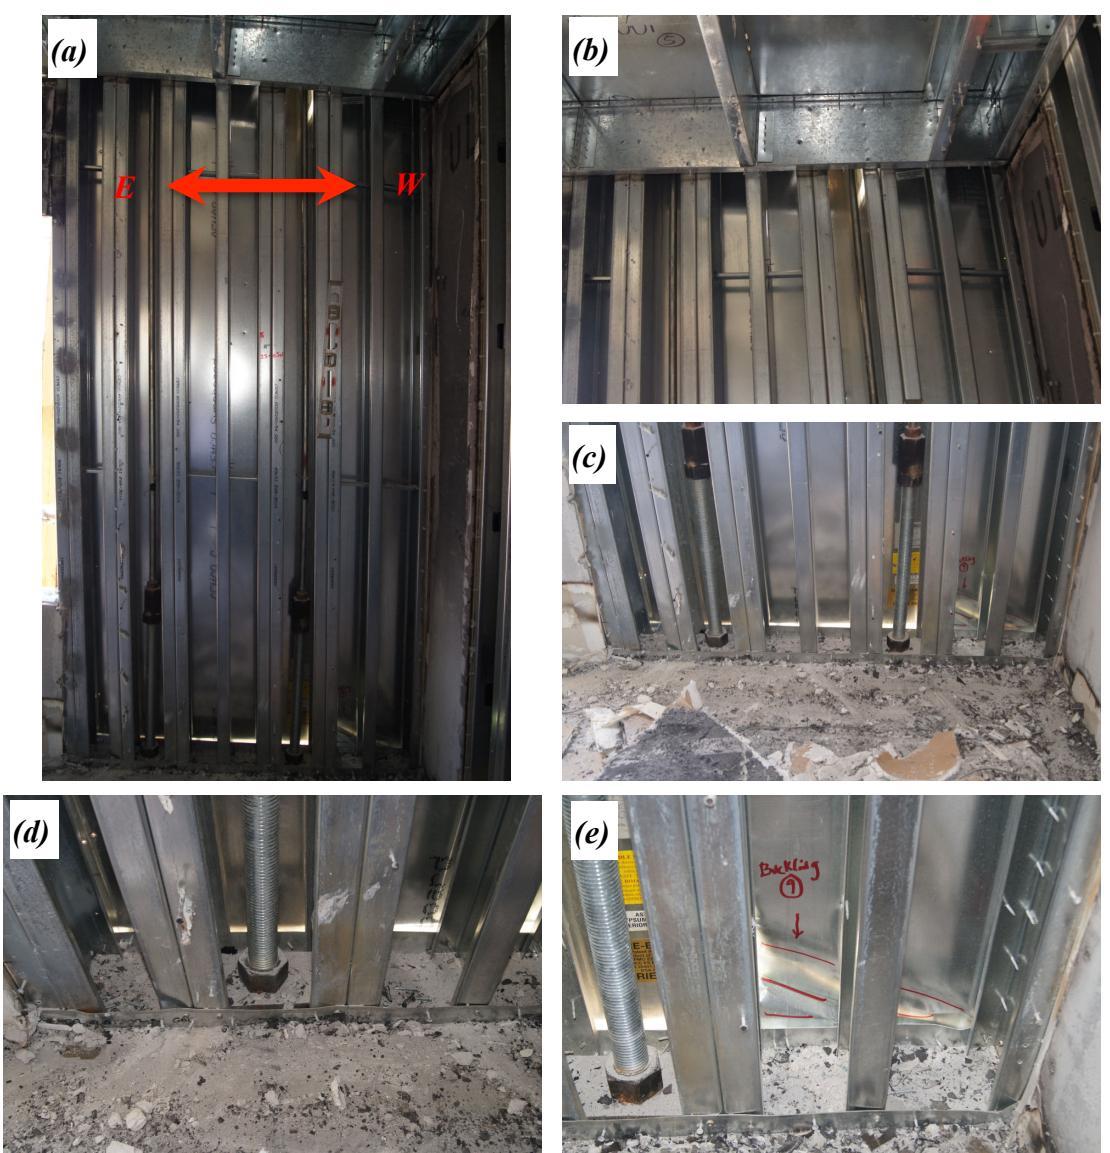
Figure 8.39. Southwest corner shear wall at level 2 following the completion of the extreme MCE event (EQ9): (a) wall framing, (b) upper framing and joist rim track, (c) lower framing and bottom track, (d) bottom track flange buckling, and (e) local buckling of exterior steel sheathing at the bottom corner and bottom track flange buckling.

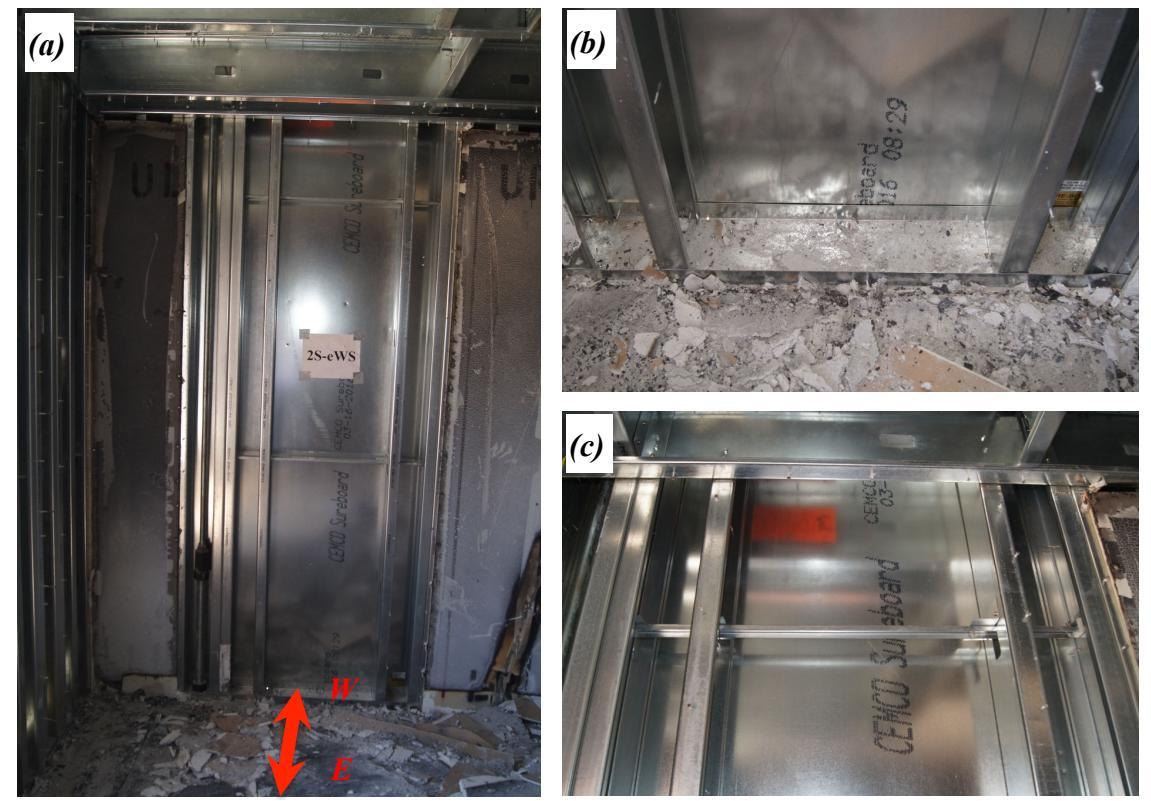
- <u>Transverse Corner Shear Walls</u>: Since the transverse corner shear walls were subjected to
  out-of-plane loading, the wall framing (studs and tracks) and the tie-down assemblies all
  performed well without apparent damage (Figure 8.43 and Figure 8.44).

Figure 8.43. Southwest transverse corner shear wall at level 2 following the extreme MCE event (EQ9): (a) wall framing, (b) bottom track, and (c) exterior structural panel steel sheathing.

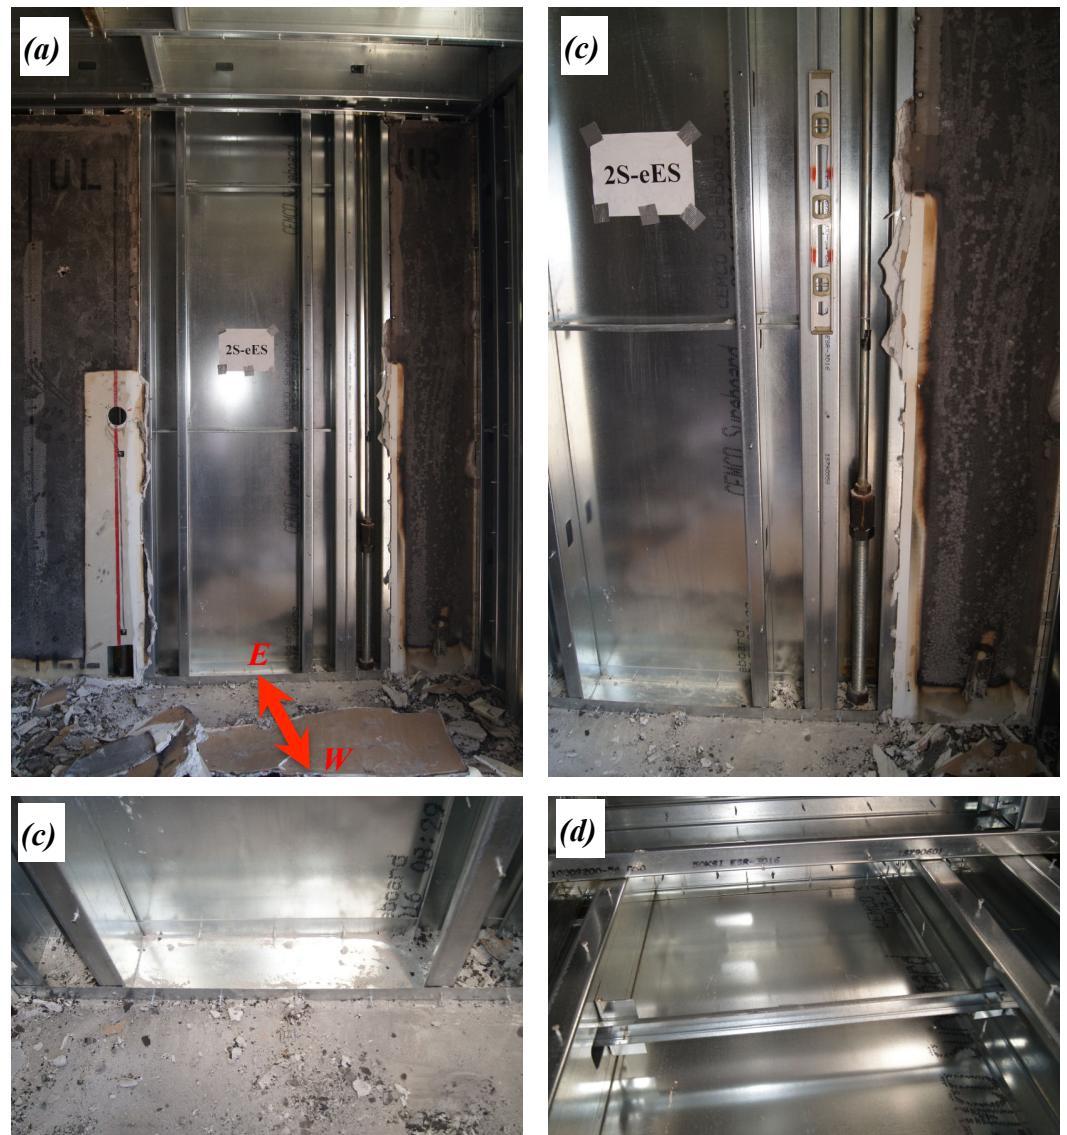
Figure 8.44. Southeast transverse corner shear wall at level 2 following the extreme MCE event (EQ9): (a) wall framing, (b) tie-down rod assembly, (c) bottom track, and (d) exterior structural panel steel sheathing.

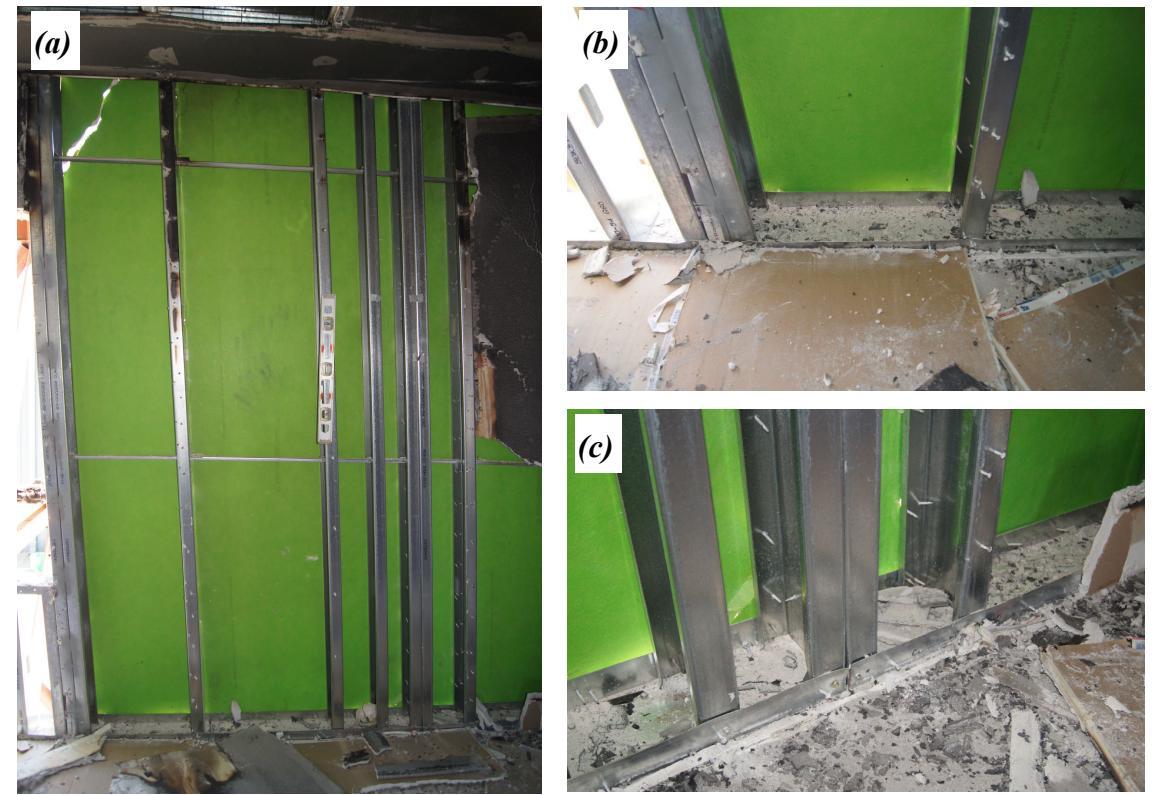
- <u>Gravity Walls</u>: The (exterior-side) sheathing panels remained attached to the framing. No apparent damage to the vertical studs and bottom tracks was detected (Figure 8.45).

Figure 8.45. Gravity wall (south side) at level 2 following the extreme MCE event (EQ9): (a) wall framing, (b) studs and bottom track (east), and (c) studs and bottom track (middle).

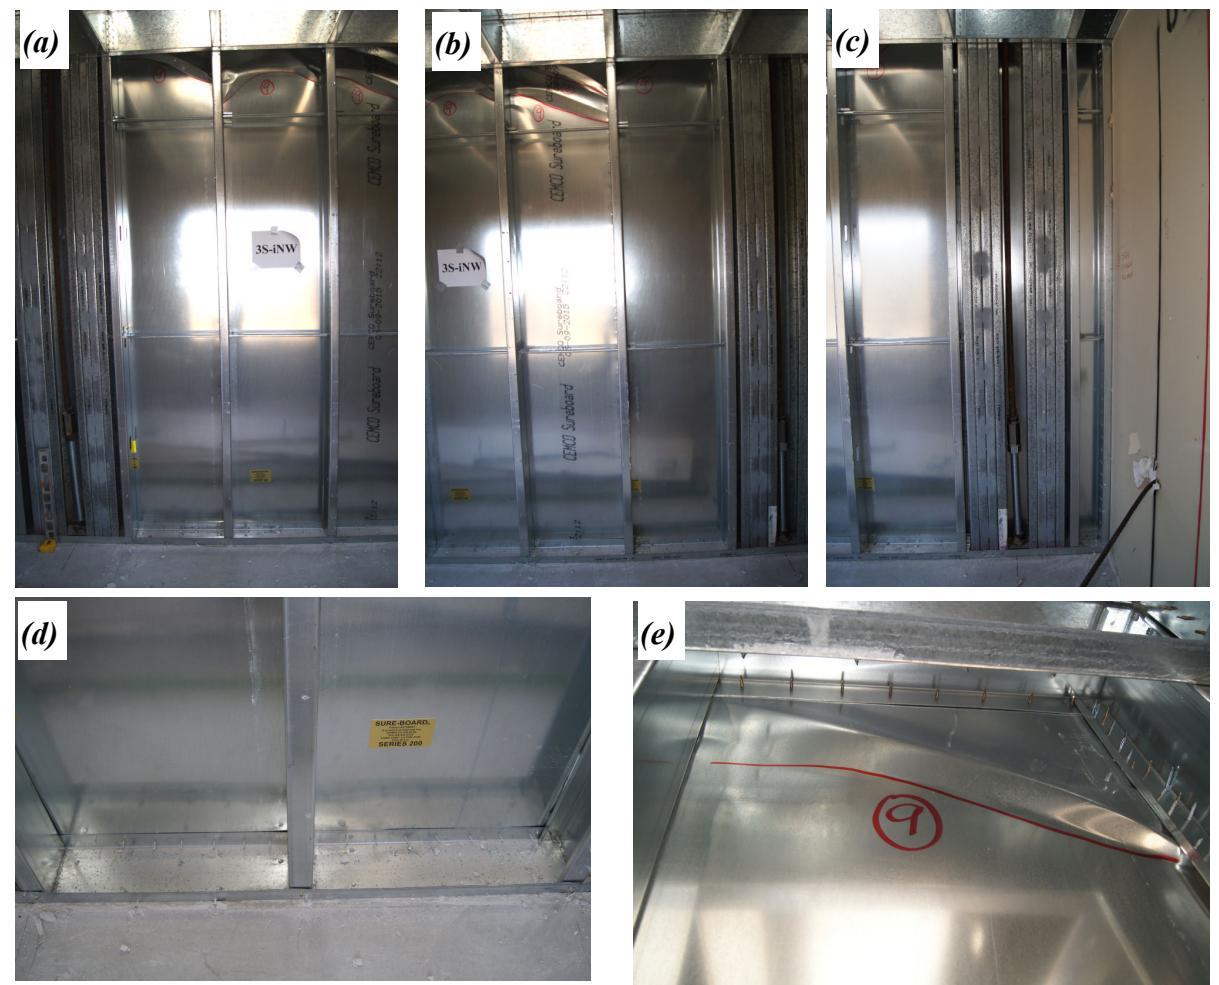
Figure 8.51 through Figure 8.55 show the damage photos related to the interior framing damage of the northwest corridor shear walls at the level 1, 3, 4, and 5 as well as the southwest corridor shear wall of level 6 (on a floor-by-floor basis). The corridor shear walls sustained sheathing steel local buckling at all levels except level 6. However, no visible damage to the corridor wall steel framing (studs and tracks) and the tie-down assemblies was detected following the extreme MCE event (EQ9). In addition, the longitudinal and transverse corner shear wall framing and the tie-down assemblies (except level 2) sustained no apparent damage, despite the large seismic drift demands (>2% at level 3 and 4) attained during the extreme MCE event (EQ9).

Figure 8.52. Northwest corridor shear wall at level 3 following the extreme MCE event (EQ9): (a) steel sheathing (east side), (b) steel sheathing (west side), (c) tie-down rod assembly (west side), (d) bottom track and lower sheathing, and (e) local buckling of steel sheathing at the top.

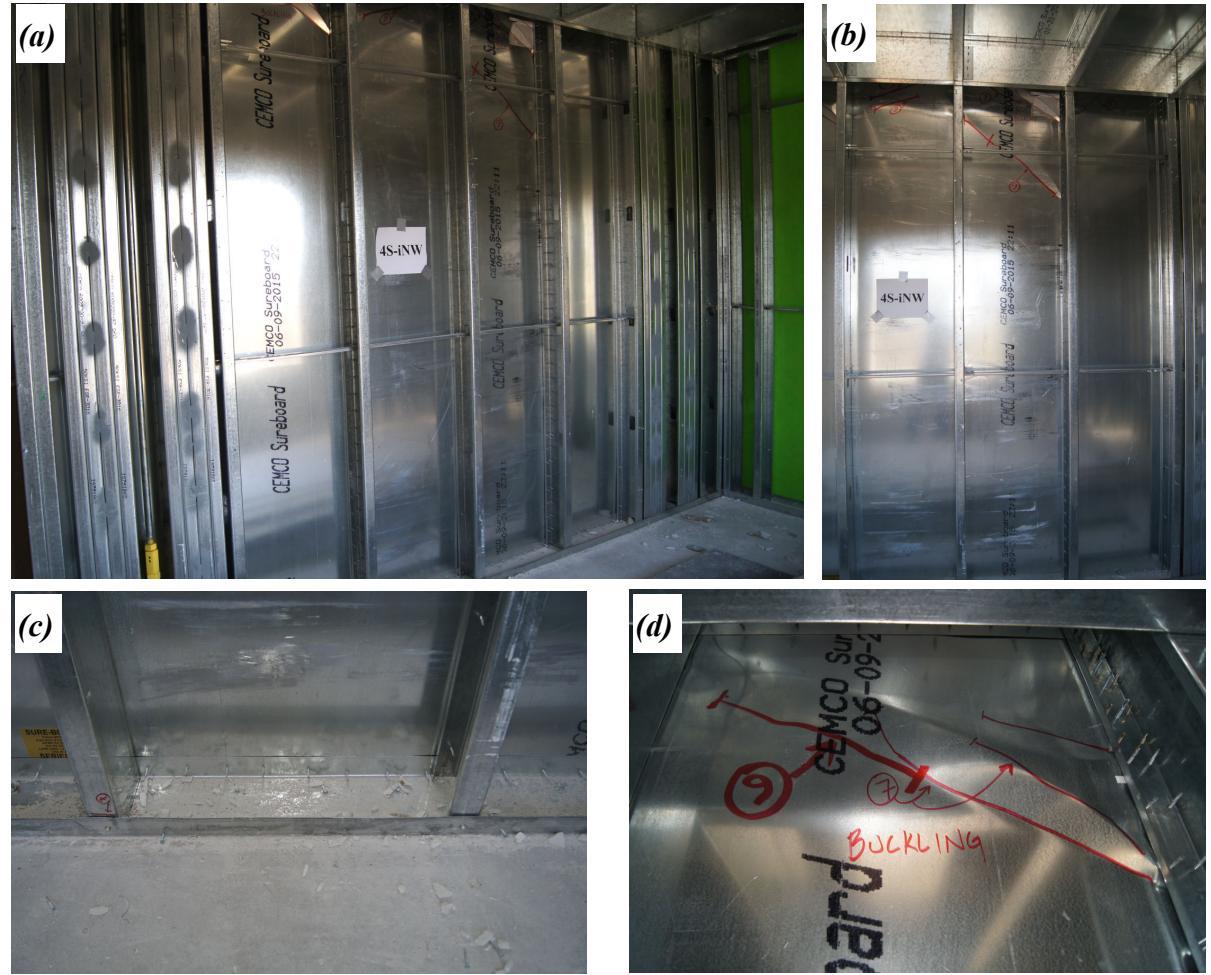
Figure 8.53. Northwest corridor shear wall at level 4 following the extreme MCE event (EQ9): (a) wall framing, (b) steel sheathing, (c) bottom track and lower sheathing, and (d) local buckling of steel sheathing at the top.

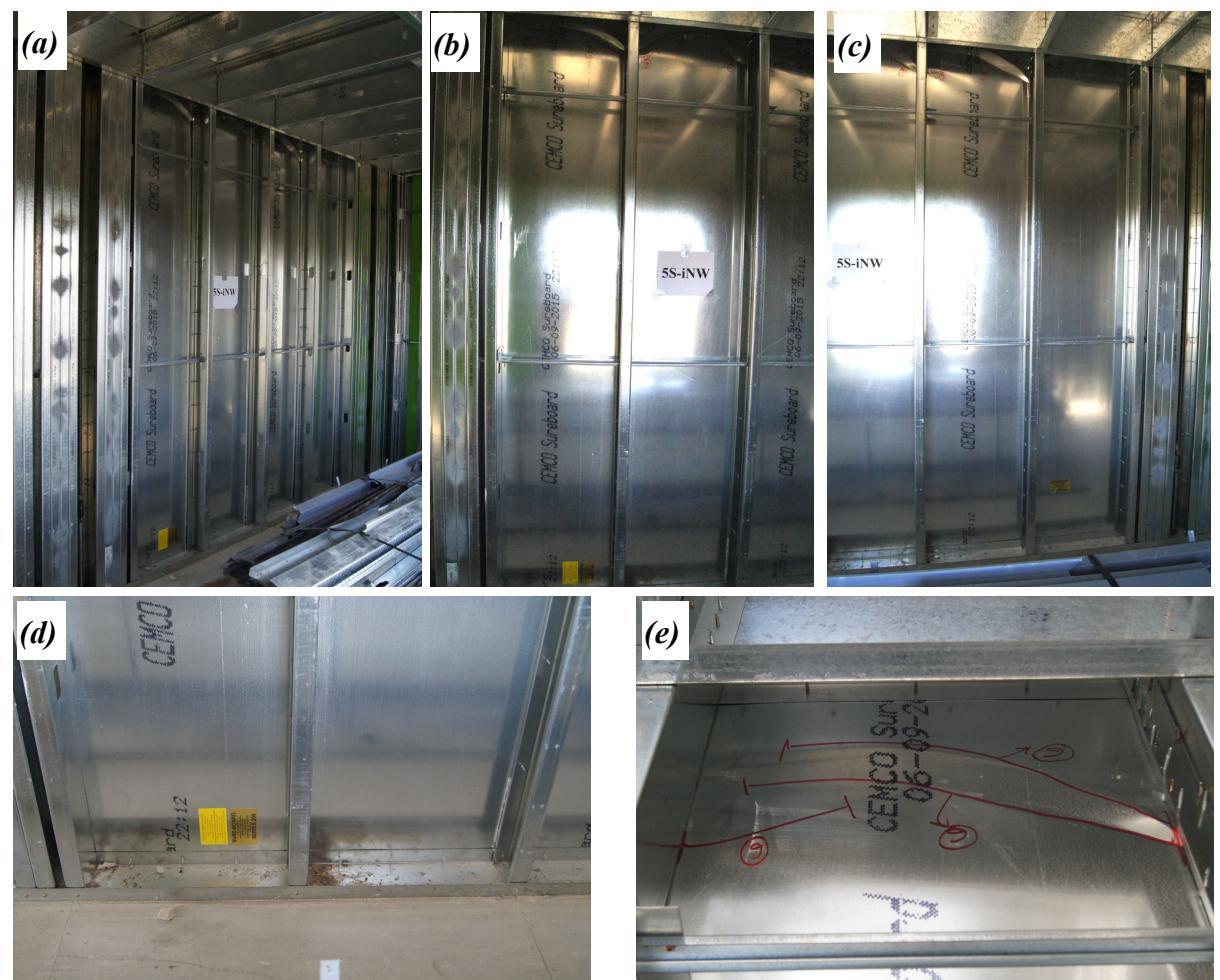
Figure 8.54. Northwest corridor shear wall at level 5 following the extreme MCE event (EQ9): (a) wall framing, (b) steel sheathing (east side), (c) steel sheathing (west side), (d) bottom track and lower sheathing, and (e) local buckling of steel sheathing at the top.

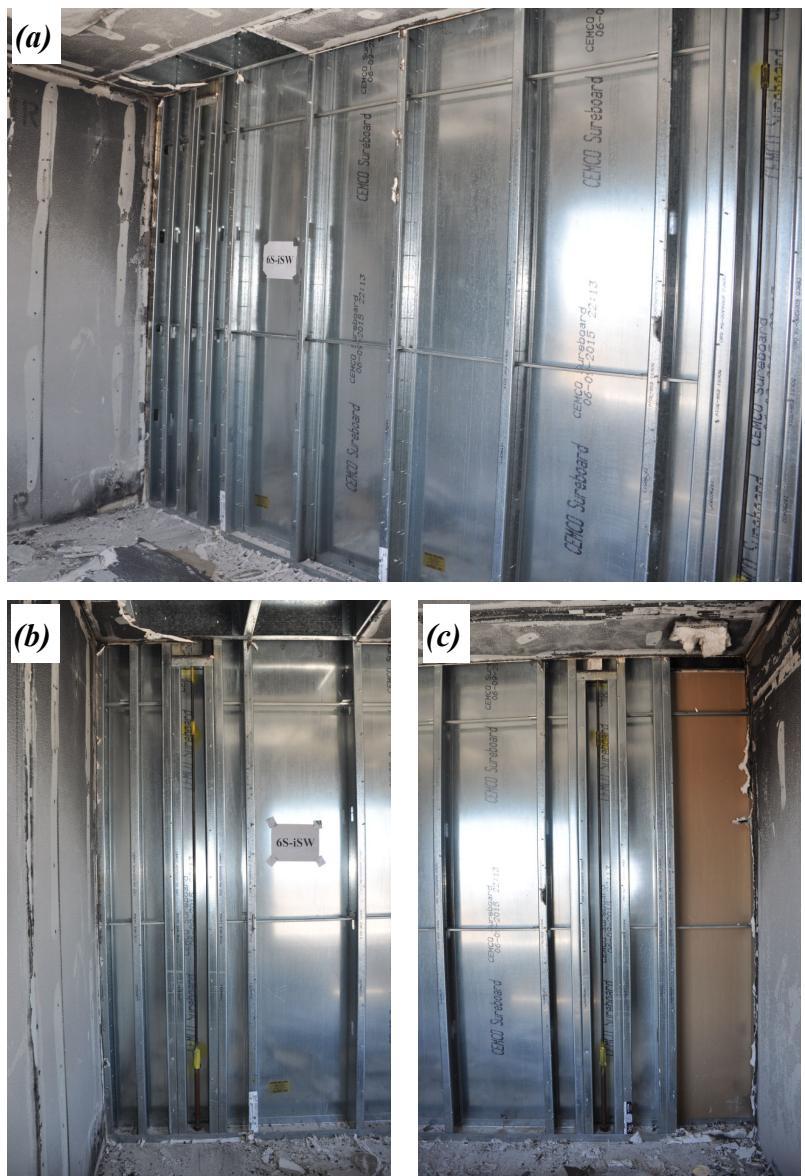
Figure 8.55. Southwest corridor shear wall at level 6 following the extreme MCE event (EQ9): (a) wall framing, (b) steel sheathing and tie-down assembly (west side), (c) steel sheathing and tie-down assembly (east side).

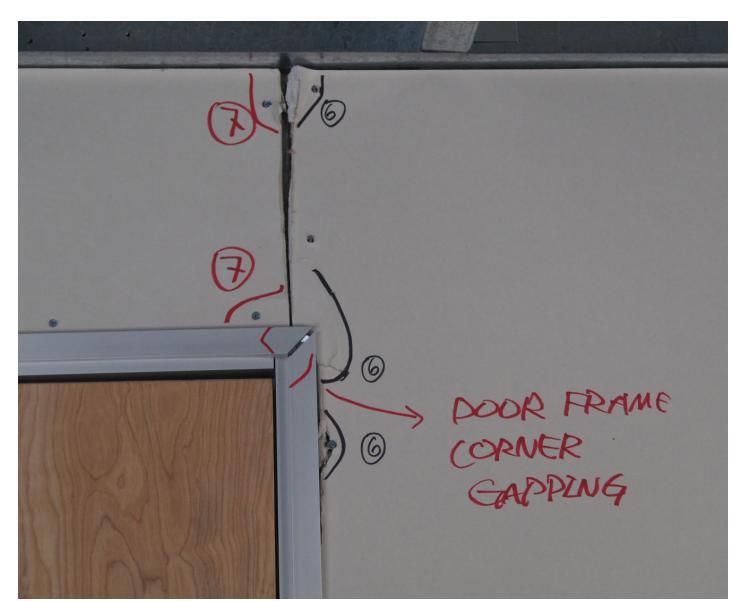
Figure H.7. Door 1-NC: door frame corner gapping following the MCE event (EQ7).

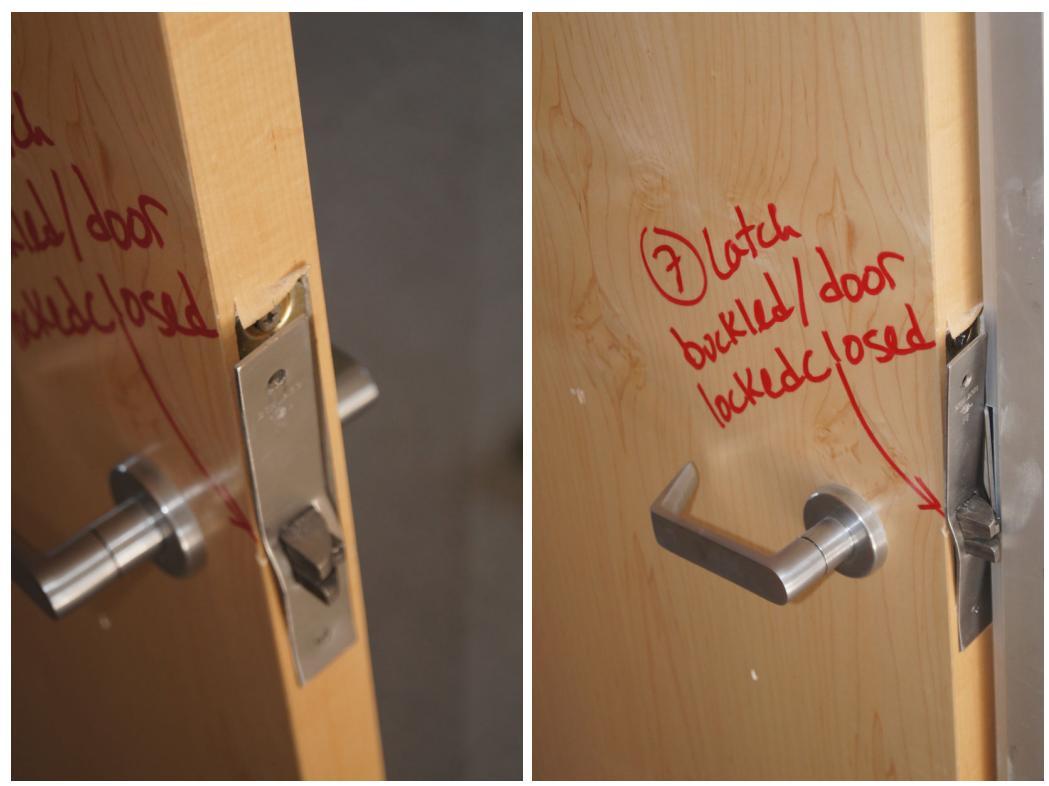
Figure H.8. Door 2-NC: buckled latch following the MCE event (EQ7).

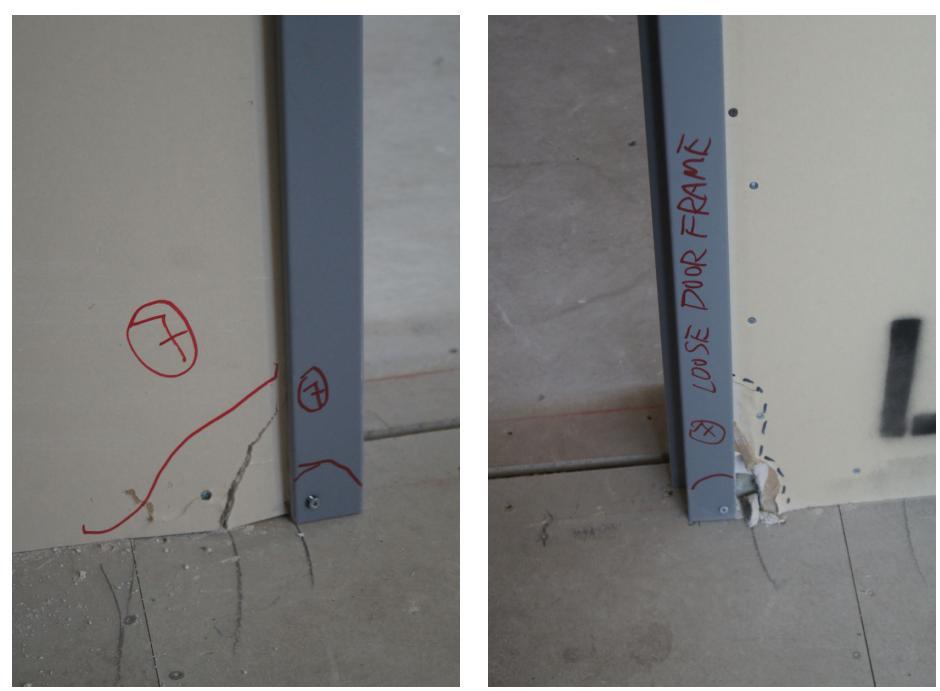
Figure H.10. Door 3-SC: Door frame screw withdrawal and loosening following the MCE event (EQ7).

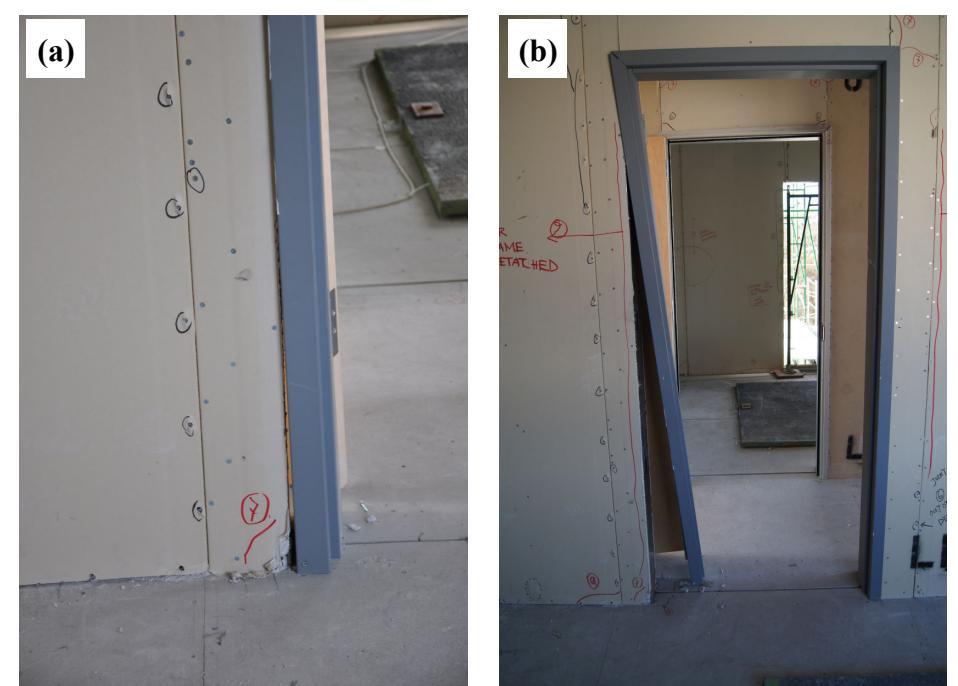
Figure H.12. Door 4-SC: (a) door frame partial detachment following the MCE event (EQ7), and (b) door frame detachment following the post-fire MCE event (EQ9).

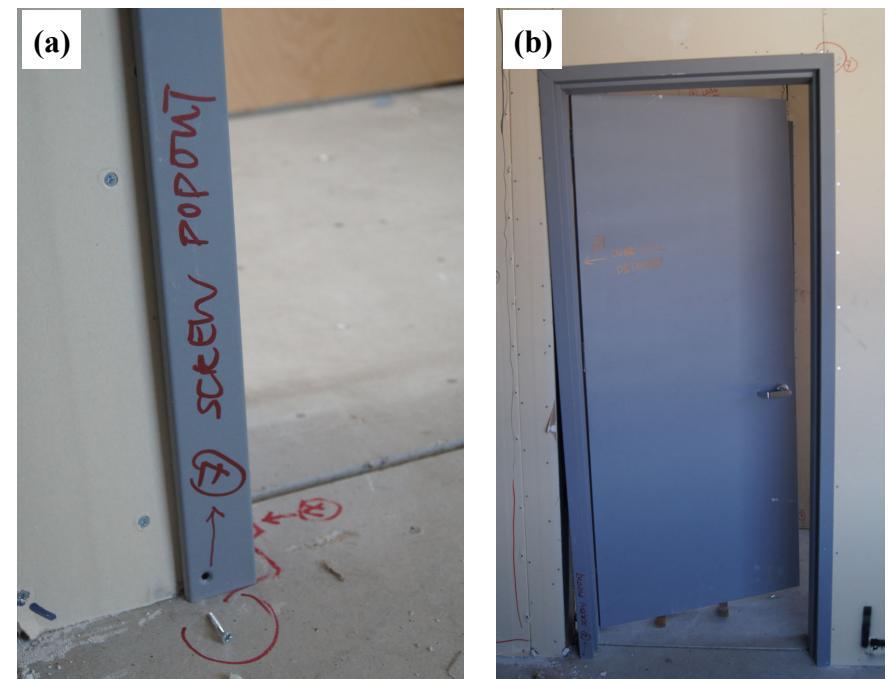
Figure H.13. Door 5-SC: (a) door frame screw withdrawal following the MCE event (EQ7), and (b) door frame detachment following the post-fire MCE event (EQ9).

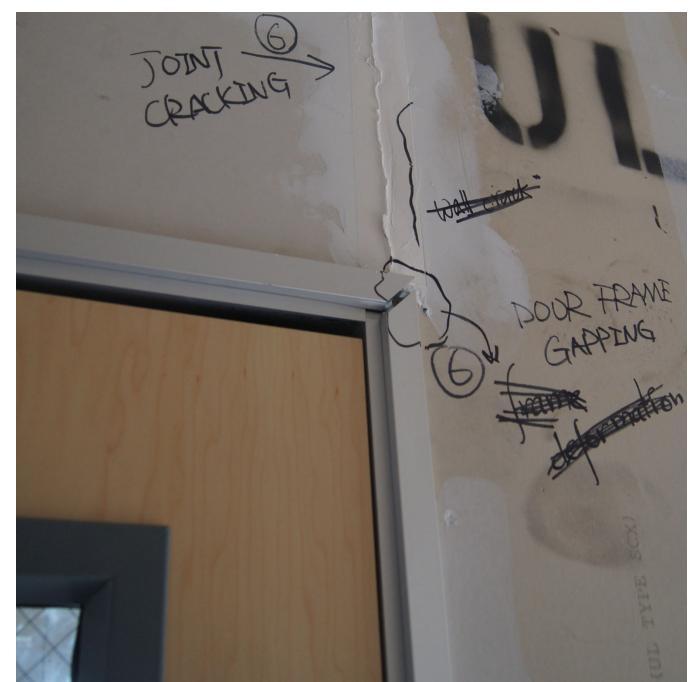
Figure H.14. Door 6-NC: door frame corner gapping following the design event (EQ6).

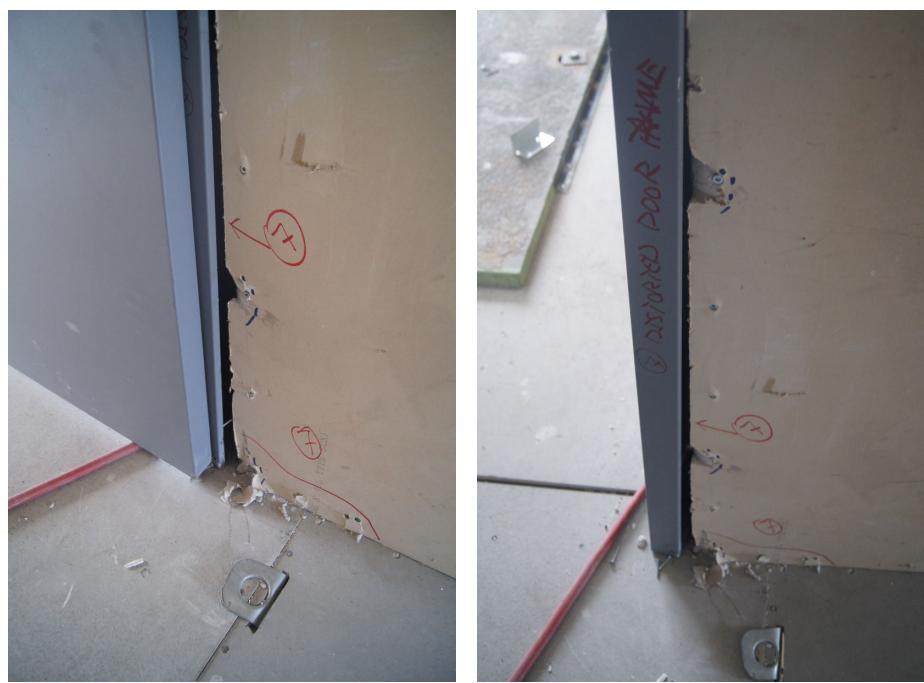
Figure H.15. Door 6-SC: door frame partial detachment following the MCE event (EQ7).

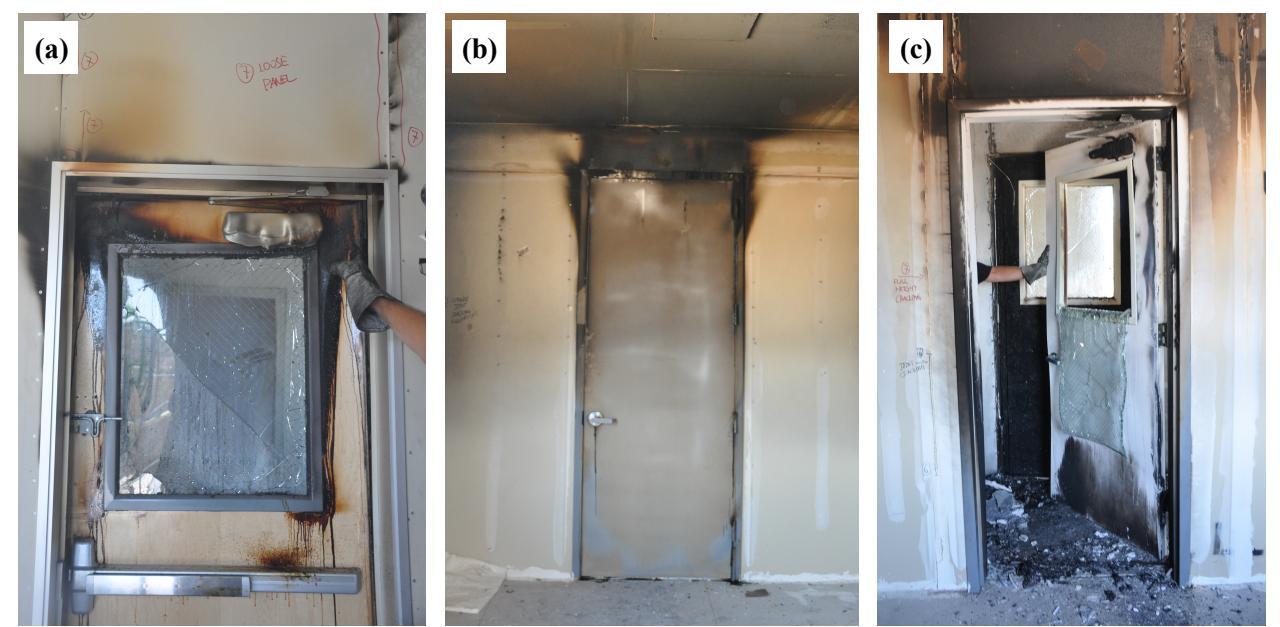
Figure H.17. Level 6 door damage following the fire tests: (a) 2-NC, (b) 2-NR, and (c) 2-SC.
