Earthquake and post-earthquake fire performance of a mid-rise cold-formed steel framed building

Tara Hutchinson, Xiang Wang, Gil Hegemier¹, Brian Meacham, Praveen Kamath², Fernando Sesma³ and Kelly Holcomb⁴

Abstract

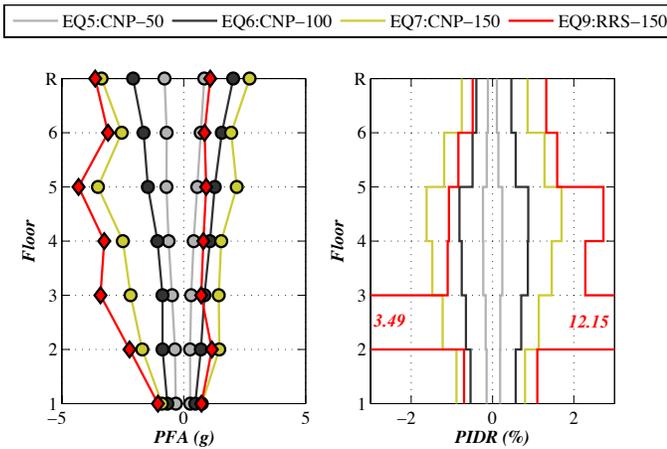
In contrast, Figure 22 presents the building PFA and PIDR responses during the above-the-service-level events (i.e. tests EQ5—EQ7 and EQ9). As the motion intensity increased, the largest PIDR reached about 1.0% during the design motion (test EQ6) and above 1.5% during the MCE motion (test EQ7). It is also revealed that the largest PIDR occurred at the mid-height of building (level 3 and 4) throughout the pre-fire earthquake test sequence. These results are consistent with building physical observations. In addition, the PFA increased almost monotonically up the height of the building during the pre-fire earthquake test sequence, indicating a fundamental-mode dominant structural response in these tests. In contrast, the final earthquake test (near-fault MCE event EQ9) subjected the building to extremely large drift demands (an interstory drift ratio of above 12% at level 2) and resulted in a near-collapse condition of the specimen. It is also noted that the residual (permanent) RDR of building exceeded 1% following the test (Table 3). This is partially attributed to the fire-induced damage to the gypsum sheathing at level 2, which reduced the shear capacity of the shear walls, encouraging formation of a soft-story mechanism during the final near-fault earthquake (EQ9) at this level.

Figure 22. Building peak responses during the above-service level tests: (a) peak floor accelerations, and (b) peak interstory drift ratios.

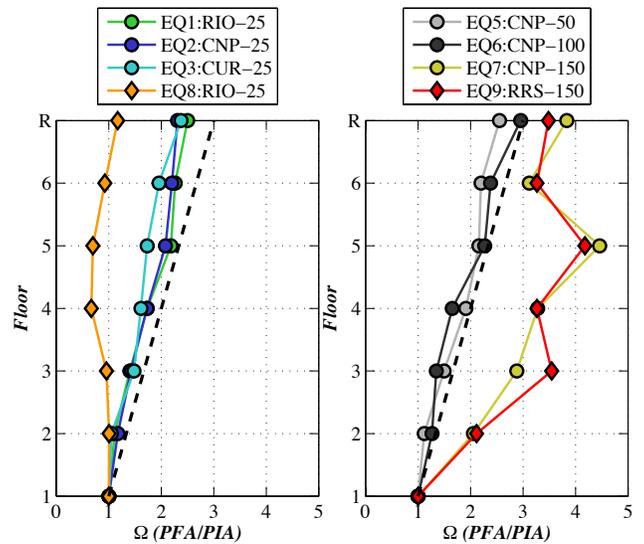
Comparison of Floor Acceleration Amplification: Figure 23 presents the acceleration amplification factor Ω of the test building during the earthquake tests, where part a includes those scaled to service level event intensity; and part b includes the above-service level scaled motions. It is noted that a mix of pre- and post-fire tests are overlaid. The acceleration amplification factor Ω is determined as the ratio between the peak acceleration achieved at each floor and the peak acceleration of the input motion. According to ASCE 7-10 (ASCE, 2010) code provisions, the amplification factor is empirically defined as $1+2z/h$ (z/h denotes the normalized building height), which represents a linear distribution along

the building height from 1.0 at the base to 3.0 at the roof. During the pre-fire service test sequence (EQ1-EQ3) (Figure 22a), the acceleration amplification factors increased monotonically up the height of the building with the largest values ranging between 2.0 and 2.5 at the roof, which is slightly lower than the code-specified value of 3.0. In contrast, as the building sustained significant period elongation prior to the post-fire service level test EQ8, the attenuated acceleration distribution was observed along the building height ($\Omega \sim 1.0$). The amplification effects continued to increase during tests EQ5 and EQ6 as the motion intensity increased (Figure 23b). It is noted that the amplification distribution achieved during the design event (test EQ6) agrees well with the code-specified distribution along the building height. During the two MCE events (tests EQ7 and EQ9), the observed floor amplification effects were significantly larger than the code-specified distribution at all floors (Figure 23b). This may also be partially due to the presence of impulse-like acceleration spikes during these tests.

Figure 23. Acceleration amplification ratios of the test building under: (a) service level tests, and (b) above-service level tests
